RECENT INVESTIGATION AND CONSERVATION OF SOME HISTORIC STRUCTURES AT MOOR POND WOOD, PAPPLEWICK, NOTTINGHAMSHIRE

by Richard Sheppard

OS Grid Ref. SK 545 550 (centred) TPA Project Code: PMP.4 October 2007

Trent & Peak Archaeology University Park Nottingham NG7 2RD

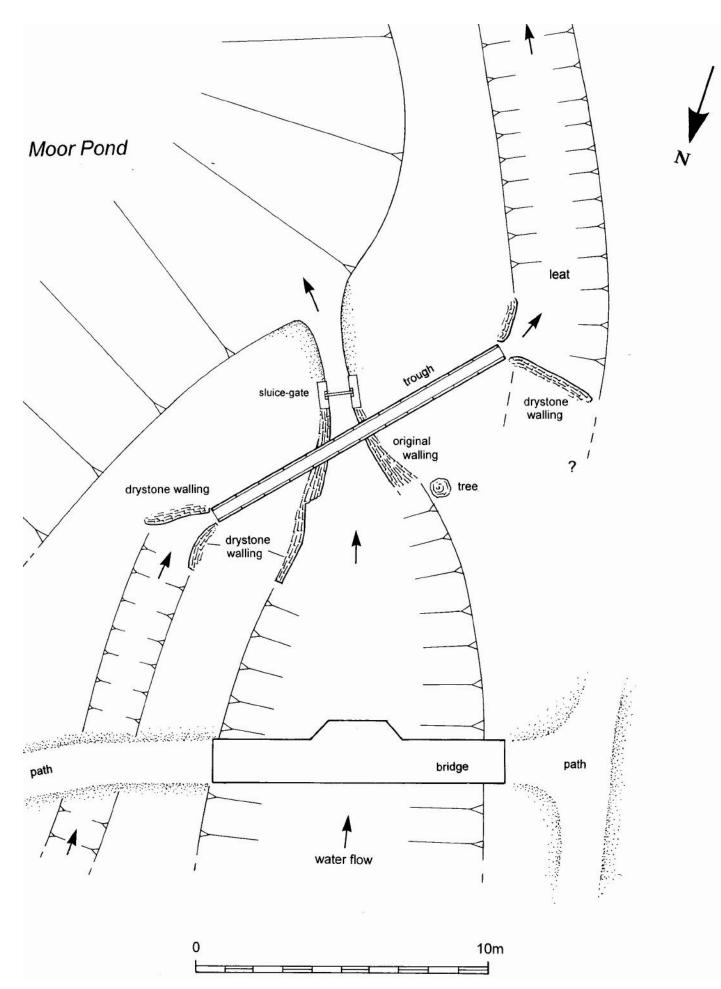
Fig. 2 Plan of Sluice 1 at the north-west corner of Moor Pond, Papplewick, showing original Phase I walling and later Phase II drystone walling and the line of the associated trough or launder that crossed over the approach to the sluice-gate. Scale 1:125.

The stonework leading up to the sluice-gate would have stood at least 2 metres high, and was battered (angled backwards), well mortared and regularly coursed. It was built to funnel water towards a sluice-gateway that consisted of large ashlar blocks, four set on top of each other on either side of the narrow slipway, with a thick timber gate. Each block was slightly shorter than the one below. Central recesses are about 12 inches (300mm) across and deep enough to have held a thick timber gate between jambs; this could have been raised by a rack and pinion device. From here water was allowed into Moor Pond. This is the original Phase I structure of the feature.

At a later stage (Phase II) some top stonework on either side of the sluice was cut away to allow for a timber trough or launder to cross the sluice at an acute angle. This trough was built of wood, with horizontal planking at the sides, at least two inches (50mm) thick. How thick the timber base was is unclear, as is whether the top of the trough was enclosed or open. It was more likely boarded on all four sides. Upright metal rods occur on either side of where the trough passed through the banks behind the stone walling, and these show that the trough was about 2ft (0.6m) wide and 4 feet (1.2m) high. The rods were arranged at 3 feet (0.9m) intervals and had small iron plates at their base which acted as brackets to help hold the horizontal timbers and maintain the vertical sides. Although most of the rods had been subsequently cut and bent over near their tops, one was found with a similar plate found at the top end; this suggests the full enclosure of the trough. Large nails and bolts have also been found along the line of the trough, and the six basic types of ironwork recovered are shown in Fig. 3. Figure 4 is a reconstruction of how the trough may have appeared.

At either end of the trough, which was about 36 feet (11m) long, drystone walling was added in Phase II at the flanks of embanked earth to help funnel water towards and away from the trough. This stonework was not mortared and was of rougher construction than the original mortared walling. Similar drystone walling was added to the east side of the main sluice walling, and perhaps on the west side, but this area is now still hidden beneath banking that supports a large tree and its roots. Drystone walling has also been partly exposed at the west end of the trough. The line of the trough has been partly excavated and is now made visible to the public by the inclusion of gravel (contained within timber lining) within the excavated east section and on the top of the unexcavated west part.

The existence of the sluice at the north-west corner of Moor Pond (Figs 1, 2) has been known for some time. Since 2002 it has been exposed, investigated and now fully consolidated by professional masons, with the stone slabs at the position of the gate re-erected into position. Plates 1-3a show these stages. A nearby footbridge provides a good viewing position and one for an explanatory board. The following description was written as background information for the latter, with some parts added since:

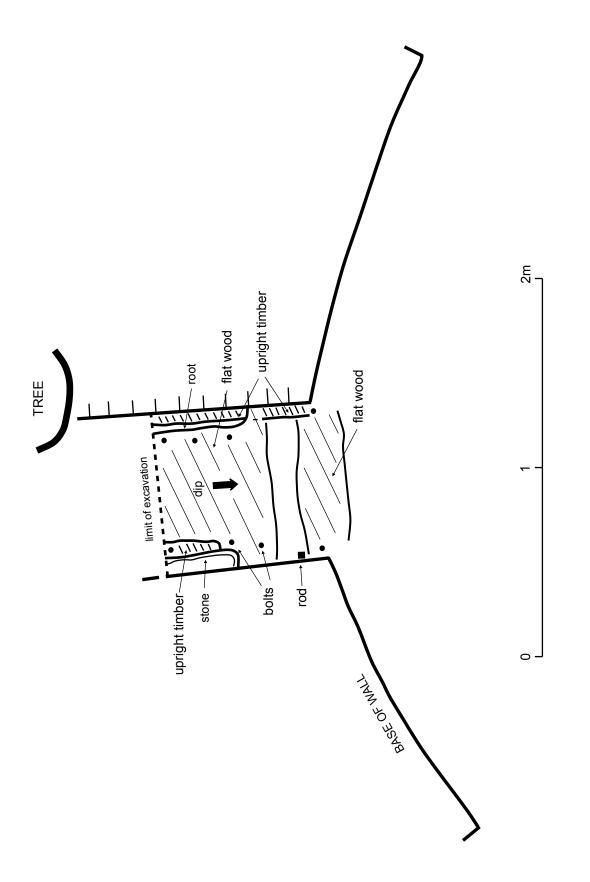
The stonework was found to be similar to the Phase II walling at Sluice 1. It was built in a curve of about 4.2m in length, battered back and without mortar (but with some tile uses as infill). At least 13 courses were found intact and the wall had probably been built much higher. In the centre there was a gap of c.0.8m. This was found to contain fragments of wood and ironwork indicating another trough similar to that at Sluice 1. Fragments of wood survived at the base, together with pieces to the sides that indicated a width of 2 feet (0.6m) for the feature. One long rod was found, 30 inches (0.76m) long. The base timberwork indicated that the feature was sloping down and that the trough was delivering water towards the reservoir rather than draining it away.

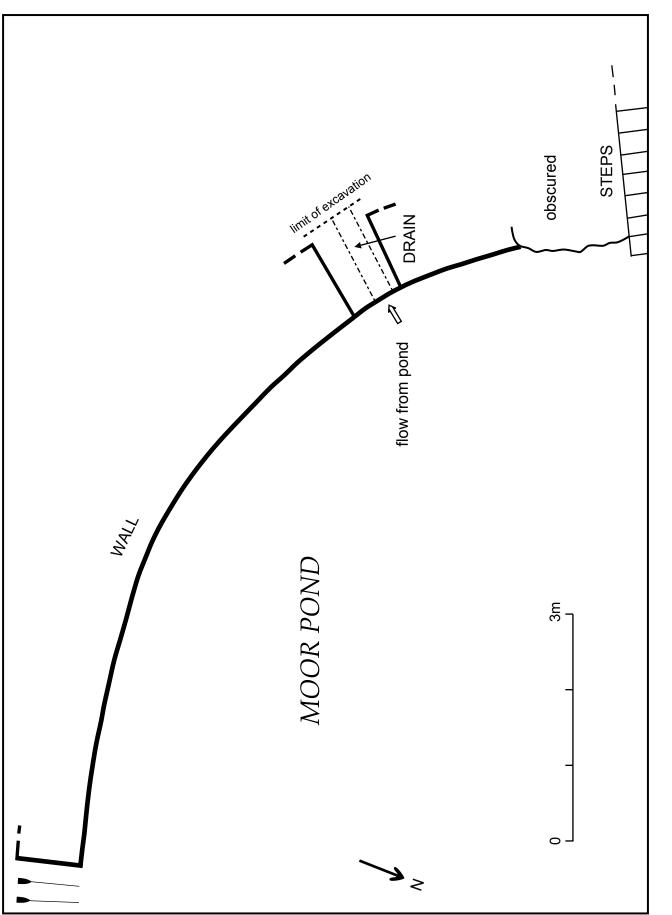
Fig. 6 Plan of the walling and drain at the south-west corner of Moor Pond, Papplewick. Scale 1:50

A length of well-built stone walling was fully revealed at the south-west corner of Moor Pond in 2003. This extended in an irregular curve for about 15m, although the full extent of its north end is not known. At the south-east end the wall was found to be 3 feet (0.9m) thick and towards its centre it was 4 feet (1.2m) thick. The stonework survived to a height of at least 1.4m, was gently battered and well mortared. The stages in its uncovering and consolidation are shown in Plates 7-9.

Towards the centre of the walling a brick-lined arched drain had carried water away to the south-west, in the direction of a brick-lined shaft (Site D), a distance of 15-20m away on the bank above the reservoir. The upper part of the brickwork arch was two-brick thick and strongly held together by mortar; it remains uncertain if it was fully or semi-circular in shape. Its diameter was 2 feet (0.6m).

The brick arch and stone walling around it had been cut through to insert interlocking sections of ceramic pipe 10 inches (0.25m) across. The ground had been cut into for some distance behind the wall as a line of disturbance and the dipping of its infill could be seen extending back from the wall, in the direction of the shaft. Whilst the 2½ inch (63mm) thick brick used in the arch indicated a date in the late 18th century, the ceramic pipe was of probable 20th century date.

The walling was later consolidated and the damaged stonework around the drain replaced. Problems with vandalisation has meant that whilst the main walling has been consolidated with the use of lime mortar, the top courses have to be held together more strongly by modern cement mortar.

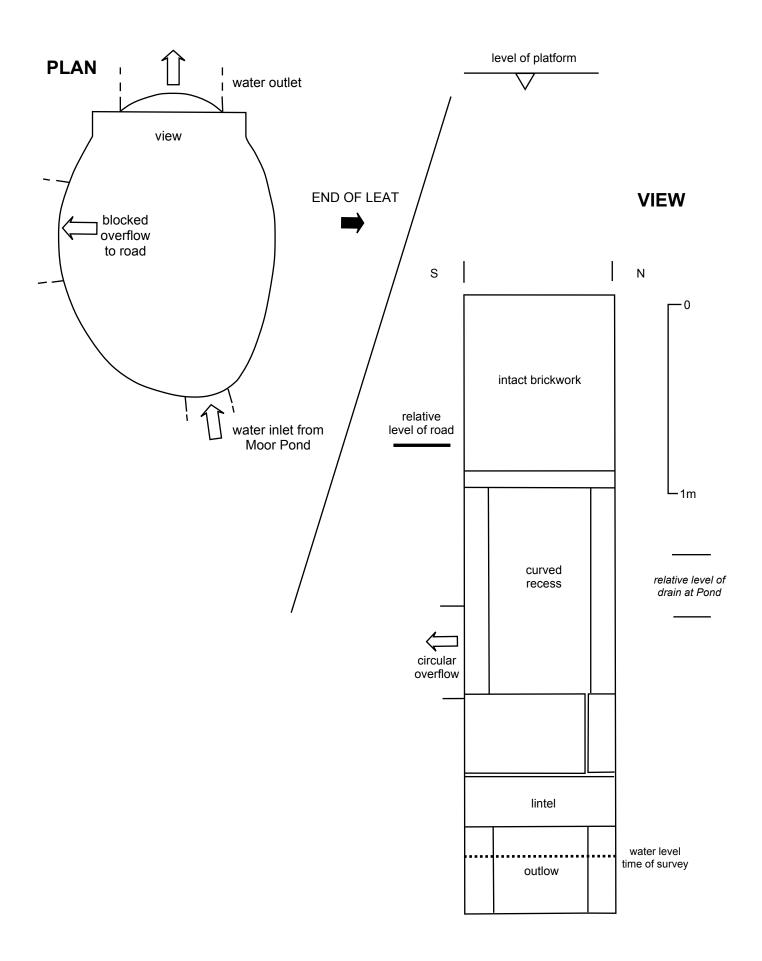
Fig. 7 Stylistic plan and west end view of the egg-shaped shaft to the south-west of Moor Pond, Papplewick (close to Papplewick Lane). Scale 1:20.

The shaft is built in an irregular egg-shape with, towards its base an inlet on the north-east side and an outlet directly opposite. It is 4.5m deep from the platform level erected around its upper perimeter. The structure is built of late 18th century 2½ inch (63mm) thick brick, laid with the header ends facing inwards. On the south-west side the walling is regular and mainly built from stone, with a lintel over the rectangular-shaped outlet (20 inches or c.0.5m across and high). The inlet opposite is within the brickwork, with an arched top of smaller dimension to the outlet (water in the base of the shaft interfered with its precise measurement. Part way up the south side there is a circular overflow drain, 20 inches (0.5m) across, tightly blocked up with infill material to prevent water loss.

How this feature (first referred to as the *plug-hole*) worked is unclear. Water flowed into it from the drain by the pond, itself estimated to have been about 1.5m above the level of the shaft inlet. Water was then either allowed to continue on through the outlet, or was forced upwards to go through the so-called overflow opening (Plate 13). Some form of shuttering or gate was used along the straight face above the outlet to control the water. No evidence for this survived although part of the upper stonework face was curved backwards to a depth of about 10cm for some associated reason – this shows in the lower part of Plate 12.

Immediately to the south-west of the pond walling the drain led to a brick-lined open shaft that was first looked at in 2002 when some of the surviving upper brickwork was exposed. It has since been emptied of infill to its base and the top brickwork repaired and heightened to allow for a platform and a protective grill. Stages in its investigation are shown in Plates 10-13.

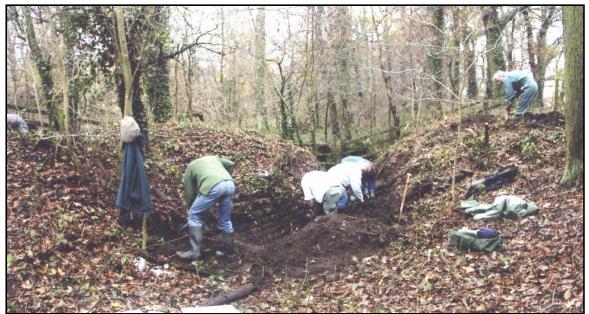
Plate 1 (AP 01)

Plates 1-3a: Stages in the uncovering, investigation and reinstatement of the stonework around Sluice 1, at the north-west corner of Moor Pond, Papplewick. Photos by author. *AP: Archive Photo number*

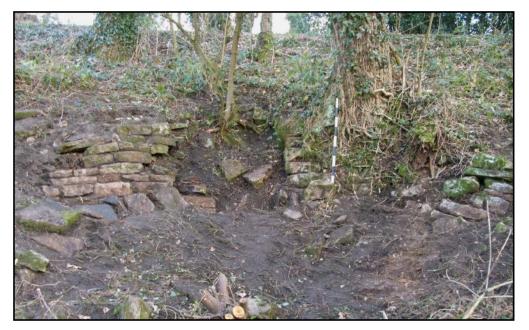
Plate 4 (AP 99)

Plates 4-6: Stages in the revealing and investigation of the stonework around the probable inlet point on the east side of Moor Pond, Papplewick. Photos by author. *AP: Archive photo number*

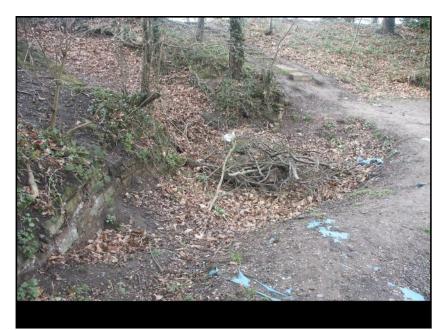
Plate 7 (AP 123)

Plates 7-9: Stages in the uncovering, investigation and reinstatement of the stonework at the south-west corner of Moor Pond, Papplewick. Photos by author. *AP: Archive photo number*

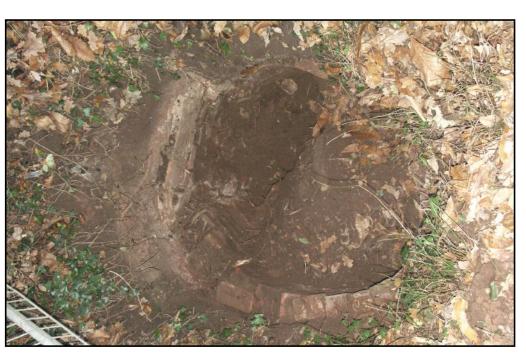
Plate 10 (AP 159) **Plates 10-13:** Stages in the uncovering and investigation of the egg-shaped water control feature, situated north of Papplewick Lane, Papplewick. Photos by author. *AP: Archive photo number*
