**GRANGE COTTAGE SLUICE, MOOR POND WOODS,
PAPPLEWICK, NOTTINGHAMSHIRE
REPORT ON AN ARCHAEOLOGICAL INVESTIGATION**

For: The Friends of Moor Pond Woods

Report Number: 060/2015

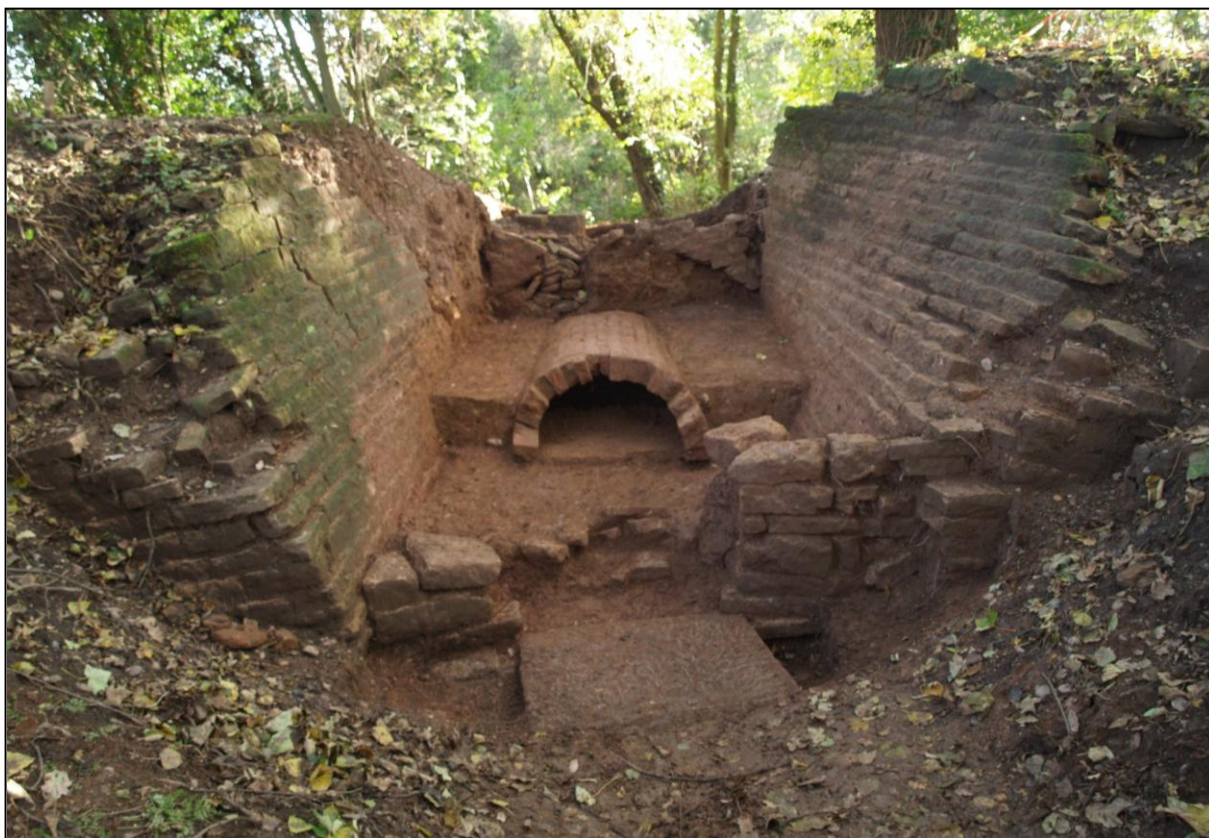
6.1.1 Removal of the brown grey topsoil (0001) and stone rubble infill (0012) revealed two stone walls, [0003] and [0004], at the terminal end of the leat (Figure 6). Both walls were north-south aligned, and 23 courses of dressed grey Mansfield stone were exposed, with the potential for more courses below the pink clay (0005) that abutted both walls. The stones ranged in size from 80mm to 120mm in thickness and were bonded with a thin layer of cream white mortar. The walls both fanned out so that the space in between the two walls widened towards the top courses, however the walls are not symmetrical in their shape. There is no evidence that the two faces of the sluice continued beyond cross wall [0019] (Plate 1).

6.1.5 Upon removal, the two walls are found to be resting on top of a large limestone slab measuring 78 x 108 cm [0011]. Excavation below this slab revealed a void containing timber fragments and iron nails (Plate 1).

Plate 1: Plan shot of sluice and brick culvert prior to the remove of the cross wall rubble (0012) and the excavation of the cut of the culvert [0008], stone slab [0011] in the front of shot. Looking south (S. Walker, 2012)

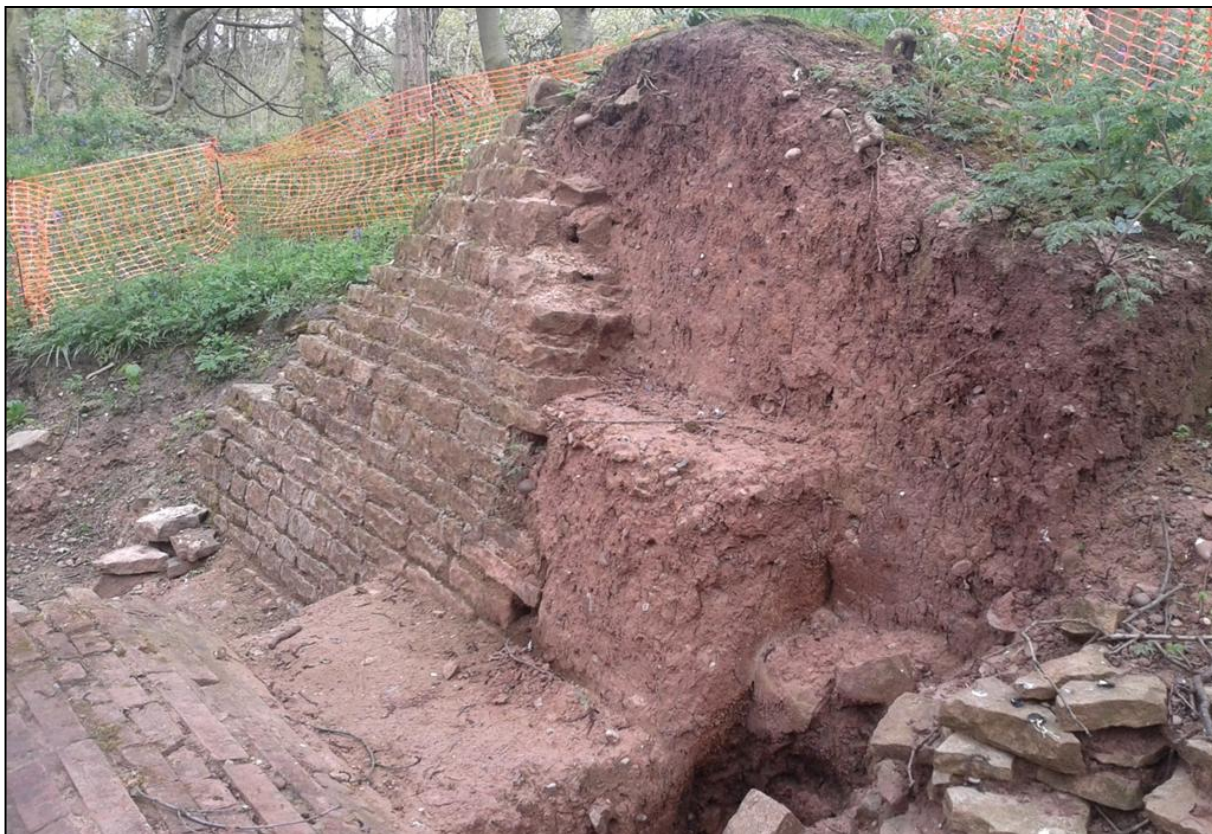
The eastern face of the sluice was observed over a north-south length of approximately 4m and an exposed height of 2.25m. The wall had been badly damaged above the tenth exposed course at the northern and southern extents where only 2.7m of the stonework remained (Plate 2). The damage to the north revealed that the stonework was cut, or reset into the bank of the leat. The damage to the south has been repaired with the application of a pink yellow clay (0005). The lower wall courses observed at the northern extent of the structure, show evidence of a return to the east suggesting here a step back into the leat bank (Plate 3). The profile of eastern wall was steeper than that of western [0004]. The lower courses were almost vertical. The face stepped back further at the north end of the structure than at the south, creating a funnel effect.

- 7.1.4 The absence of a large part of the eastern sluice wall suggests that, at some point, this part of the structure was destroyed and then repaired with pink clay. It cannot be said as to whether the damage was accidental, when this damage occurred, or whether it was associated with the collapse of the cross wall [0019].

Plate 2: Eastern wall of sluice, partially destroyed. Pinkish clay has been used to fill this gap. Looking north east (L. Binns 2015)

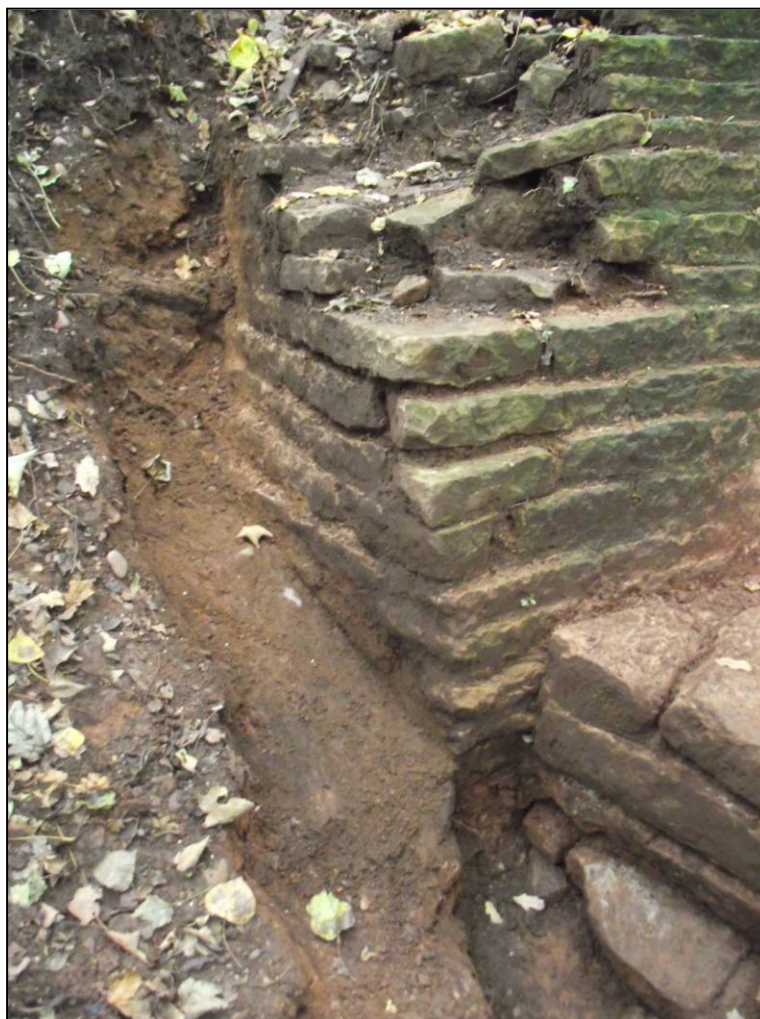
Plate 3: Eastern wall of sluice, the northern end, with clearly visible return. Looking south east (L. Binns 2014)

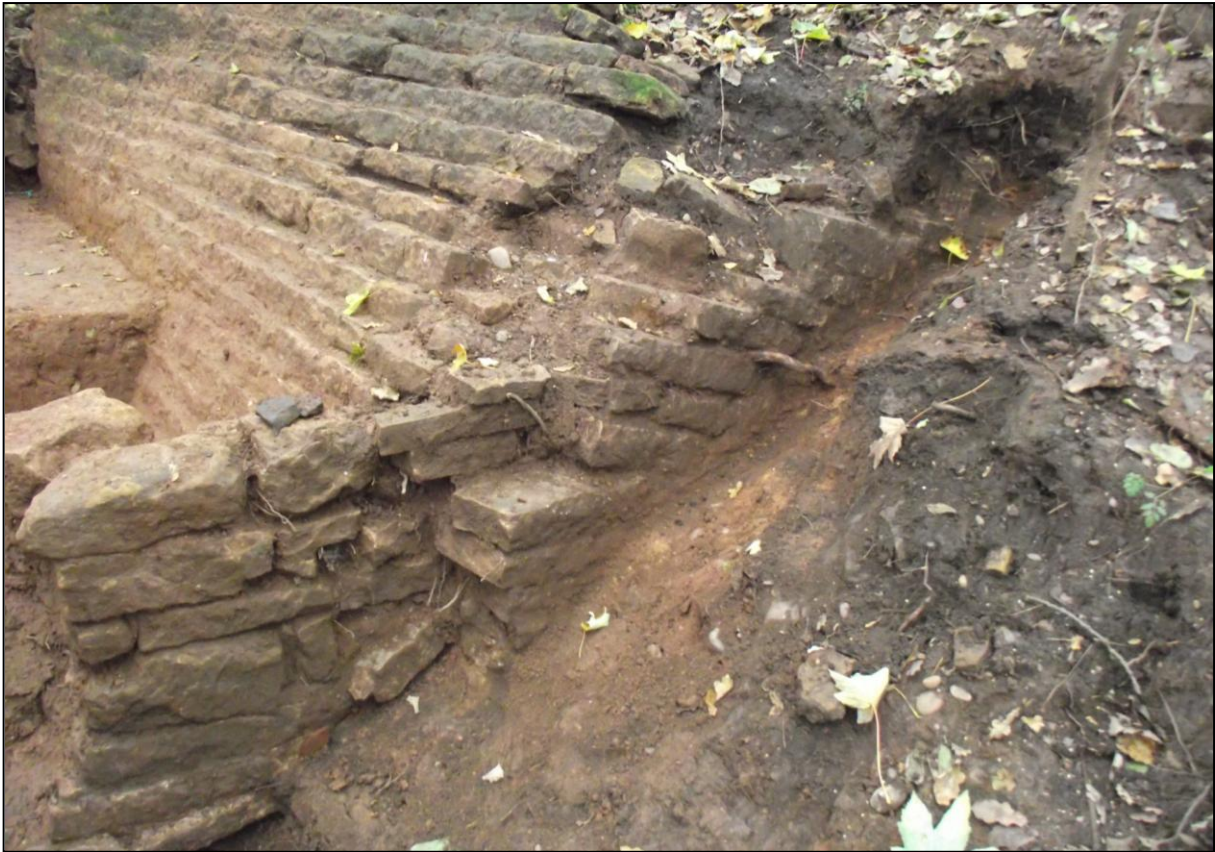
Two low stone walls, were uncovered at the northern end of the sluice. Both walls were east-west aligned and were located within the central part of the structure, reducing the sluice aperture from approximately 2.5m to 90cm. The western wall [0010] had 7 remaining courses of dressed grey Mansfield stone, ranging from 70mm to 130mm in thickness. The eastern wall had 4 remaining courses ranging from 90mm to 130mm in thickness. It was clear that the eastern section of wall abutted the eastern face of the sluice [0003] and is not keyed in to it (Plate 6) This was not clear with the western wall [0010] as the relationship with wall [0004] had been lost due to localised damage (Plate 4)

Plate 4: Western wall of sluice, the northern end, where the evidence of the wall returning is unclear. Looking south west (L. Binns 2014)

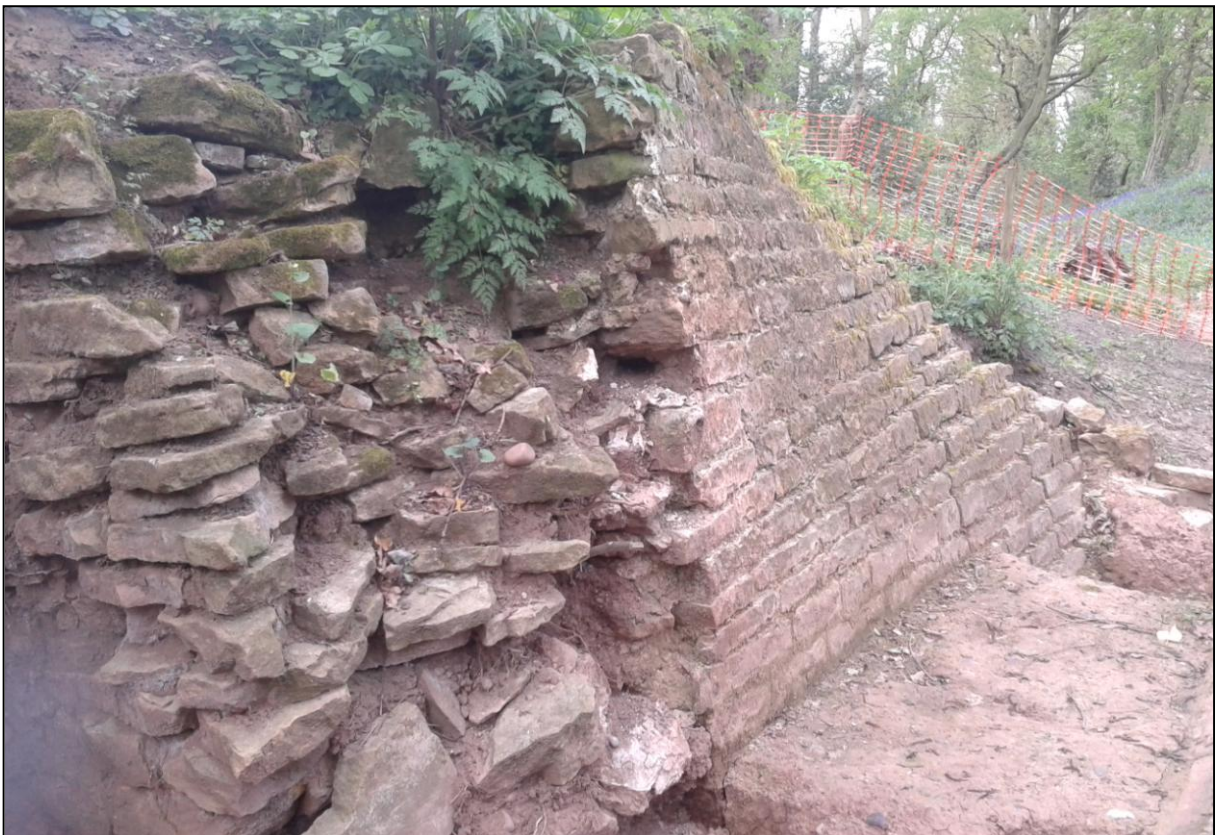
The western face of the sluice was 3.9 m in observed north-south length and 2.05m in exposed height. The northern extent of the stonework fanned out more considerably than the eastern face. There was the suggestion that the northern of wall [0004] returned to the west, however this is uncertain and may represent a continuation of a smaller east to west aligned wall [0010] of which only a small amount remained (Plate 4). The western face seems to have been tied into cross wall [0019] at its southern end. Five roughly hewn foundation courses of [0019], which are below a possible springer course for an arch [0023], continued along the alignment of the western face at a lower level. Courses further located higher up on the structure suggest that the western face was keyed in to the cross wall (Plate 5).

Plate 5: Western wall of sluice, the southern end, where the sluice face seems to be keyed in with the cross wall. Looking north west (L. Binns 2015)

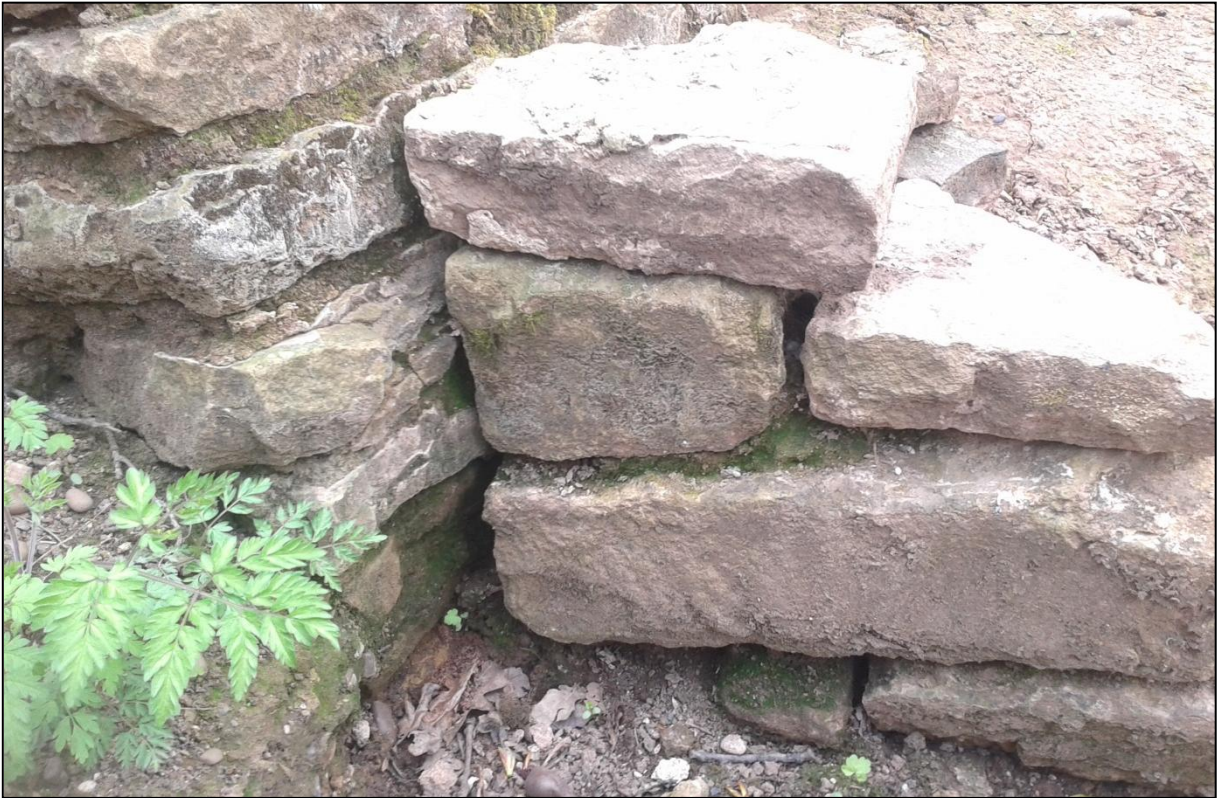
Plate 6: Dry stone northern wall [0009] abutting the eastern wall of sluice. Looking south east (L. Binns 2015)

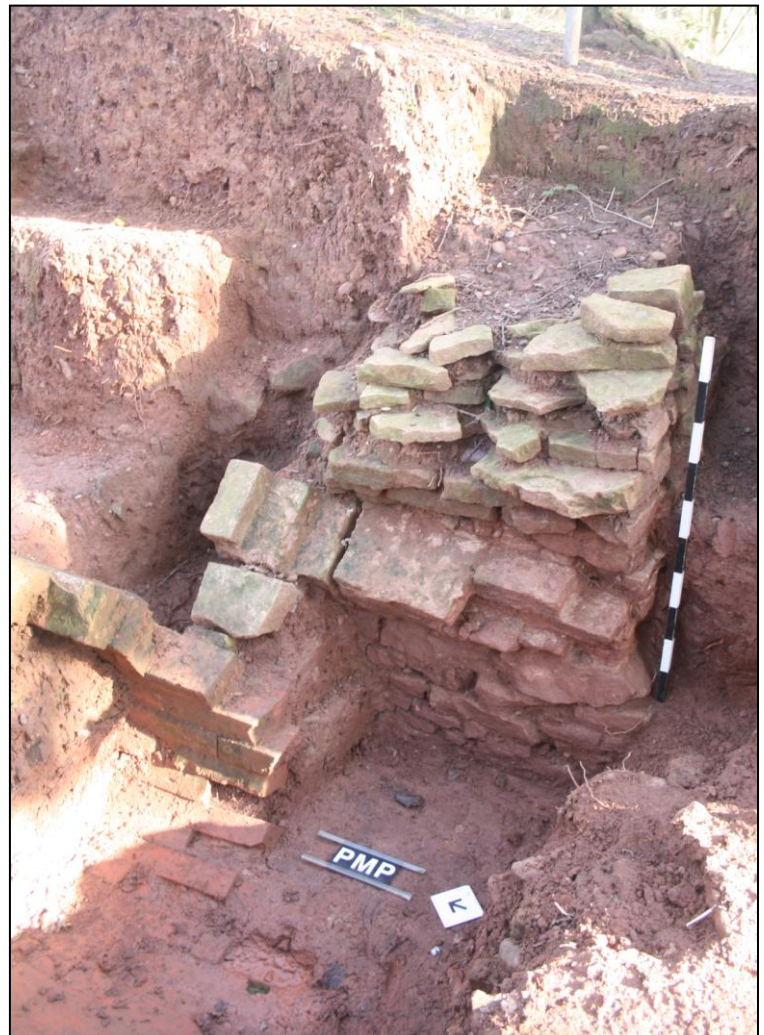
Plate 8: Western end of cross wall [0019] above remains of springer course of brickwork [0023]. Looking north west (L. Binns 2015)

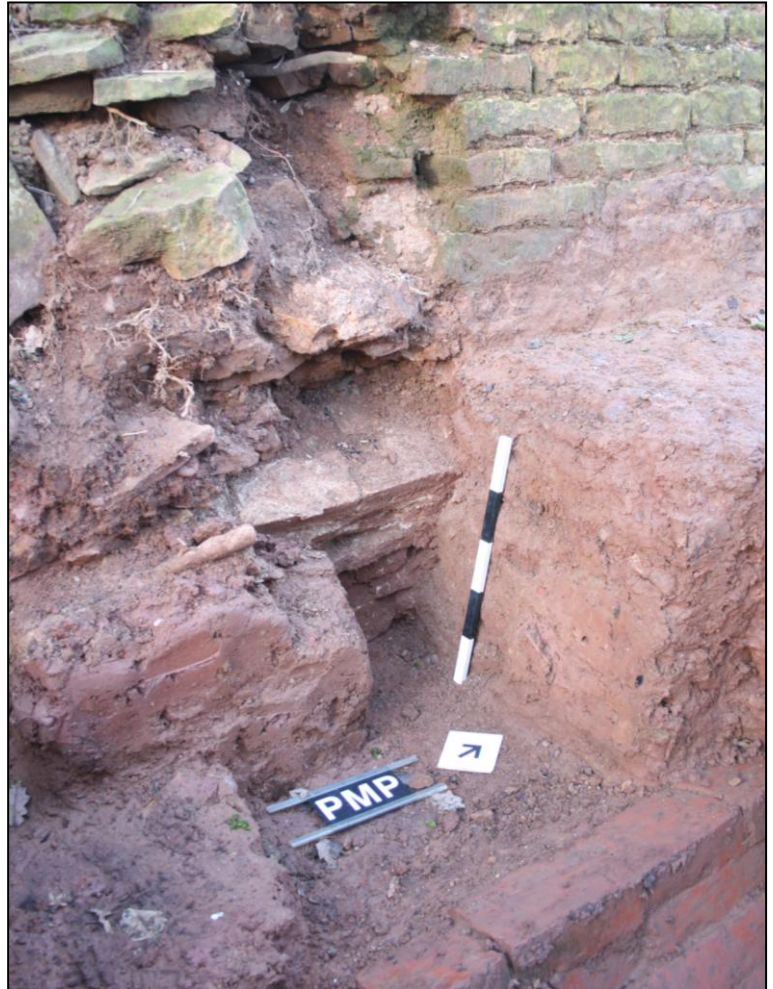
6.1.8 Once the rubble infill was removed however, more intact sections of walling were revealed on both sides of the sluice with stonework apparently keyed-in to the western face of the sluice. The southern face of this feature comprised roughly hewn stonework not as well built as the two main walls of the sluice with an absence of mortar between the stones. A line of seven mortared bricks were found sitting in a diagonal position on top of thinner courses of un-mortared stonework at the eastern extent of the feature, in alignment with the main stone faces of the sluice, suggesting a 'springer' course for an arch [0017] (Plate 7). This may be why there was no intact wall in the centre of the sluice. A similar course of bricks was located under the loose infill (0012) of the western side of the cross wall [0023], suggesting that the arch would have spanned a width of approximately 2m (Plate 8). Remnants of the arch itself [0013] and [0016] were visible in the north facing section of the rubble infill (0012) before it was removed (Figure 8). The shape and location of masonry [0013] in particular suggests that the arch would have been directly keyed-in to the western face of the sluice as both sets of stonework align (Plate 9).

Plate 9 (below): Cross wall infill (0012) before its removal. Remains of the arch are visible in section. Looking south (S. Walker 2012)

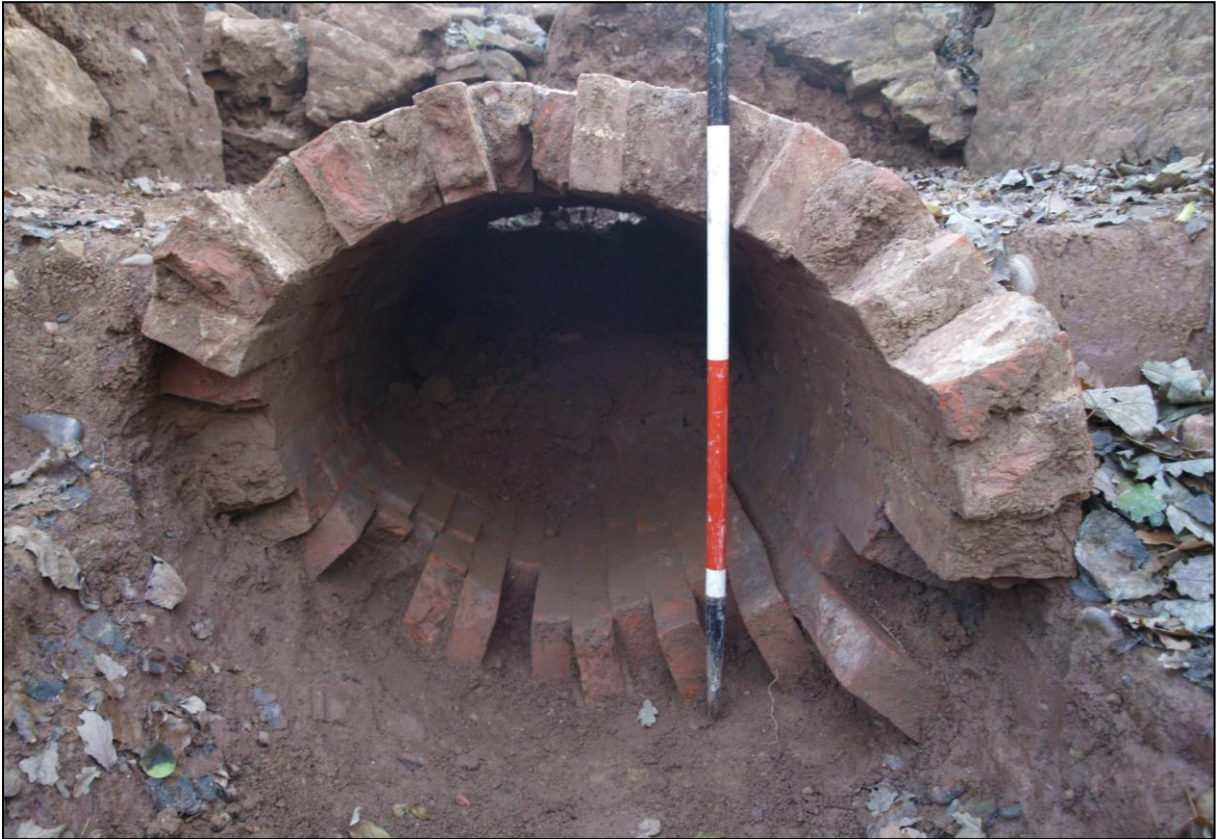
Plate 10: Profile of the culvert. Looking south (S. Walker 2012)

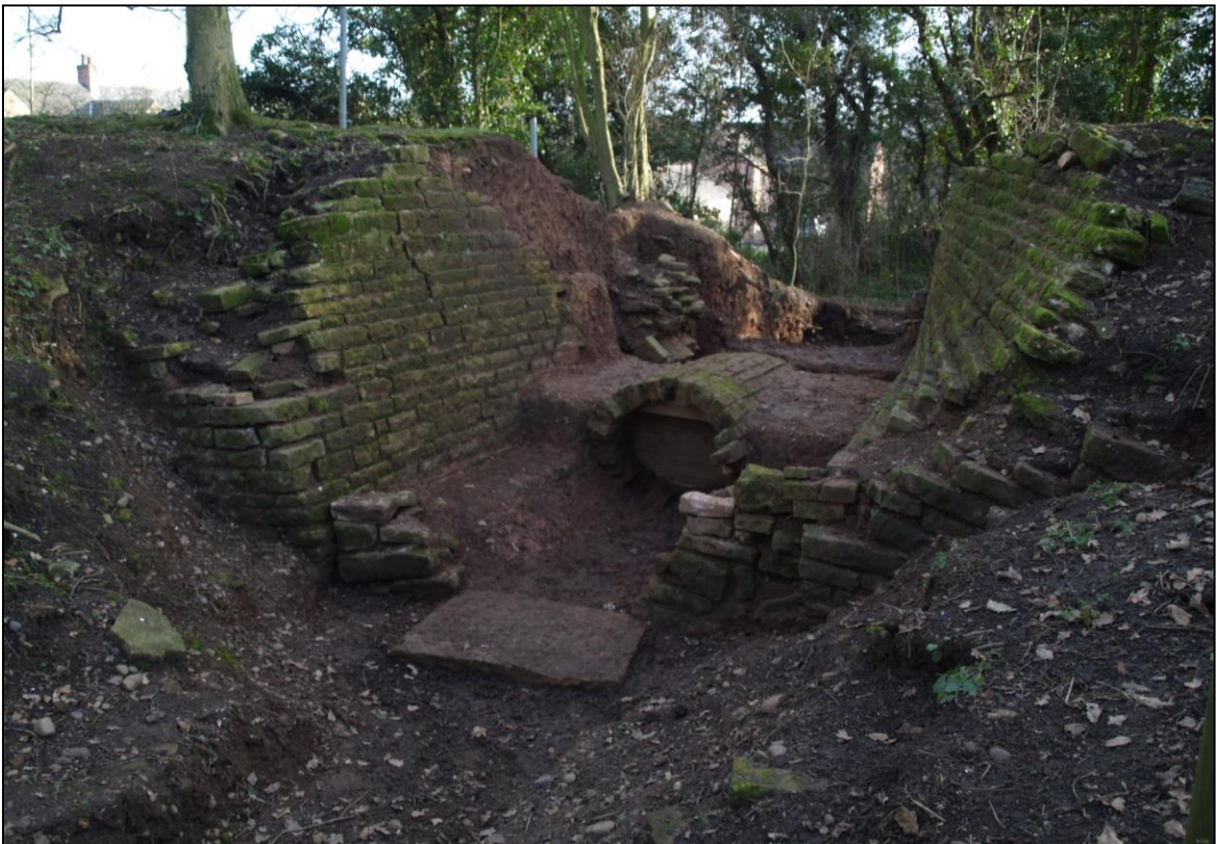
Plate 11: The brick culvert running parallel to and the same length as the sluice walls. Looking south east (S Walker 2015)

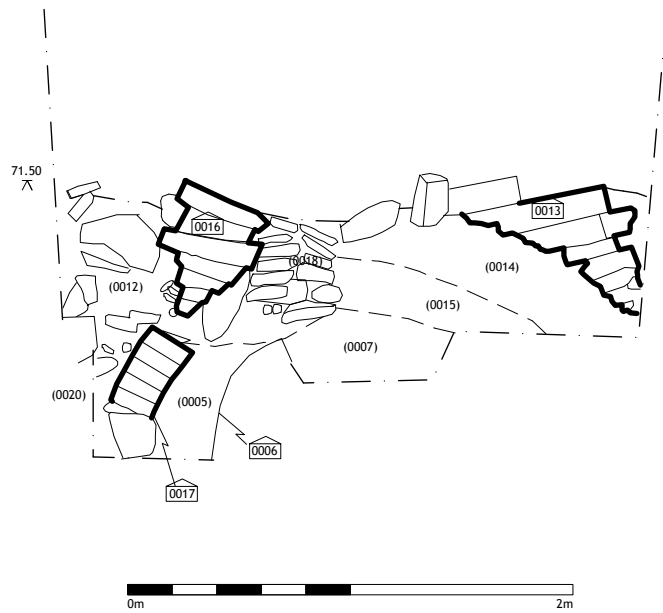
Fig. 8

- 7.2.1 A brick culvert was built to run underneath the cross wall. It is possible that it was built after the cross wall collapsed, so that water could continue to flow through the structure (Plate 11). The cross wall could have then been rebuilt over the top of it, with further debris and soil and placed on top of the culvert to strengthen and support the original sluice walls (Walker 2015). However, the presence of the apparently keyed-in arch masonry [0013] in the rubble infill might suggest that it is unlikely that this rubble was removed to build the culvert, and then redeposited. It is possible that the sluice was built whilst the cross wall and arch were still standing and clay was packed in around the culvert and underneath the arch to make the entire structure narrower and watertight, potentially speeding up a dwindling flow of water (Figure 8).
