Grange Cottages Wood Sluice: A proposed plan of conservation

Compiled by Stephen Walker
on behalf of the
Moor Pond Woods Project Steering Group

November 2014

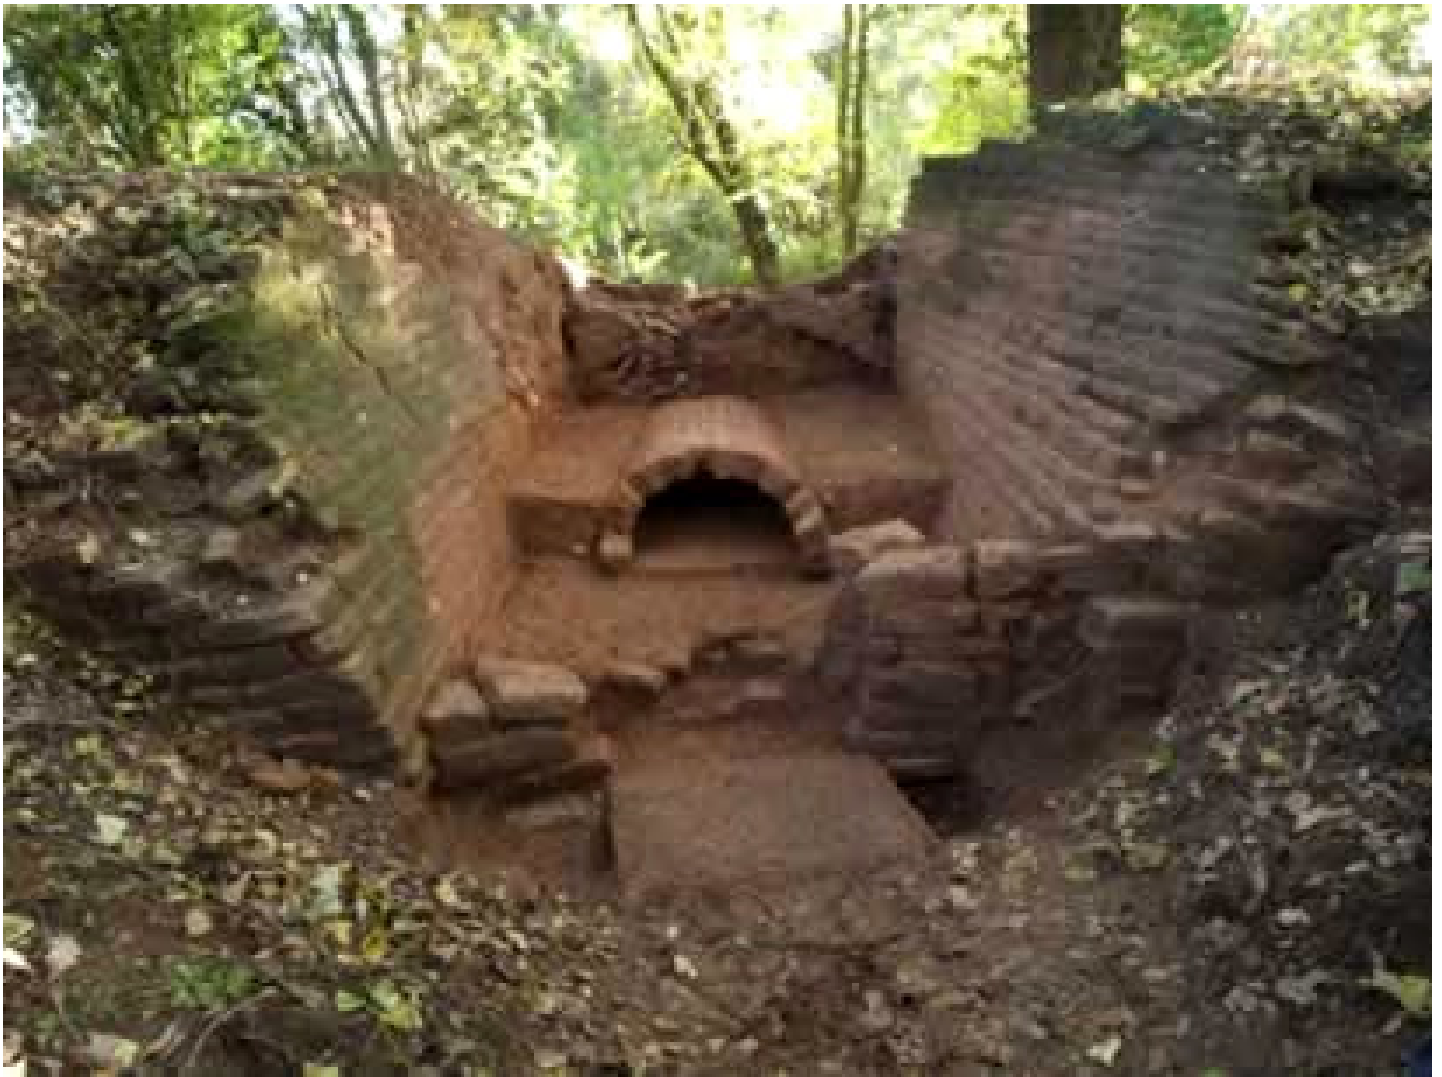
Figure 1: The sluice, looking south (November 2012)

seen in situ in figure 1, and the position of the tie stones can be seen on the right hand side in figure 8. The space between the brickwork of the tube and the arch was packed with red clay.

9. Exploration at the southern end of the west wall will reveal whether there are foundation stones for an arch on that side too. See figure 8. It is proposed to build a brick or stone arch over the width of the feature, replacing the damaged arch that was seen in figure 1. The space between the arch and the profile of the tube will be made up with compacted earth (as it was when it was discovered). At the southern end of the brick tube a narrow shaft will be created to allow light to penetrate. This will be fitted with a grill.

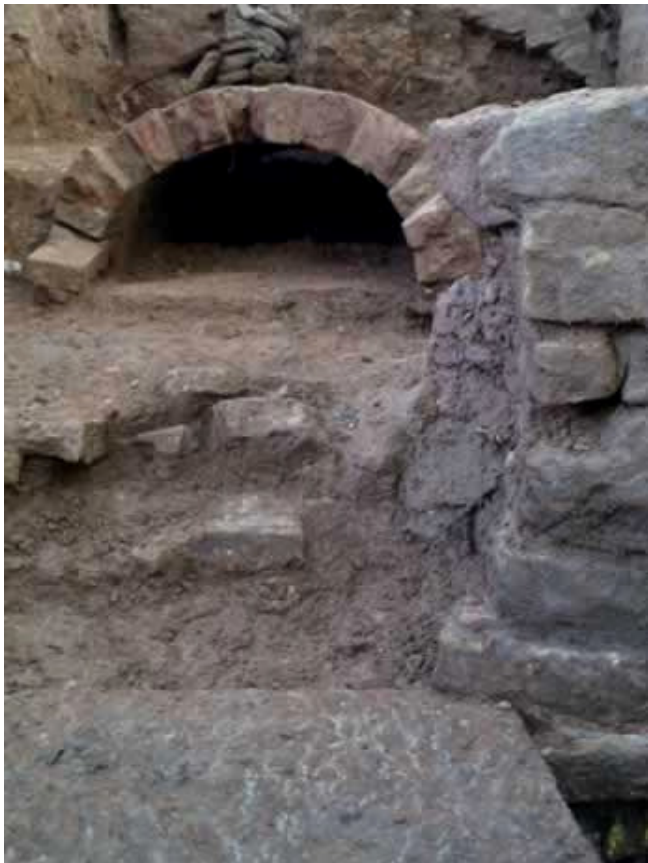
Figure 3: Detail of the wall at the northwest corner (November 2012)

The wall on the north-west side is seen to be curved at its inner end, mimicking the curve on the brick arch further south. (Figure 3)

5. Refer to figures 3 and 4. The low wall at 3 was observed to mirror the shape of the brick tube. It is proposed to reform the lower profile of the tube using baulks of treated timber that will serve the purpose of supporting the damaged courses at the northern end of the tube and visually connecting the missing north end of the tube to the entrance walls. The timbers will be of the same thickness as the bricks, so each course in the tube will be continued northwards with timber. They will form a secondary purpose by providing seating.

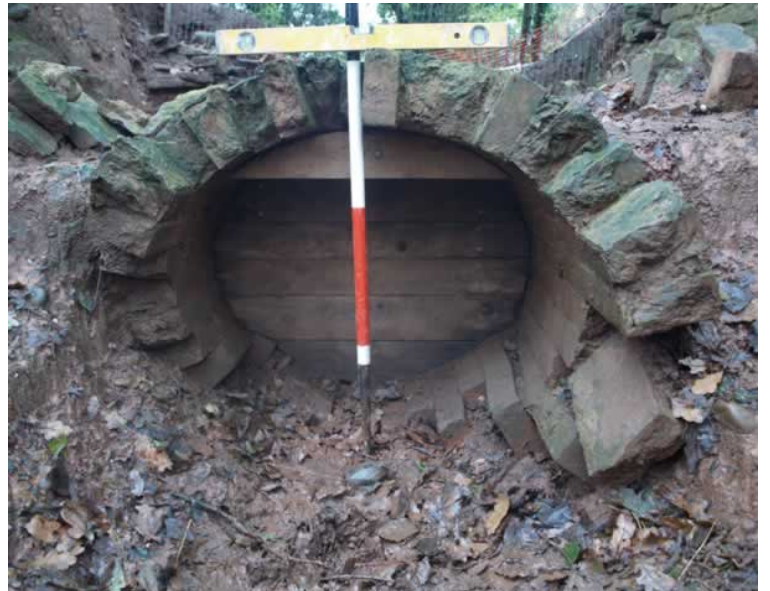
Figure 2: Detail of the brick tube (November 2014)

3. In the centre of the structure is a **brick tube**. It is oblate, being 90cm high and 125cm wide. The crown is composed of bricks of different lengths ranging from 25cm to 45cm. There are 18 courses in the upper half, 9 either side of the centre line. The lower half only has 17 courses. The northern end of the tube has been broken. The crown is seen to be cracked but seems sound. (see figure 2) The crown of the arch is also missing at the southern end, but the more of the bricks that formed the floor are still in place (see figures 6 and 8). The tube was found to have been packed with 50-60cm of red clay down the sides and across the crown.

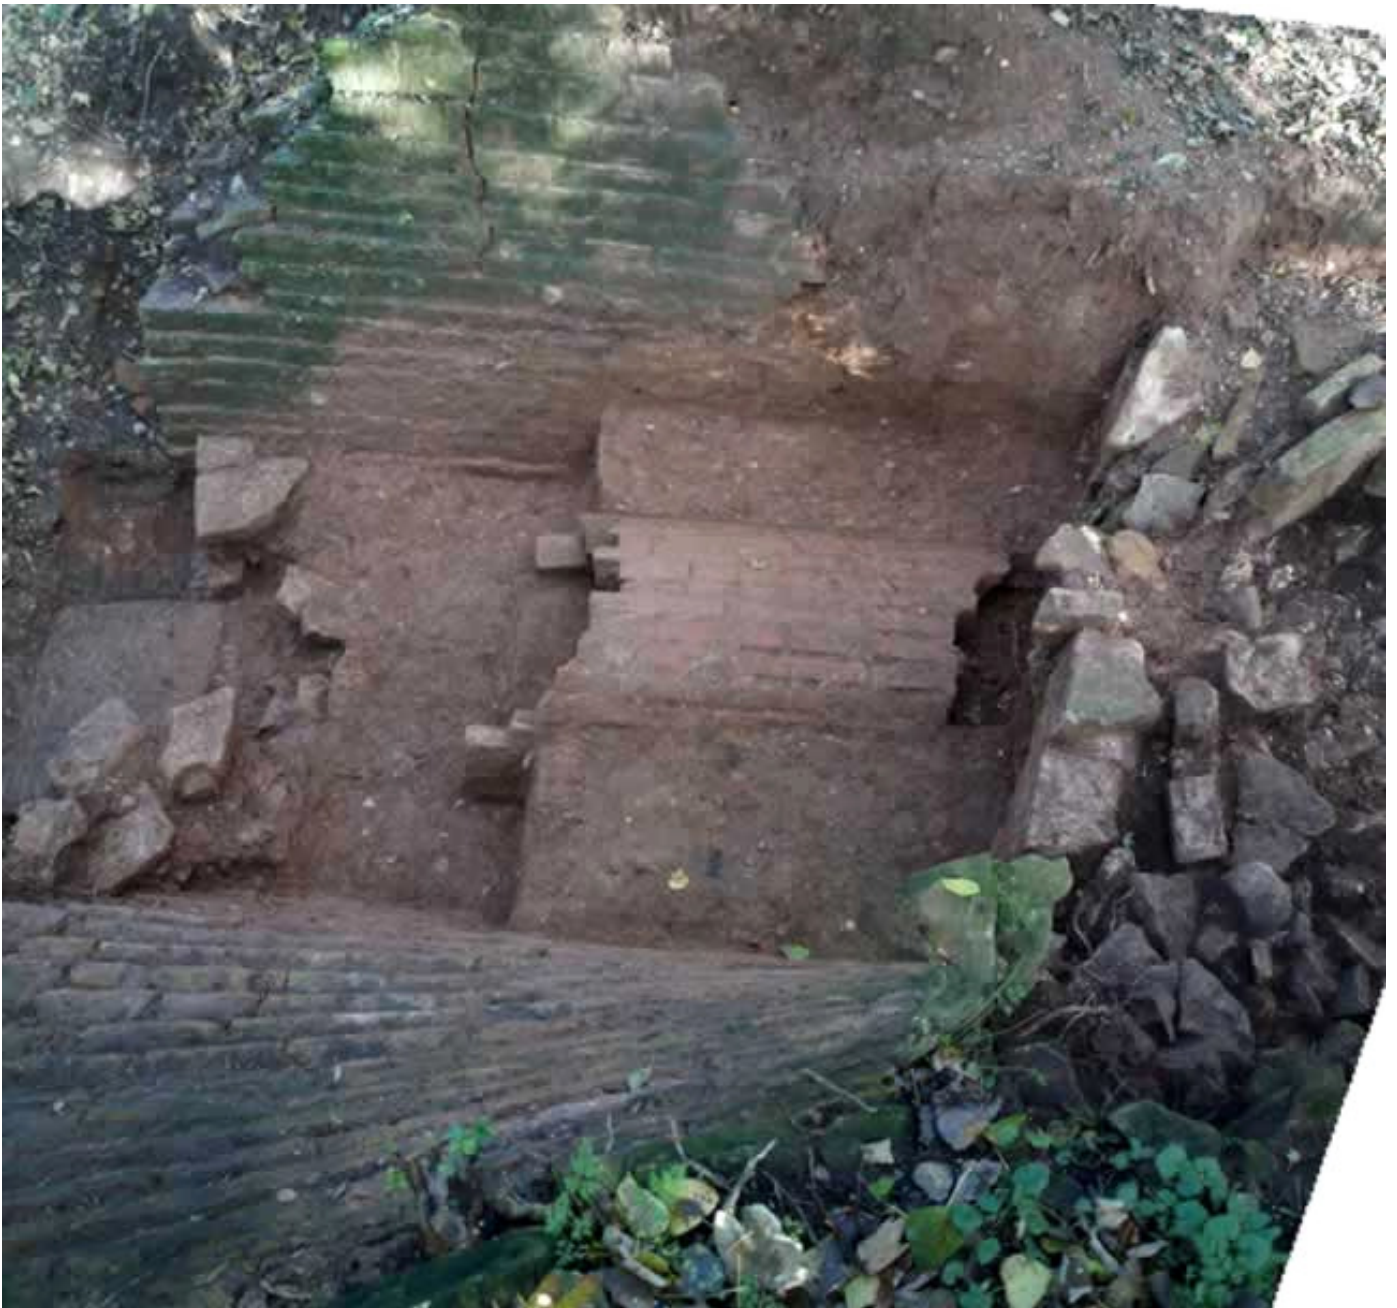
Figure 4: The sluice, from above, looking east (November 2012)

The **eastern wall** is steeper, the concavo-convex centre section is present but not as pronounced. The courses are returned to the east at the northern end. The southern half of this wall has, at some time, been demolished. (See figure 4)

2. The **northern entrance** to the feature has a pair of crude walls that extend towards the centre, narrowing the aperture from about 2.5m to about 90cm. Neither of these stub walls is tied into the stonework of the main walls. At their inner end, both are seen to be resting on a large limestone slab forming the floor at this end of the structure. (Figures 3 and 4)

7. Refer to figure 4. The south end of the east wall was demolished at some time in the past. The replacement is compacted earth, which will not be stable if left exposed. It is proposed to dig out and install a concrete foundation layer. This will need to be done with consideration for the remains of the arch foundation (seen in figure 7) and with care not to disturb the brick tube.

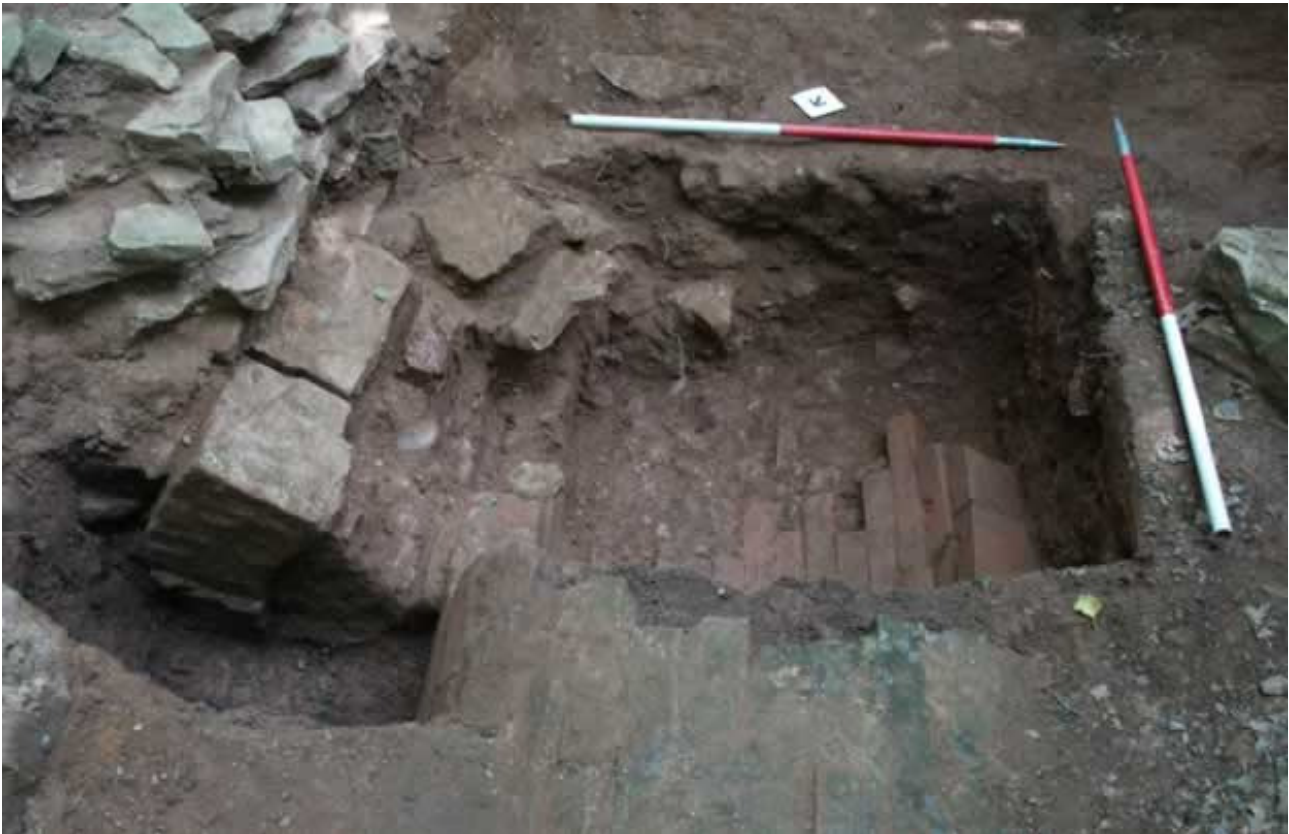
Figure 7: The south end of the sluice, looking south (July 2013)

1. The **main walls**, which are similar but not symmetrical. Each consists of 22 courses of grey Mansfield Stone in courses that range from 80mm to 140mm thick. The mortar courses are thin. The **western wall** has a pronounced parabolic shape, with near vertical top and bottom sections separated by a concavo-convex central section. The courses of stone are returned to the west, and embedded into the side of the leat. The upper courses are set well back compared to those near the base. The upper courses are missing from the northern end. At the southern end the western wall was tied into the stonework of a cross-wall. (See figure 7)
