**MOOR POND WOOD,
PAPPLEWICK
An Archaeological
Site Survey and some
Trial Excavations**

**Results of field survey for the
Moor Pond Wood Project,
Papplewick, Nottinghamshire**

*by
Richard Sheppard*

TPAU Project Code: PMP.2
OS Grid: SK 544513-550504
File Name: 2016 / PMP-Rept2
June 2002; **Amended March 2003**

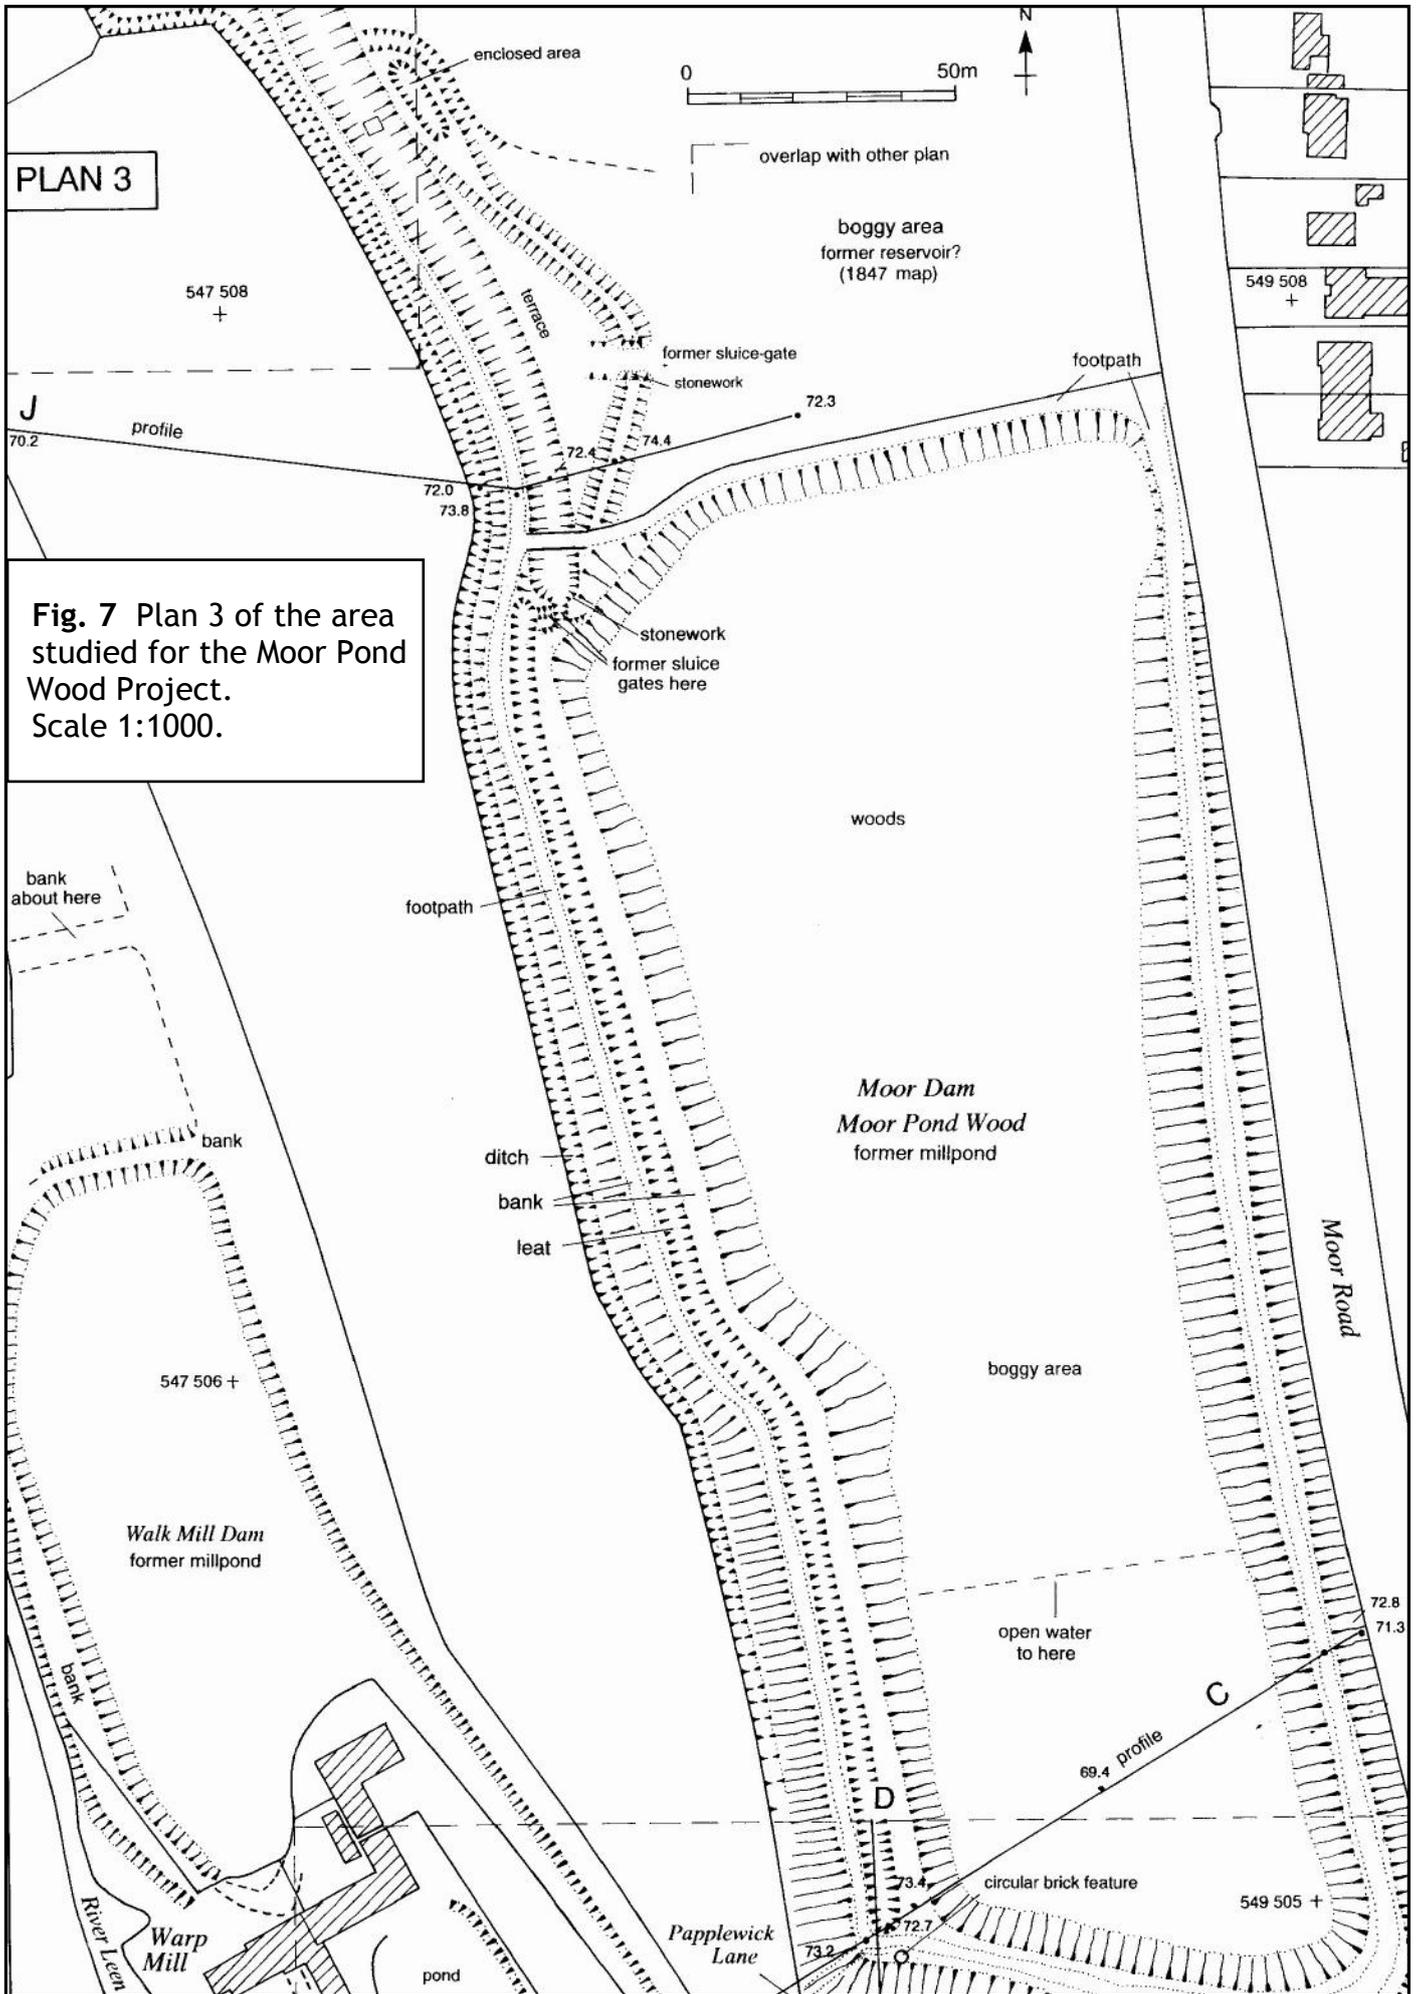
Fig. 7 Plan 3 of the area studied for the Moor Pond Wood Project. Scale 1:1000.

To the south, the second length of leat culminates in and runs through a curious triangular-shaped enclosure with high banks surrounding it and a terrace within it. Openings at the east and south points of the triangle indicate former sluice-gates, in part confirmed by stonework still showing in places. At the north point of the triangle a narrow channel connects with the leat at a high side level and runs around a fully enclosed and deeply cut depression of unknown purpose. The former runs towards a boggy area which on various maps dating between 1835-1847 is shown as an irregular-shaped pond. It is shown on a map of 1847 (Fig. 9) with a fan-shape similar to that of Upper Dam. In both cases the shape may have resulted from the geomorphological effect of water flow through the middle. The pond here may have resulted from a westward-flowing stream or channeled spring water and the impeding effect of the bank around the triangular-shaped enclosure. It could then have acted as a reservoir to provide water to both the leat and the larger Moor Dam respectively. The close proximity of the lower drainage channel may also be significant, as excess water may have been a seasonal problem at this part of the system. All this remains speculative though.

Where the main leat comes towards the north-west corner of the larger reservoir, Moor Dam, there is compelling evidence for a controlling sluice-gate set between narrow high banks and above a major dip in slope. There is also stonework to be seen here. This point controls water-flow into the main reservoir, with only a narrow off-shoot channel providing water to enter a new section of leat. This break between what, for convenience, is here called the second and third sections of leat, appears to have been missed in previous site surveys. It may not have been the original arrangement however, and the leat may have once flowed unhindered through this point, before the demands of the main reservoir required a detour of water-flow.

Moor Dam, or Moor Pond Wood as it is presently known, covers a significant ground area and must have held a large quantity of water. Profile C indicates a depth of at least 4m from the top of the surrounding banks to the open water at the south end of the area. To the north, the base of the area rises to relatively dry ground at the far north end, which is most pronounced at the north-east corner. It may have been from this point, still the main access point into the woods, that the reservoir was largely infilled during the 19th century. This would explain the lower depth of the south end. Even when the area was shown fully dry on an Ordnance Survey map of 1915, a pathway through the middle of the area, stopped well short of the south end of the former reservoir.

The third section of leat, running alongside the west side of the reservoir, is accompanied by a drainage channel just down-slope. The leat stops abruptly with a rounded end above the south-west corner of the reservoir and above Papplewick Lane. Whilst it is aligned on a corresponding leat south of the Lane (the fourth stretch), there is no obvious evidence for a former viaduct across the road connecting the two. A circular brick-lined feature close-by may be related to whatever means was used to get water across the road, but only through excavation and recording can its purpose be determined for sure. On the First Edition Ordnance Survey map of 1880-81 it is shown as a well. The same map also shows Papplewick Lane narrowing here and this suggests that some form of structure may have crossed the road at this point. Culverts recorded down-slope at the corner of the area (pers.

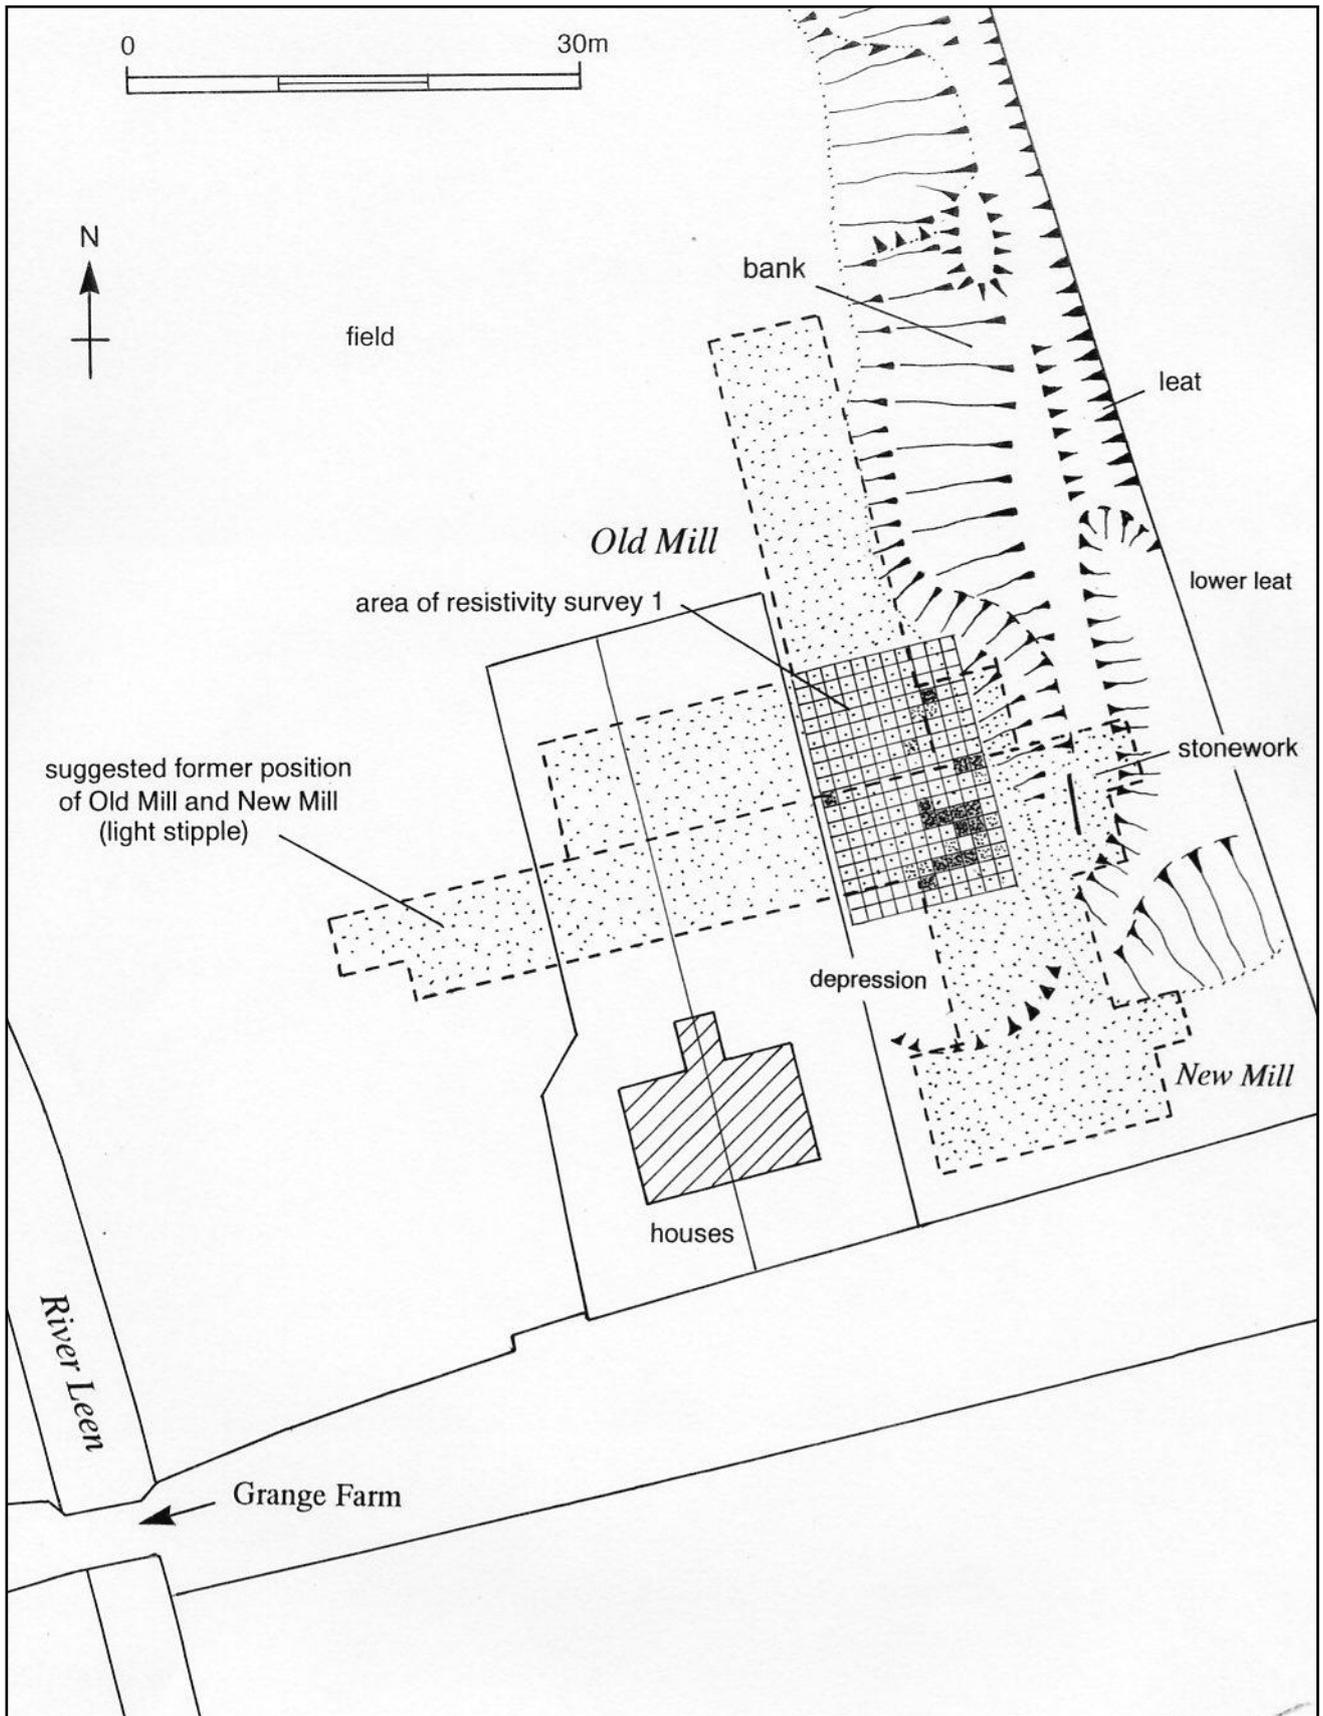
Fig. 10 Suggested position of Old and New Mills near Grange Farm (also together known as *Grange Mill*) and the results from geophysical survey 1 (13/1/02). Scale 1:500.

The fifth section of leat, south of Grange Cottages, is straight and relatively level but is now cut through by a boundary hedge, is heavily disturbed on its west side and has lost part of its east bank. It ends in a slight curve just above the lane to Grange Farm, where early 19th century maps show it flowed through a large mill building, alternatively and confusingly referred to as Old Mill, New Mill and later as Grange Mill. Some geophysical survey was conducted close to this point in early 2002 – see below.

In the field west of this leat are a number of depressions and a possible terrace where a former mill building once stood, according to the Linby tithe map of 1841. All trace of two other buildings immediately to the south have probably been lost where a deep depression can now be seen. The river to the west has been canalized and made straight and is crossed by a small bridge which is probably of 18th century date. The crossing is shown on the 1847 map, above an unknown building alongside the river which has since disappeared without trace.

- With regard to Area A, there is a good possibility that a further programme of geophysical survey and some carefully-positioned follow-up trial-trenches could reveal the full plan of the former mill building. With further co-operation from the farmer of the land assured, it would probably be advisable to concentrate effort in this area and to deal with this one single achievable objective before looking further afield.

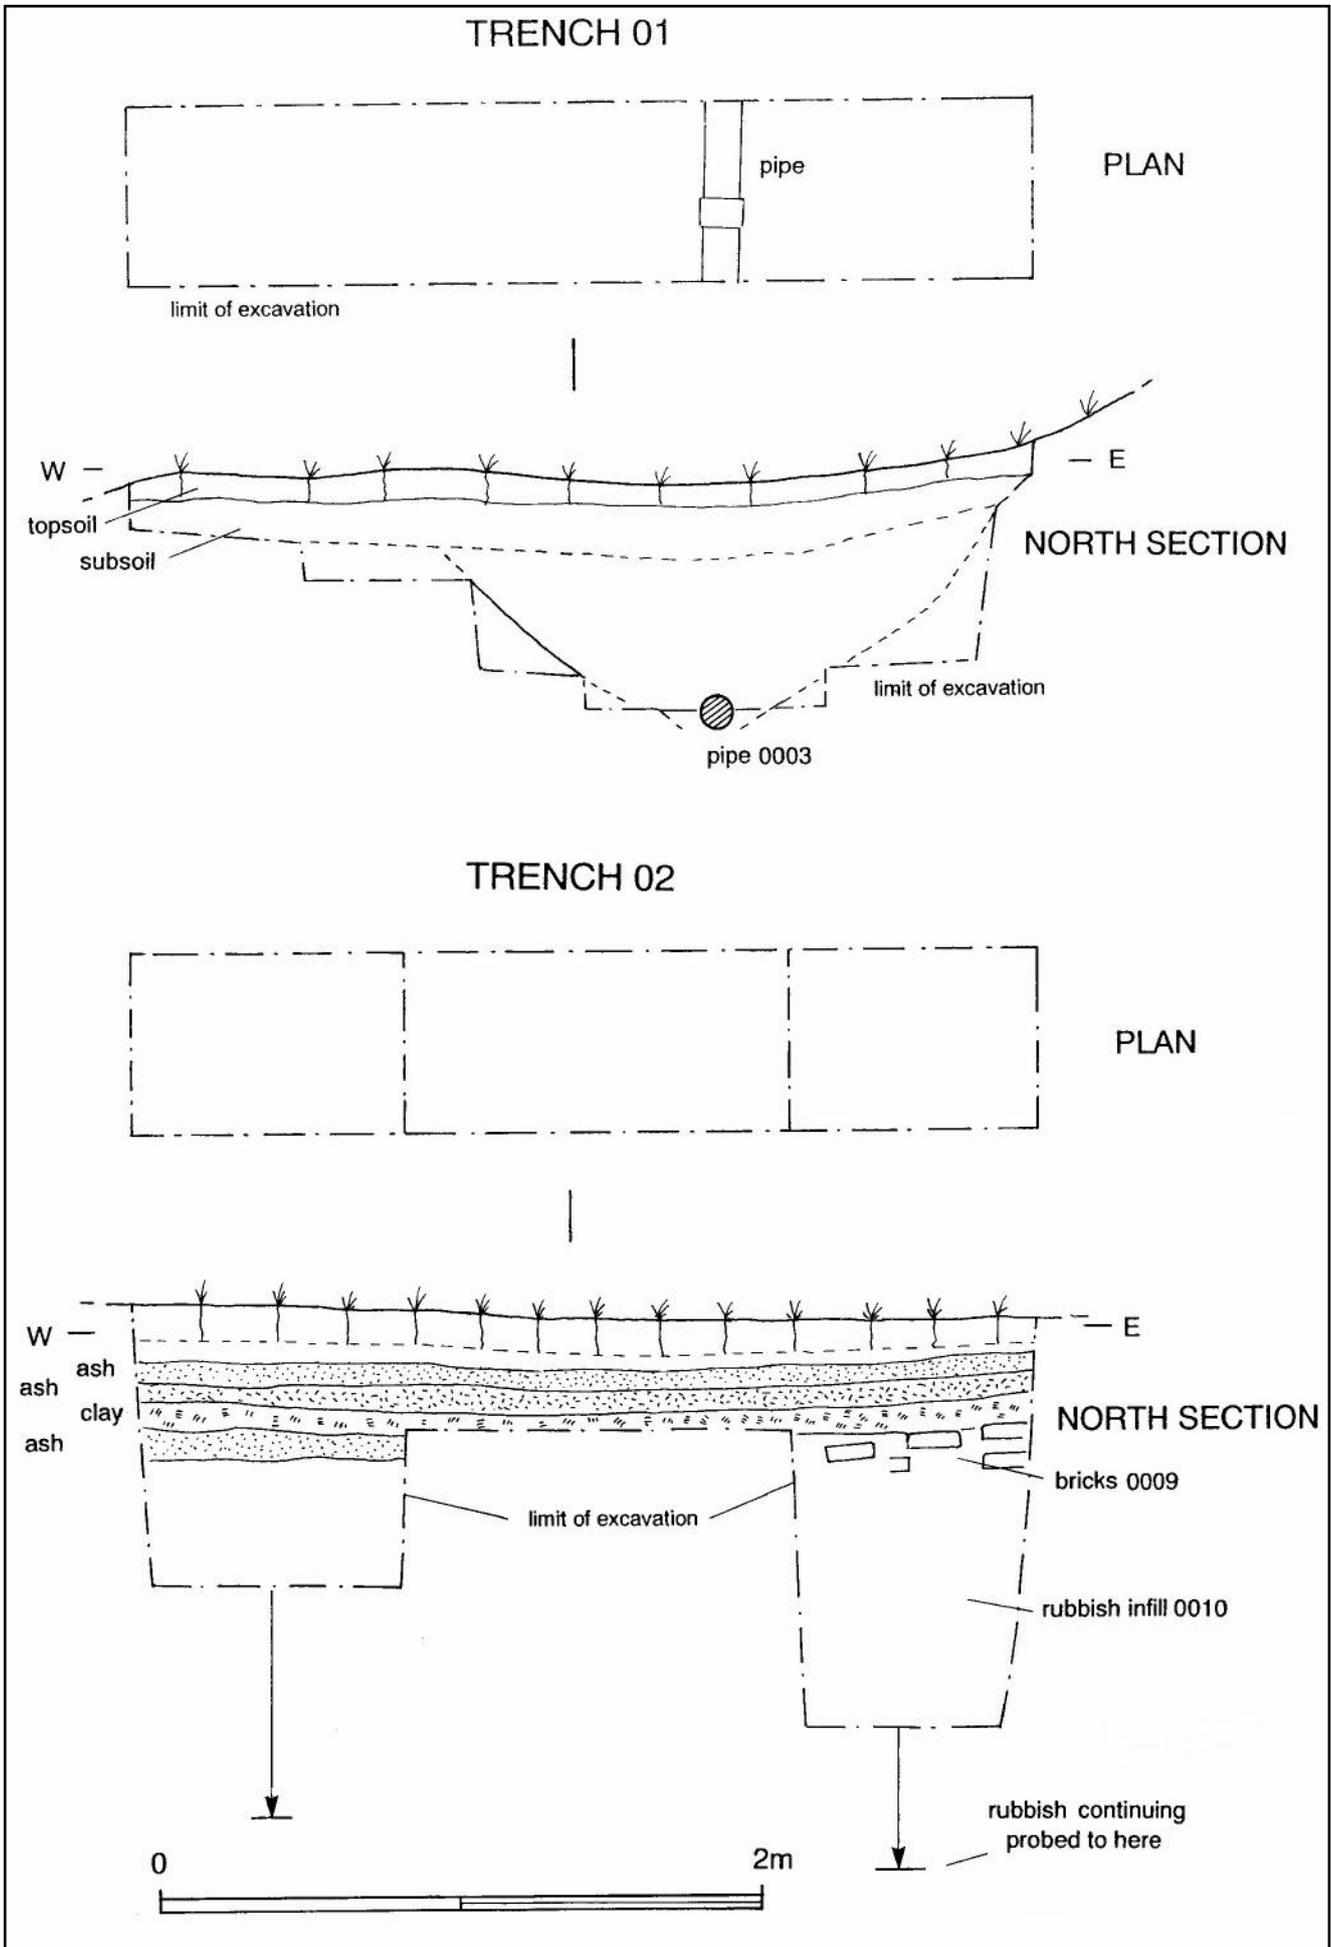
Fig. 12. Plans and sections of Trenches 01 and 02, Area A. Scale 1:25.

A trench 3m long and 0.6m wide was excavated across the leat near the site of the former mill. A stone-lined culvert was reported to have been witnessed in this general locality and the trench was intended to see if it might still exist in this southerly position. Culverts are found on other mill-sites such as the Arkwright mills at Cromford, Derbyshire, and here at Papplewick a similar structure could have helped to channel water in both sufficient quantity and at some speed on the down-slope towards the Robinson mill's water-wheel. However, the excavation only uncovered a relatively modern ceramic field drain (0003) at a depth of 0.7m. The wide cut for this through the sandy-clay composition of the bank was evident in the section. As there was no sign of a foundation cut for an earlier feature, it suggests that any stone culvert would have been at a shallower depth and that the later drain cut had probably removed all trace of its position within the leat.

A trench 3m long and 0.6m wide was excavated to investigate an area within a noticeable depression and where the geophysical survey had found evidence for disturbance. Beneath the topsoil and a shallow subsoil the trench uncovered a series of ash and clay layers (0005-0008), and a layer of bricks (0009), 2¼ - 2½ inches thick, 4½ ins wide and 9 ins long (60 x 115 x 230mm). Beneath these layers was a layer of varied discarded rubbish and dark soil (0010), indicative of material used to infill a hole or depression. Finds included a quantity of pottery, glass, shoe fragments, metal containers and assorted debris, none of which appeared to be of pre-19th century date. A sample selection of these were retained for further examination. The discovery of this infill material, probed down to a depth of at least 1.8m, suggests that the mill-wheel had been situated hereabouts in the field.

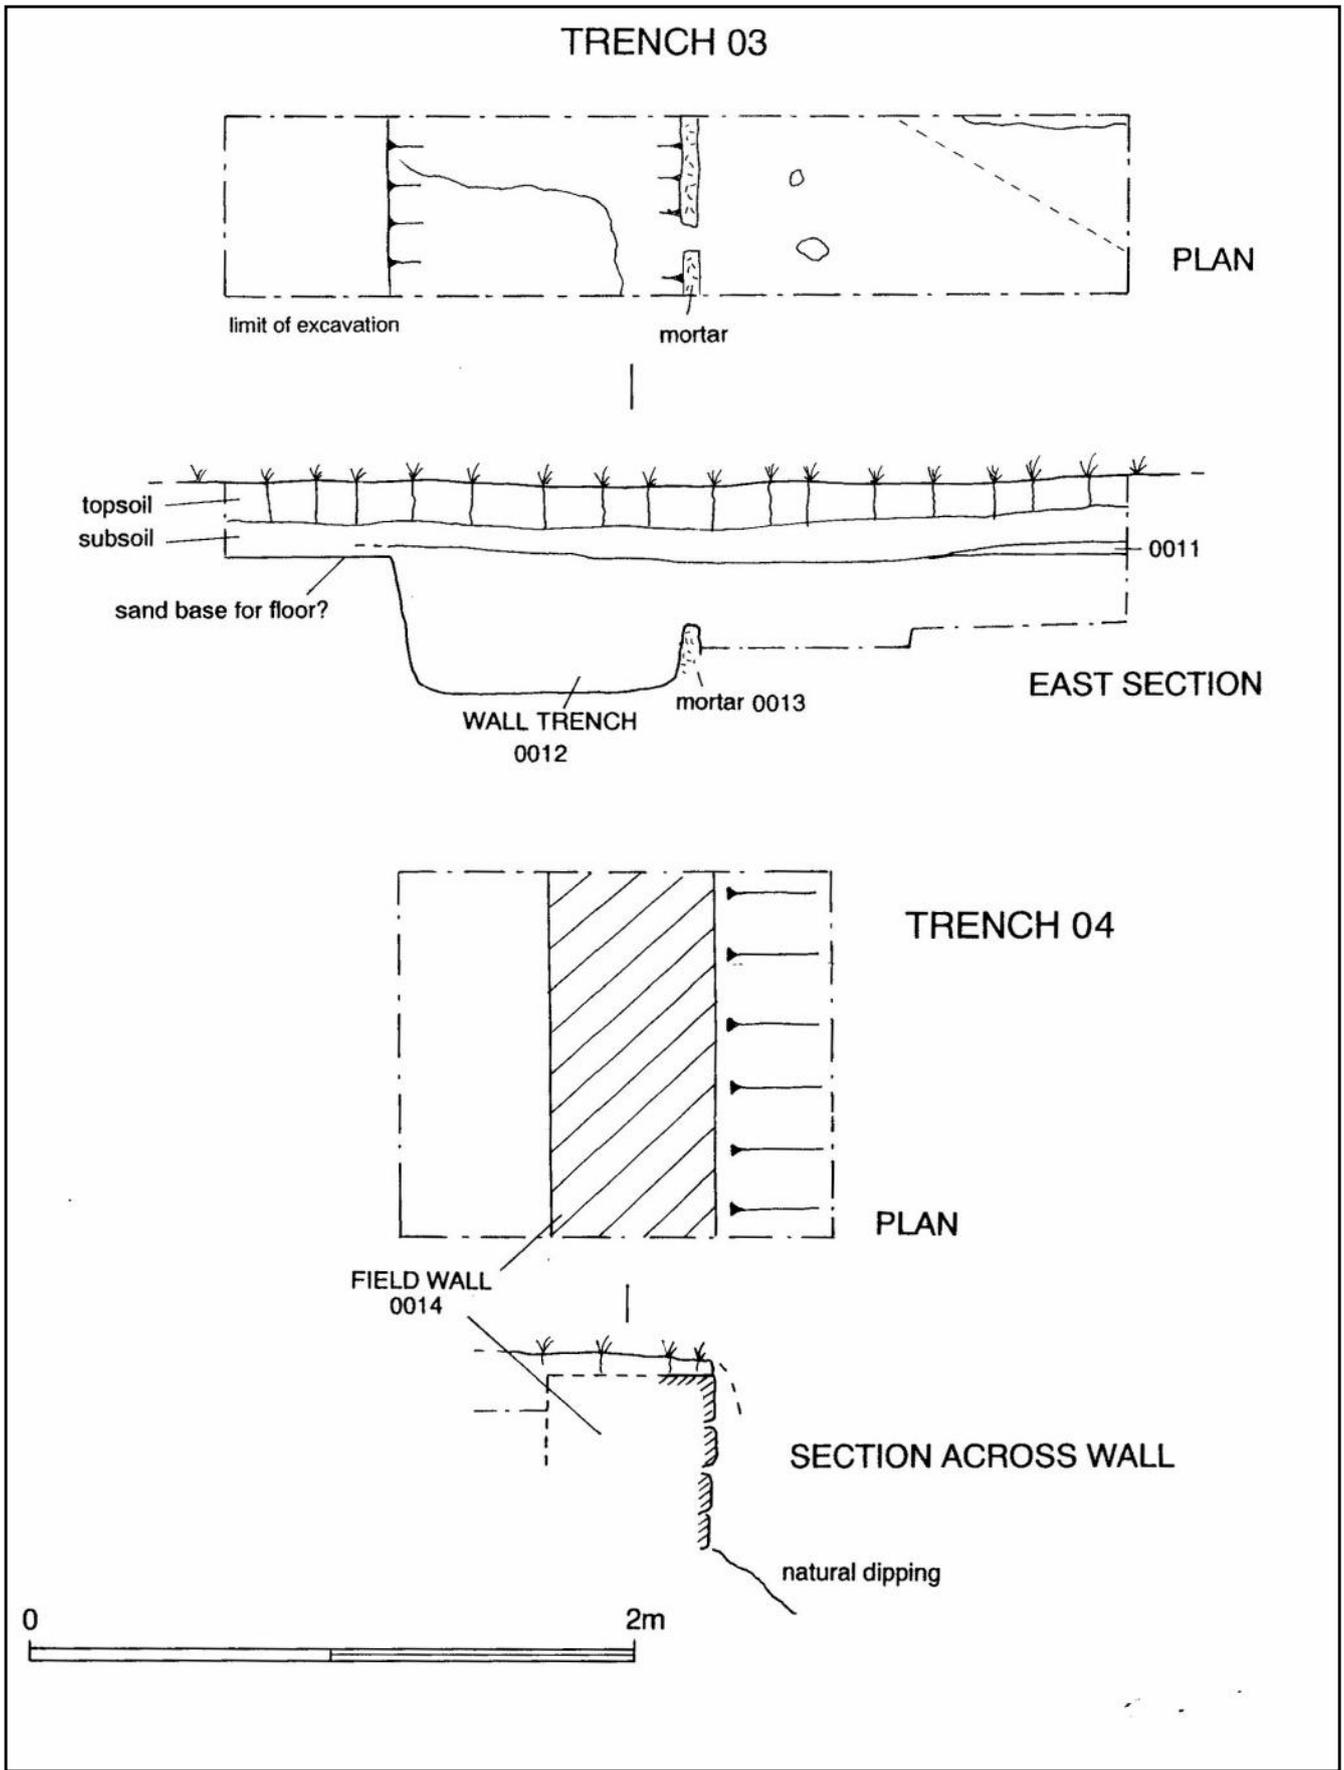
Fig. 13. Plans and sections of Trenches 03 and 04, Area A. Scale 1:25.

This trench, 3m long and 0.6m wide, was excavated to examine a distinct east-west running linear feature brought out in the geophysical survey. At a depth of about 25cm, immediately below the subsoil, there were indications of a former floor level, showing at the north end as a hardened sandy base, and at the south end as remnants of a plaster spread, beneath which was similar hardened sand. Between the two areas was the foundation trench for a former wall about 3 feet (0.9m) wide. The base of this was at 0.7m depth. Associated with this was stone rubble, a line of lumpy mortar (0013) and fragments of ceramic flue-tiles. One complete tile was rectangular in section and was ¼ inch (6-7mm) thick. Its internal cross-section was 2 x 2¾ ins (51 x 70mm) and the length 5½ ins (138mm). It was set within plaster and had probably been used to convey heat up the outer face of a wall within the former mill. Similar tiles are known from 18th century heated walled gardens.

The final trench, 1.20 x 1.75m in size, was set around some walling showing in the side of a dip. A wall 57cm thick and four courses deep was exposed and photographed. It was a roughly made wall without mortar, and appeared to be a field wall rather than a wall belonging to the former mill. No dating evidence was recovered. Its make-up suggests a wall of possible agricultural use.

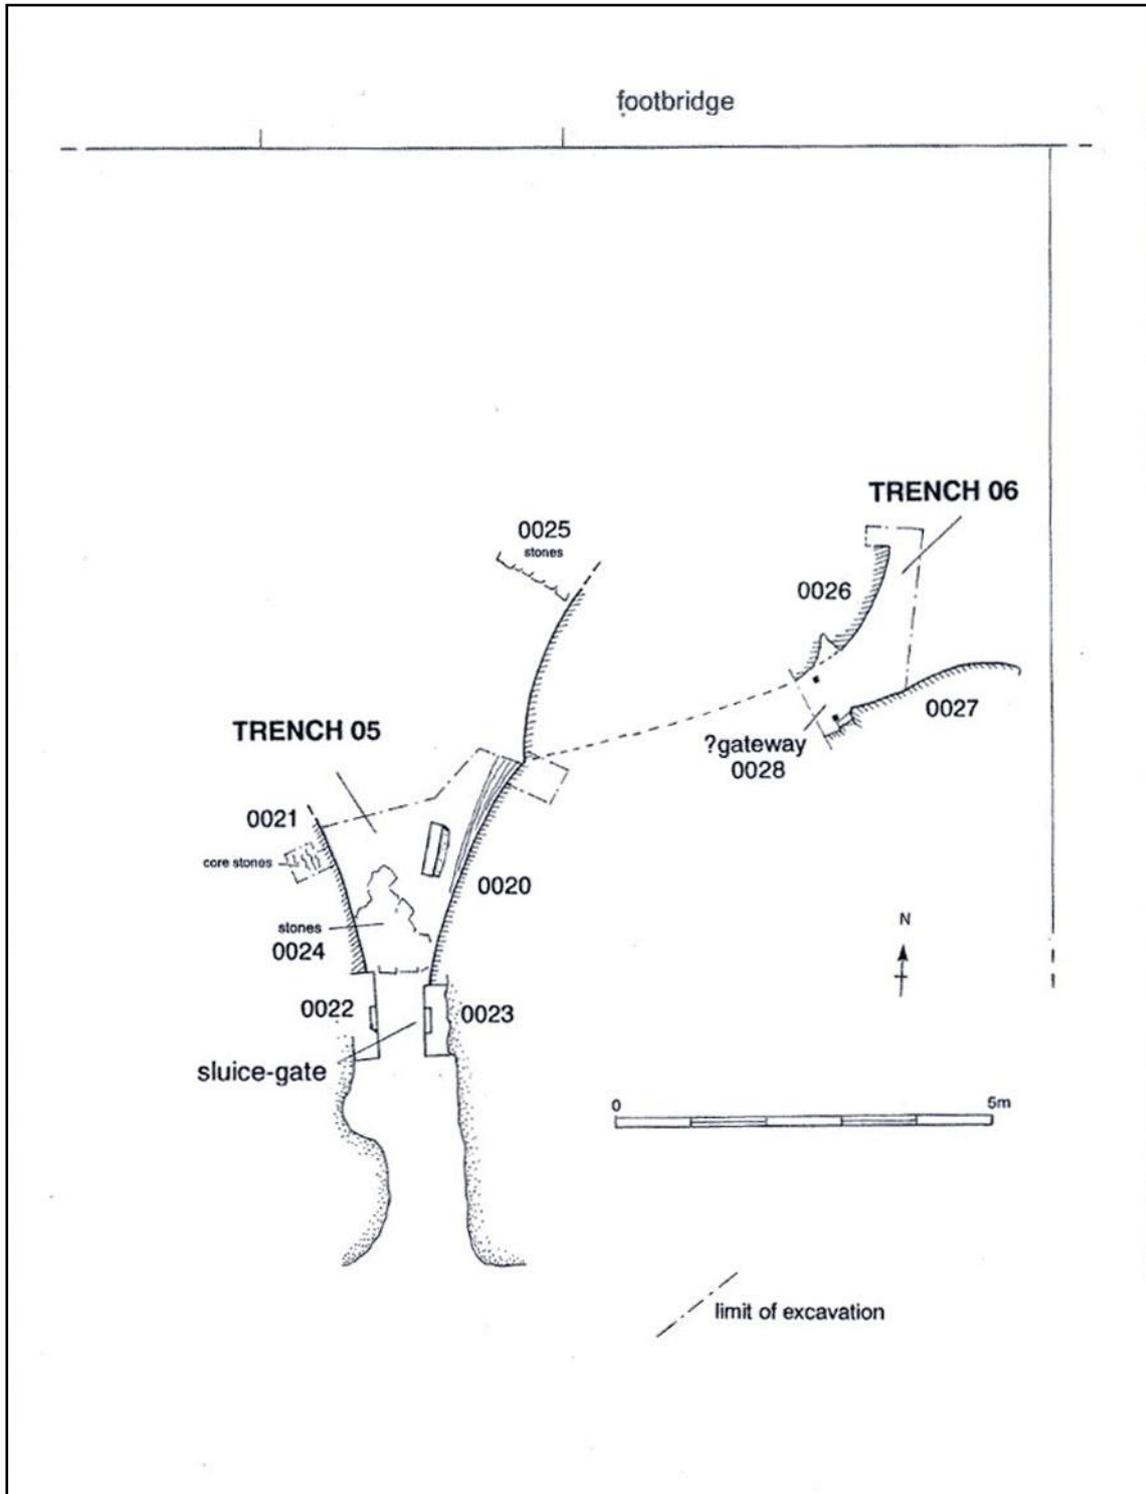
Fig. 14. Plan of Area B at the north-west corner of Moor Pond. Scale 1:100.

Stonework leading up to and including a sluice-gate at the north-west corner of Moor Pond had been exposed in the recent past during environmental improvements associated with the erection of a timber footbridge (pers. comm. Lee Scudder). It was decided that this part of this stonework, including the exact position of the sluice-gate warranted further exposure to enable it to be recorded and measured in. A number of volunteers helped to clear turf and loose soil from above the walling and to remove soil masking two large worked stones where the sluice-gate had been positioned.

The position of the sluice-gate was marked by two large stones, one (0023) 36 inches (0.91m) long, the other (0022) 48 ins (1.22m) in length. The south ends of both stones were still in alignment. Similar stones have been seen at a lower level in the dip beneath them (pers. com. Lee Scudder), suggesting that they may have been coursed to accommodate a tall sluic-gate, or that a cascade feature may have existed. Large stone rubble (0024) had been intentionally placed behind the former gate to help manage the flow of water (Plate 5). This may have happened after the system went out of use, as one of the stones appeared to be another 36 inch long stone from the sluice-gate.

The walling leading up to the sluice-gate was both curving and lightly stepped to form a batter, and survived to 7-8 courses high on the east side (0020). A change of angle may indicate where a side-channel had come in at a high level from the north-east. The northern extent of the walling was not traced, as another spread of rubble was found obscuring its position. The west walling (0021) was not so well preserved. Although the outer facing of these walls appeared to be unmortared, any mortar had probably been leached away as the the inner corework (examined on the west side) was found to be heavily mortared.

A side channel to the north-east was also examined. The stonework here was more irregular and not so well built as in the main channel in Trench 05. The north and easterly termination points of both sides of the curving walls (0026, 0027) were found, and the walls were followed to a point where two vertical iron rods were found, still apparently in situ (0028); this coincided with a change in the stonework to a more rubble-like consistency. A section in the soil behind this point indicated that there may originally have been timber boarding running from these metal rods into where this feeder channel narrowed to the main channel beyond.

- The uncovering of the walls at Area B indicates that they survive reasonably well. It should be feasible (should the decision be made at official level) to expose and conserve some of the walling as a visible feature from the footbridge. This would act as both a reminder and an educational tool for helping to explain the significance and historical background of the earthworks – at a general position where they are at their most prominent. A display board and some actual stonework to view would be a good combination.

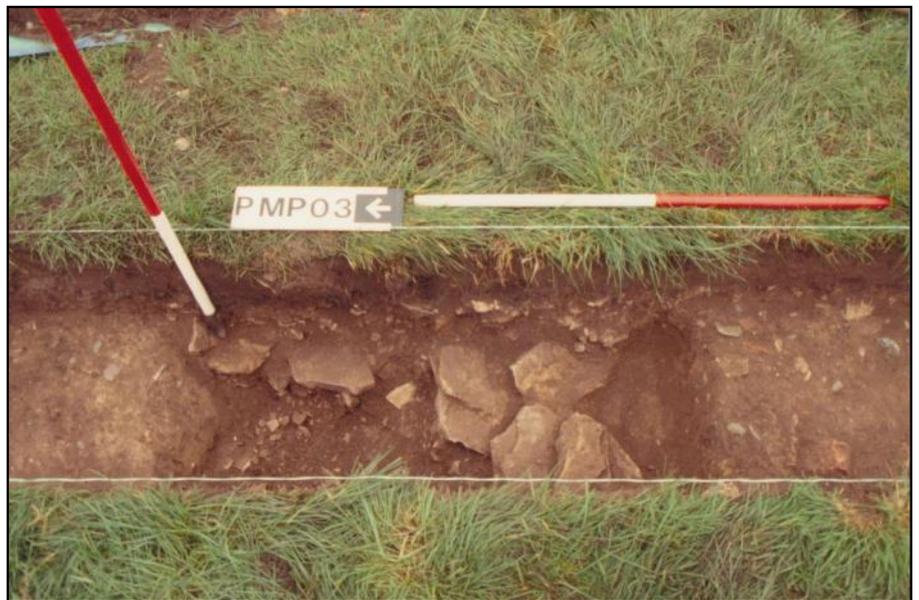
2

Plates. 1: Excavations by local volunteers taking place near Grange Farm, Papplewick in October 2002; 2: Stone rubble in the foundation trench 0012 uncovered in Trench 03, Area A; 3: Stone walling 0014 cleaned in Trench 04, Area B.

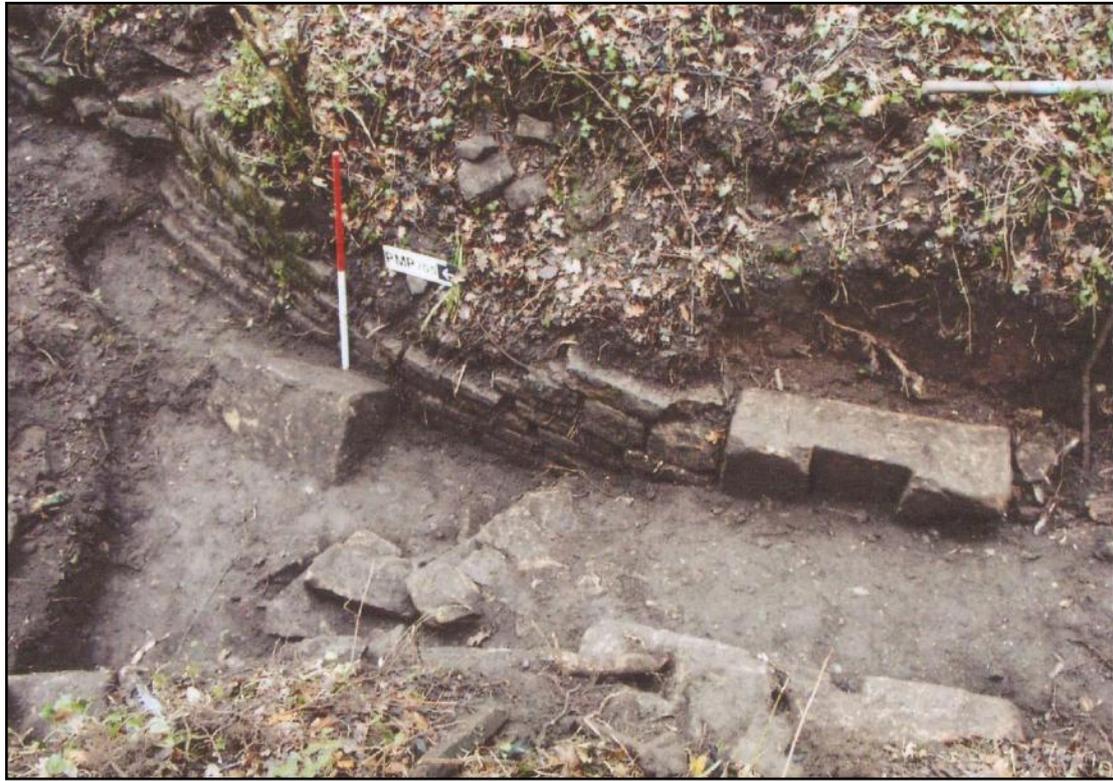
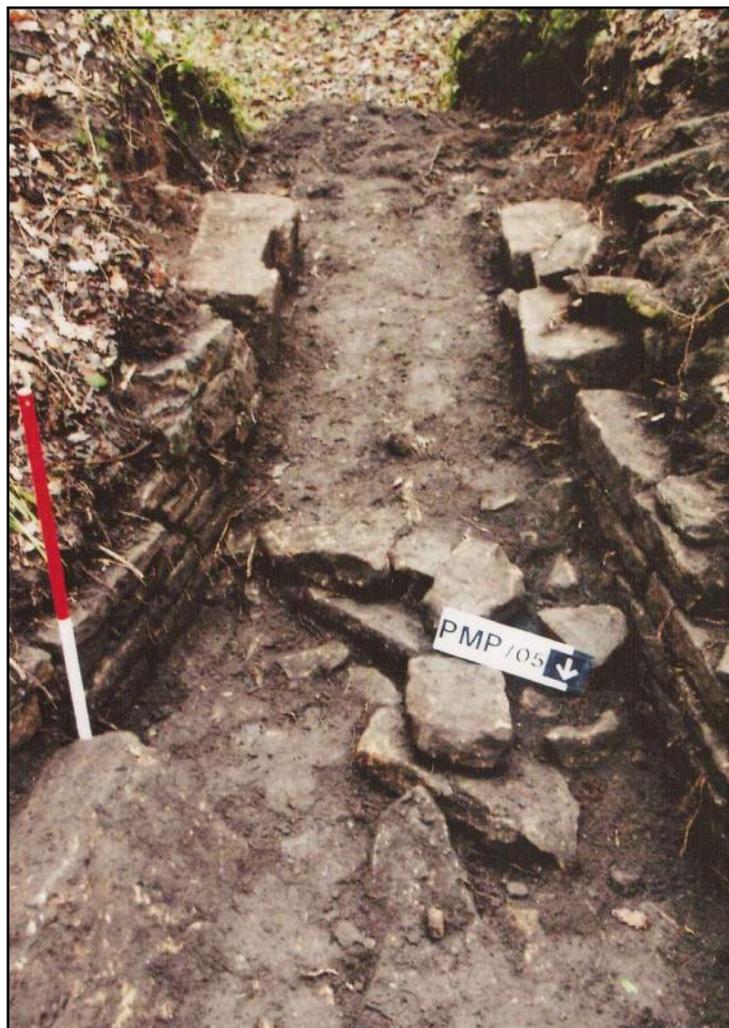
Plates 4 and 5: Curving stonework (0020 and 0021) leading up to where a sluice gate (stones 0022 and 0023) was once positioned at the north-west corner of Moor Pond, Papplewick (Trench 05, Area B). Exposed by volunteers in November 2002.
