Title	Archaeological Project Report Moor Pond Woods, Dam Banks East Sluice
Author(s)	Stephen Walker
Date	6 th December 2005
Revision date(s)	13th November 2014
Revisor(s)	Stephen Walker
Version	v2.2
MPW project code	DBES_phase1
Location of site	OS Grid SK 54768 50792
File name/location	MPWproject_Report_DBES_phase1_v2-2_20141113.docx

Abstract

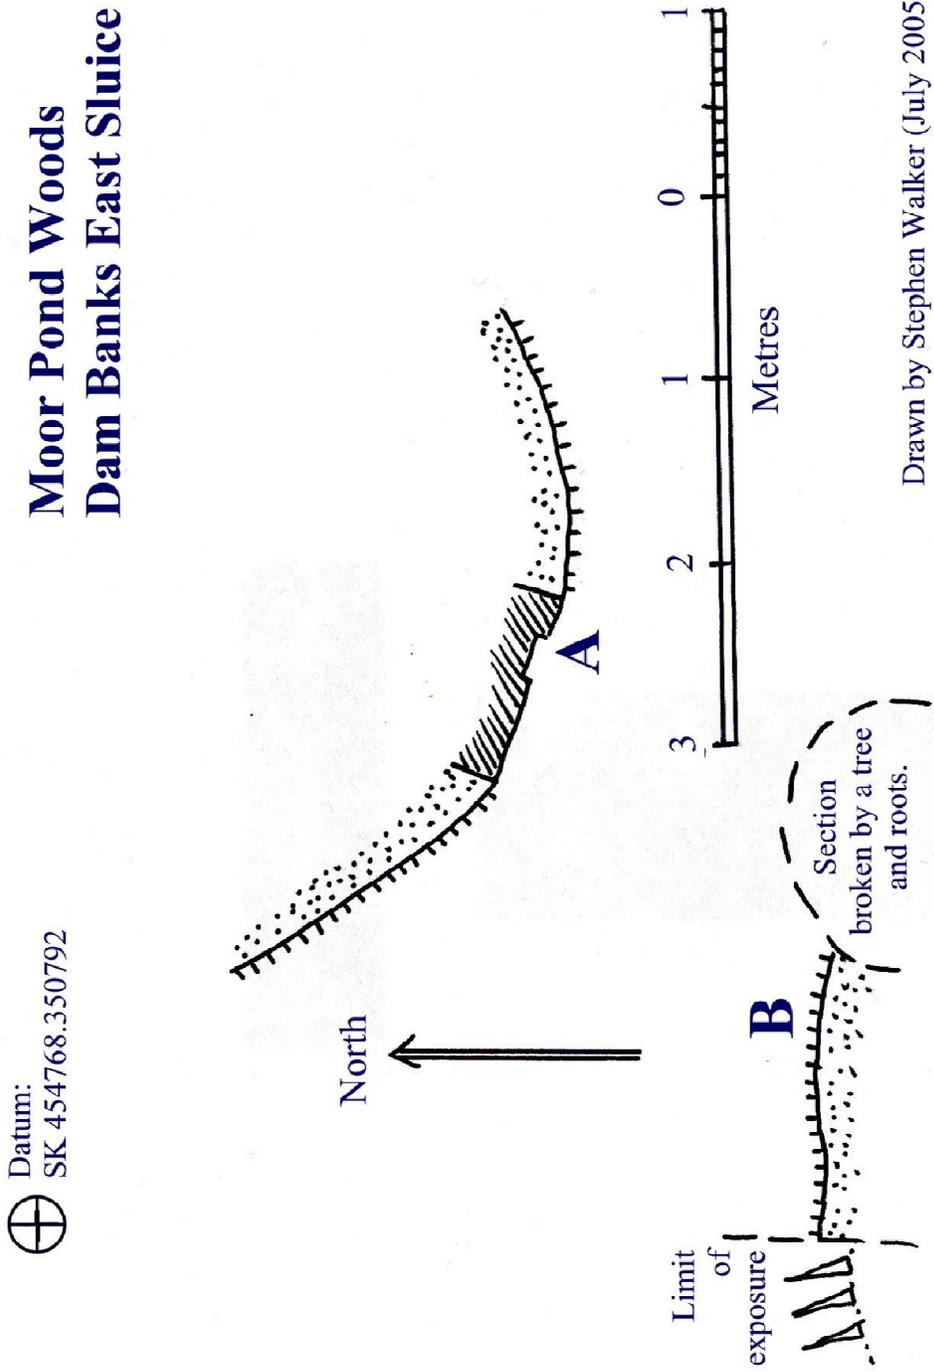
Figure 4: Plan of Dam Banks East Sluice, as revealed by excavation July 2005

1. The exposure. The excavations revealed that on the north side of the gap in the embankment there is a curved stone wall, with a 'sluice block' in the centre. To the south the tree probably stands on the corresponding wall. The stone in the roots is seen to be a 'sluice block', though measurements are not possible. Also on the south side there is a short length of wall at right angles to the embankment. See the plan in figure 4.

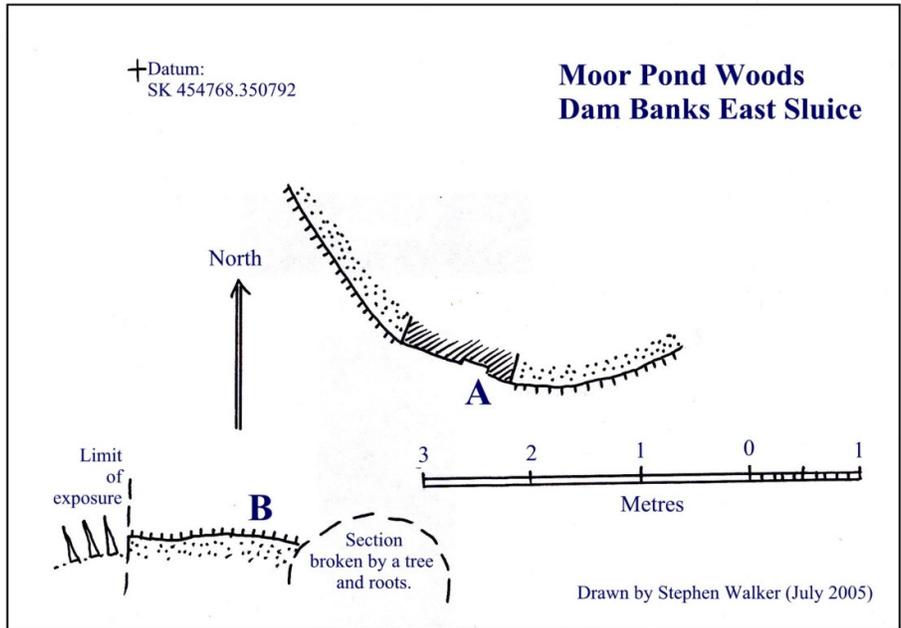
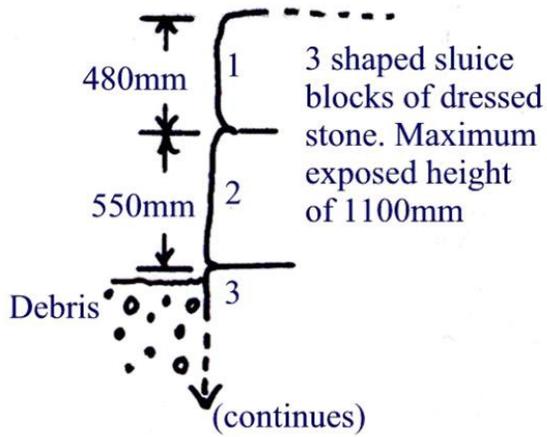
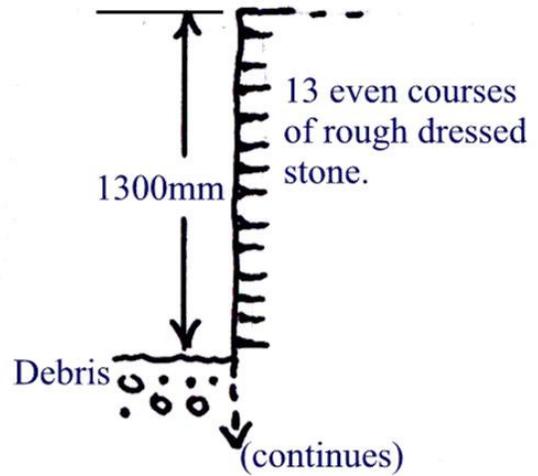
Figure 5: Dam Banks East Sluice, sections through the exposure July 2005

2. The north side. (See figures 5, 6, 7 and 8)
 - a. There was a near vertical wall on the north side of the excavation, made up of between 7 and 9 courses of square-cut stone. The courses are of uneven thickness and are either built without mortar or with a mortar that has weathered away.

- e. In plan, the wall was observed to be curved around the embankment on both sides of the sluice.
3. The south side. (see figures 5 and 9)
 - a. On the south side of the sluice a 1.5m length of a vertical retaining wall was exposed, seen to extend to a depth of 1.30m from the top (but the base was not found). The wall was formed of blocks of roughly shaped Mansfield stone, in fairly even courses each of about 10cm thickness.

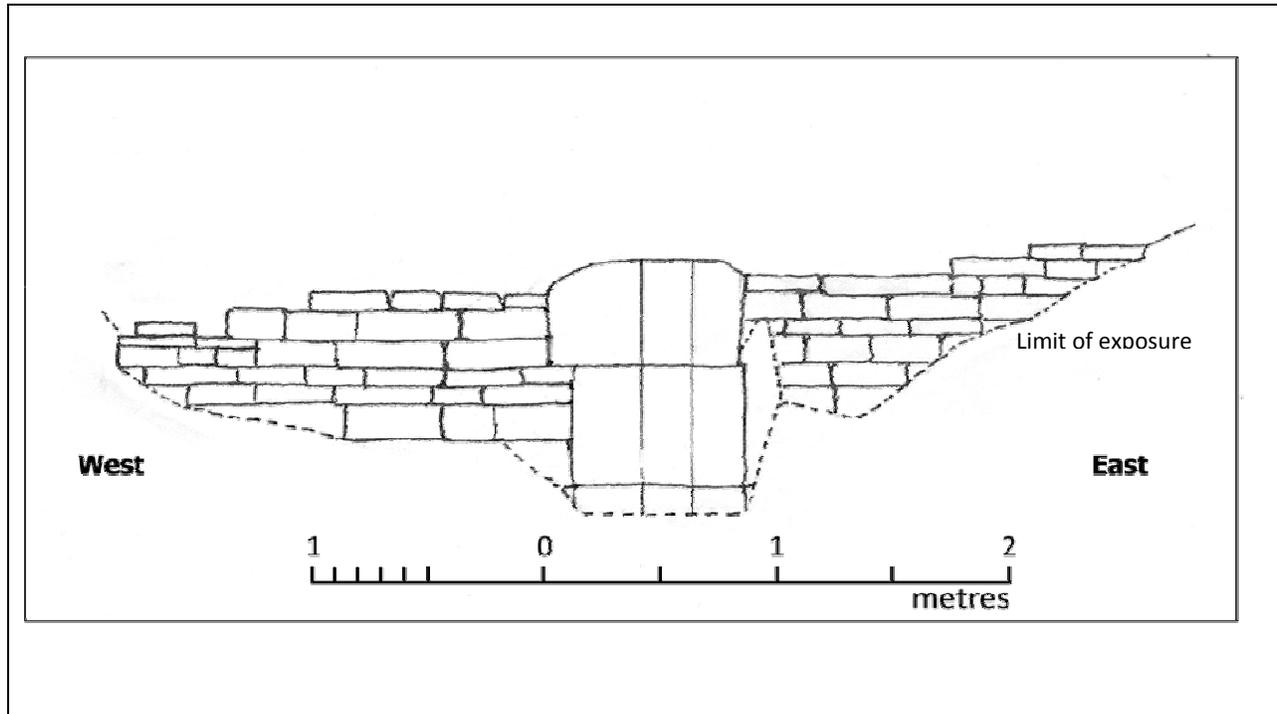
Figure 6: Dam Banks East Sluice, side elevation of the sluice gate (north side)

- b. There were three large shaped blocks providing a slot to hold the sluice-boards in place. They were seen to extend to a depth of 1.10m from the top, but the base was not found. The slot is 0.21m (8¼") wide and is recessed by 0.06m (2¾"). Only the top 0.07m of the bottom block was exposed during the weekend and it continued downwards.

- c. The top block was wider than the others and shaped in both its length and width to create a curved profile. By levelling, the upper surface of the top block was calculated to be at an elevation of 0.07m above the blocks on the south sluice.

- d. There were also two other intermittent courses of stone set into the embankment above the sluice blocks, but set back from the edge. The relationship between these and the other courses of stone was not determined.

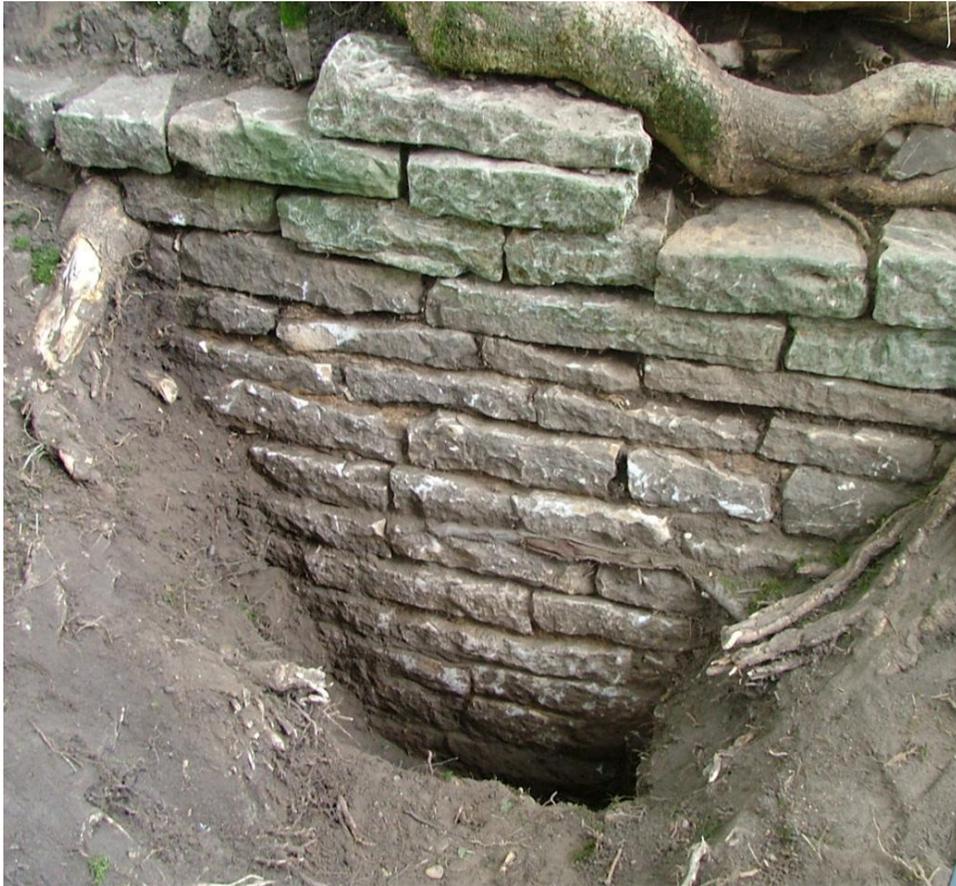
Figure 9: Dam Banks East Sluice, south side facing south

- b. The wall extends further to the west, but time did not allow its full extent to be revealed. To the east, the wall is severely affected by tree roots. In the centre of the roots there is a sluice block, but its position and orientation were thought to have been changed by the growth of the roots.
