Title	Archaeological Project Report Moor Pond Woods, The Dam Banks Ponds
Author(s)	Stephen Walker
Date	29 th November 2008
Revision date(s)	14th November 2014
Revisor(s)	Stephen Walker
Version	V2.1
MPW project code	DBES_phase2
Location of site	OS Grid SK 54768 50792
File name/location	MPWproject_Report_DBES_phase2_v2_20141114.docx

This report was originally compiled in November 2008, but was revised in November 2014 to include new mapping, references to the project archive and to present it in the house style of Moor Pond Woods Project reports.

The site lies to the north of the Dam Banks South Sluice and bridge, west of Moor Road and between Papplewick Lane and Linby Lane. The OS reference for the site is centred at SK 547 507.

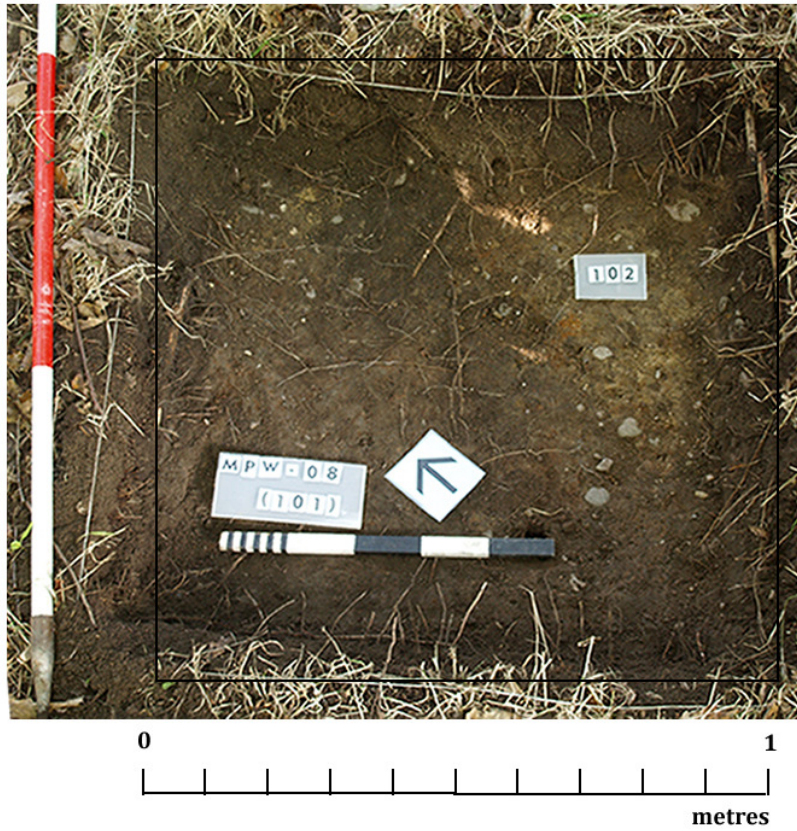
Figure 4: Test pit T1400, on the terrace NW of the East Sluice

1. The test pits.
 - a. Test Pit T1400 was excavated on the terrace a few metres north-west of the East Sluice at OS Grid Ref SK 54759.637 50801.064 ; See figures 3 and 4.

- i. Under the thin humus layer, was context 101 - reddish-brown clay/silt loam subsoil, containing few pebbles. This continued to a depth of 15cm.
 - ii. Below 15 cm was context 102 - an indurated gravel layer with yellow sandy matrix. At its surface was a layer that contained pebbles up to 3cm in length.

- a. The structures observed in T1400, the test pit on the terrace feature, are consistent with an interpretation that the terrace was periodically flooded, (rather than containing flowing water that would have been more likely to deposit coarse-grained material), and for the context 102 to represent the former land surface.
- b. The structures in T1500 are possible indications that this was the site of a channel linking a possible north pond to the bridging structure at the South Sluice.
The stones may be remnants of a channel lining.
Alternatively they may be remnants of a demolition phase, perhaps marking the site of a stone dump where useful material was stored and/ or sorted. The stones that were exposed were angular and showed no sign of being shaped to form parts of a wall. There was no mortar debris in the fill.

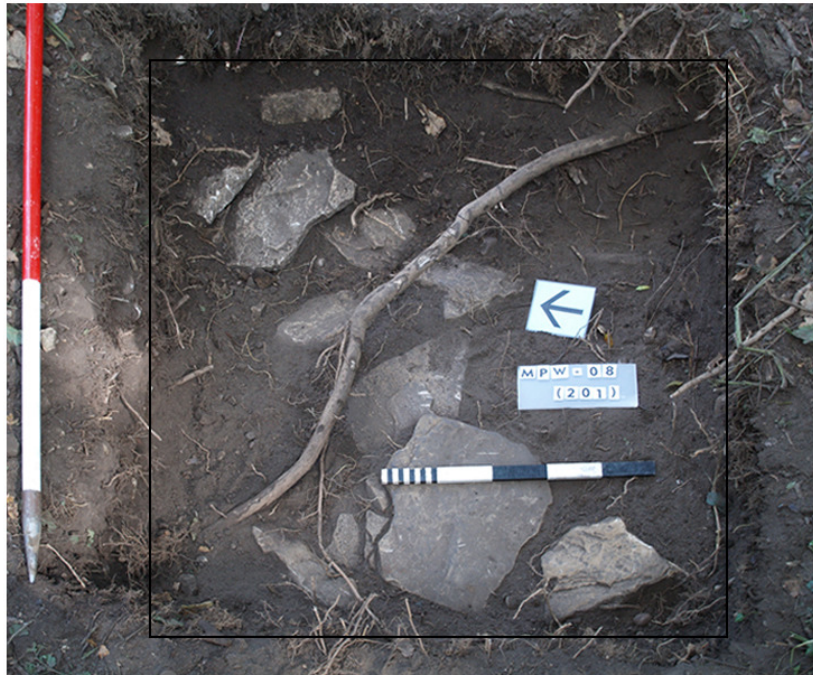
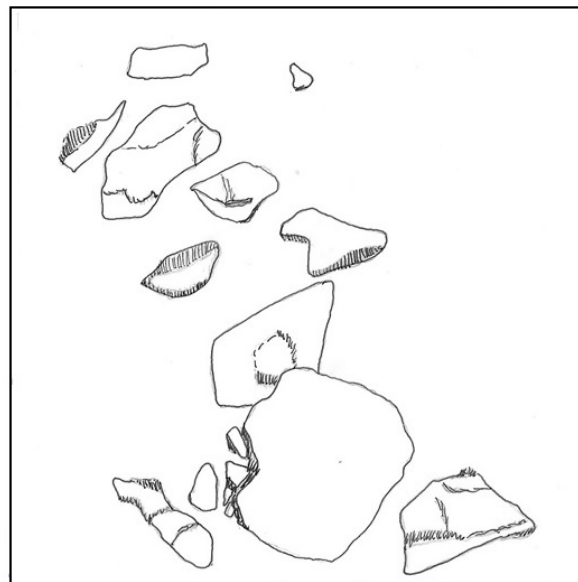
Figure 6: Test pit T1500, between the subsidiary pond and the South Sluice

- b. Test Pit T1500 was located on the low lying area between the channel leading to the South Sluice and the boggy area thought to have been the subsidiary pond at OS Grid Ref SK 54782.787 50753.873 ; See figures 3 and 6.

- i. At the surface there were only a couple of centimetres of dry, humus-rich topsoil, with fine roots.
 - ii. Beneath the topsoil was context 201 - a 10cm layer of a friable, grey-coloured sandy/silt loam.

- iii. Only 10-12cm beneath the surface were numerous pieces of flaggy yellow-grey Magnesian limestone set into the grey sandy subsoil. By observation the stone more closely resembled Mansfield stone than Linby stone (which is generally orange/cream coloured).

- iv. The biggest slabs were in the range 20-35cm length. They were all lying in the same plane.
 - v. No attempt was made to lift the stones, nor to dig through them.

- c. The evidence in test pit T1500 suggests that there may have been a channel at this position. To be more certain, there would need to be more intensive exploration of the site.
