Title	Archaeological Project Report Moor Pond Woods, Dam Banks East Sluice
Author(s)	Stephen Walker
Date	6 th December 2005
Revision date(s)	13th November 2014
Revisor(s)	Stephen Walker
Version	v2.2
MPW project code	DBES_phase1
Location of site	OS Grid SK 54768 50792
File name/location	MPWproject_Report_DBES_phase1_v2-2_20141113.docx

Abstract

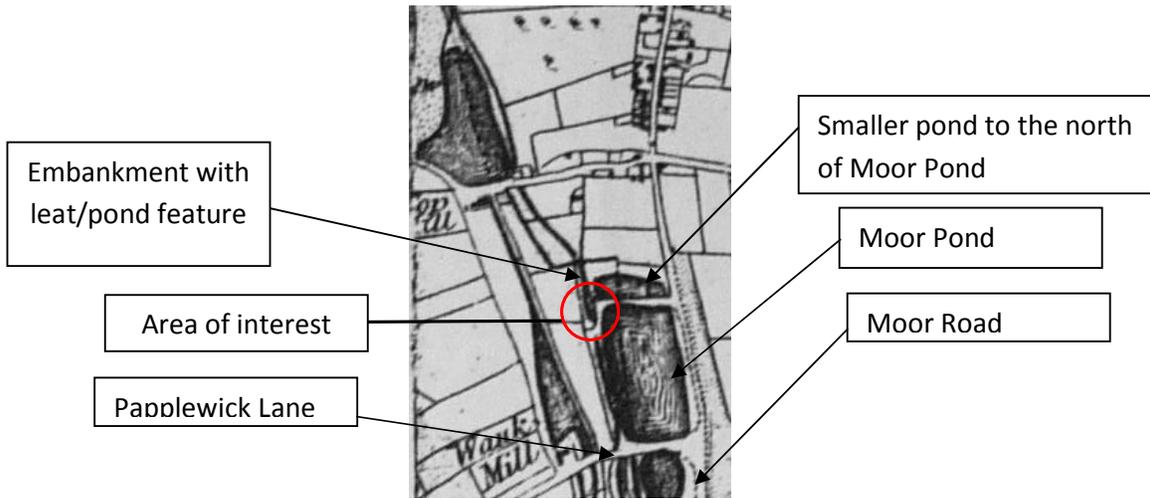
Figure 1 : Extract from the 1835 Sanderson map

At this scale, Sanderson is not very clear but he appears to show that north of Moor Pond is a smaller pond, joined to the leat/pond feature that runs southwards through Dam Banks. (See figure 1) Field survey revealed that there is a large ash tree, marking an obvious break in the line of the embankment that separates these two features. There are stone blocks visible in its roots.

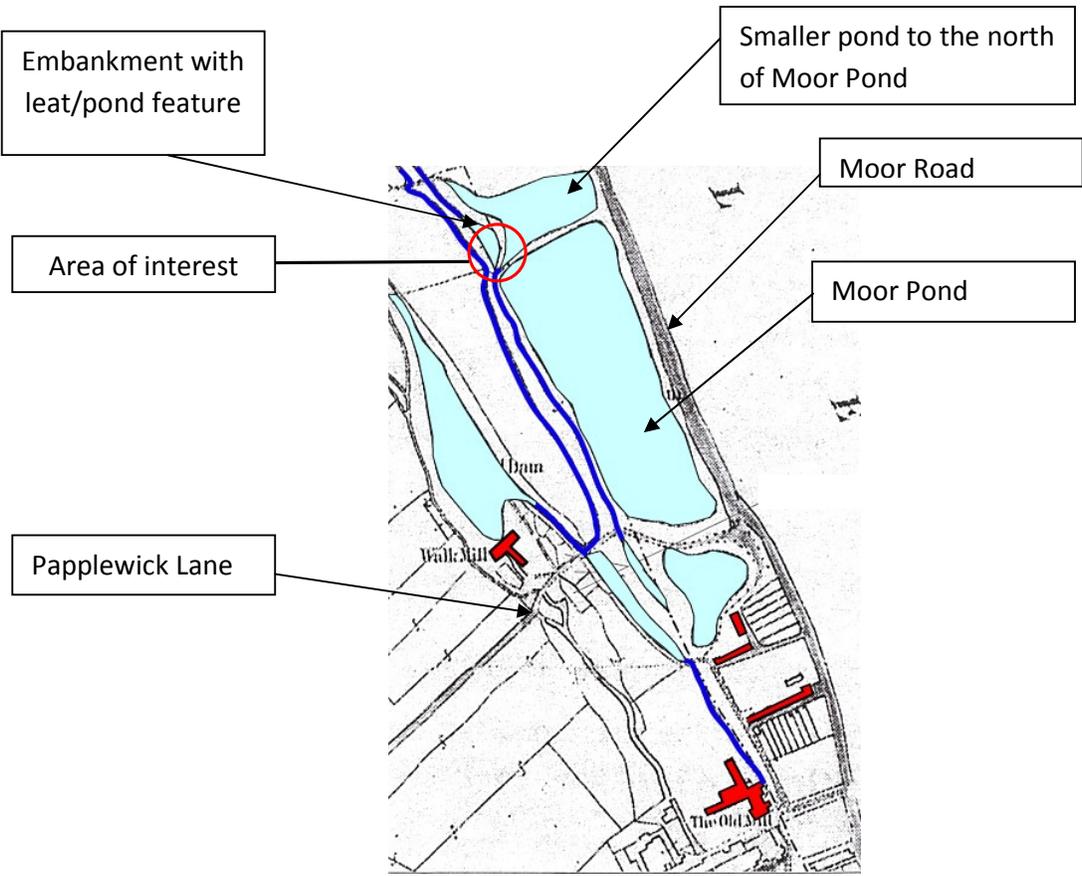
Figure 2: Extract from the Montagu estate map of 1847

There is a bit more detail on the 1847 estate map, seen in figure 2. However, this map does not show an east-west channel linking the two features. Nevertheless the shape of the features is delineated more clearly and the positions of the other channels and ponds are in similar positions. This adds weight to the value of the Sanderson map as a fairly accurate source.

1. That there was indeed a sluice in the embankment separating the two pond features seen on the map in figure 2.
2. The height of the sluice block exposed on the north side is close to the height of the remaining blocks at the nearby South Sluice, perhaps indicating that the two sluices were worked in conjunction with each other. Of course, if there is a block missing at the south sluice that would probably have been a little higher than the east sluice.
