DAM BANKS SOUTH SLUICE POND, MOOR POND WOODS,

PAPPLEWICK, NOTTINGHAMSHIRE

REPORT ON AN ARCHAEOLOGICAL INVESTIGATION

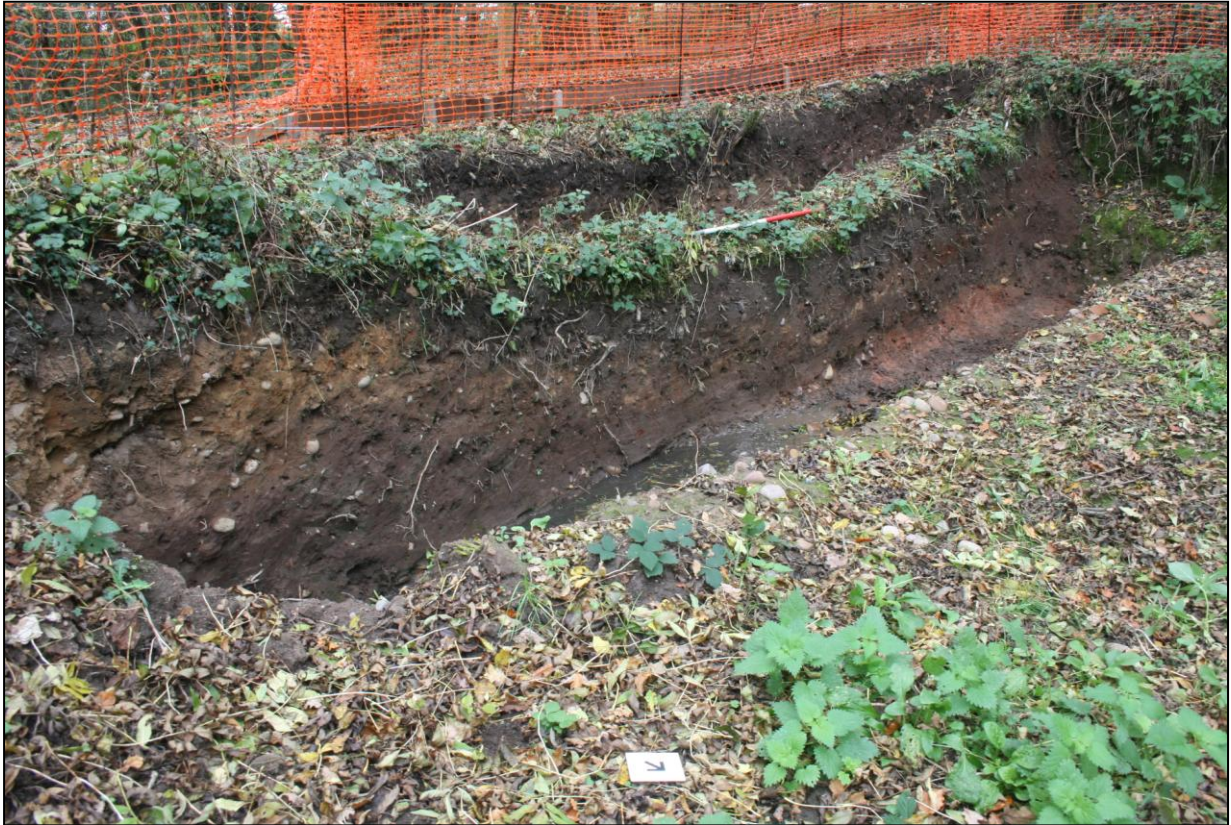
Plate 1: North facing section of trench 1 Looking south west (L. Binns 2015)

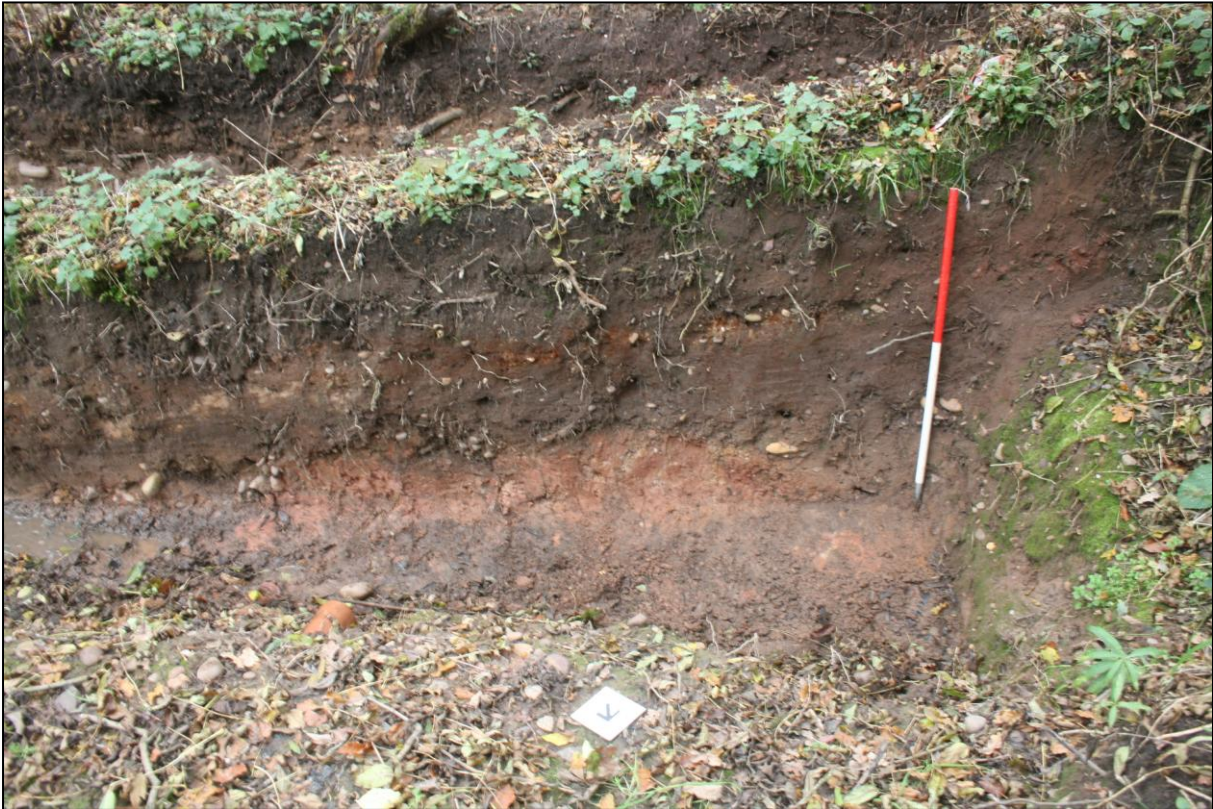
Plate 2: Western end of North facing section, showing potential ditch feature. Looking south (L. Binns 2015)

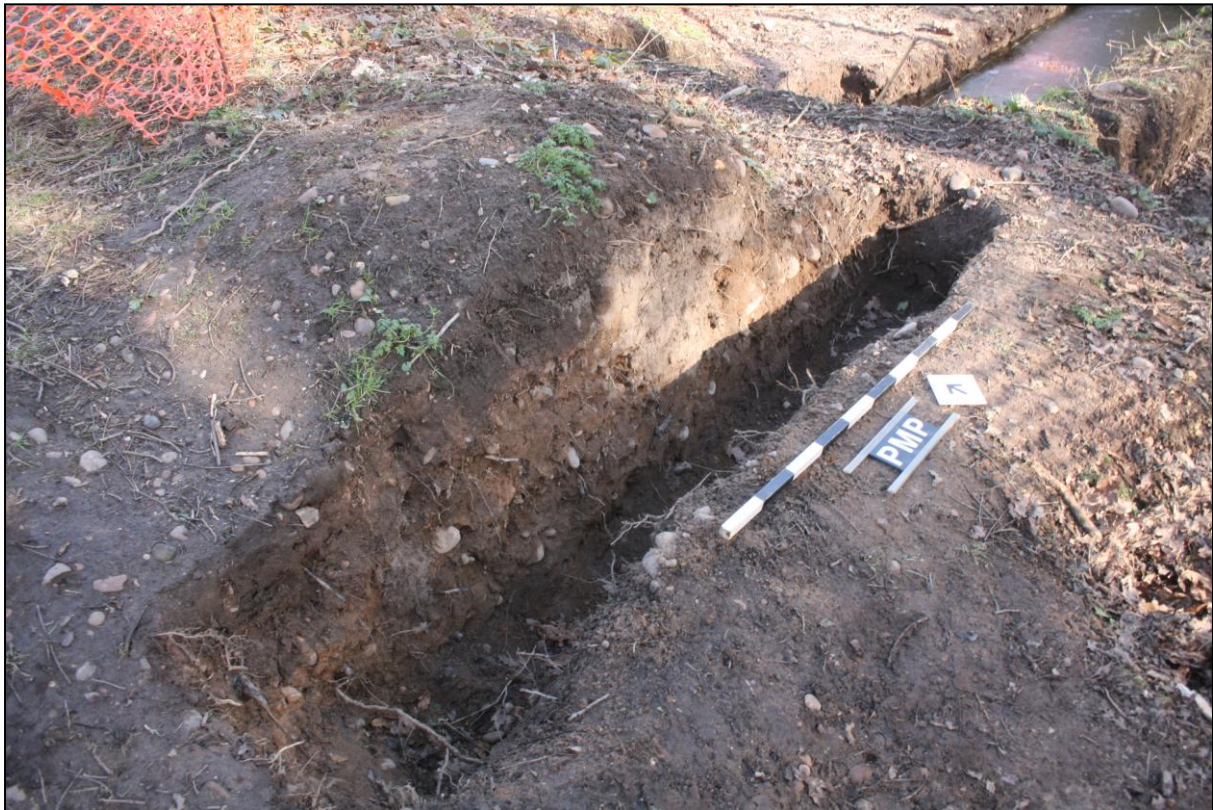
Plate 3: Trench 4 showing bank build up. Looking north east (L. Binns 2015)

- 7.3.1 Trench 4 was excavated at the top of the pond bank to establish whether the subsoil layers were the same as the layers identified in trench 2 (Plate 3).
- 7.3.2 Trench 4 measured 2m east to west long by 40cm wide north to south and a maximum of 60cm deep. Below the thin layer of topsoil (1000) a 25cm deep layer of mid brown yellow sand with sub rounded pebbles was observed, similar to (1010) in the North facing section. A mid grey silt subsoil (1003) was found below this but its depth was not fully excavated.
- 7.3.3 This trench suggests that the banks could have been built up at a later date when the pond was already beginning to silt up. They could relate to the period of time when the pond had become an area of marsh land, as suggested on the 1847 map, when they were raised up to prevent flooding.

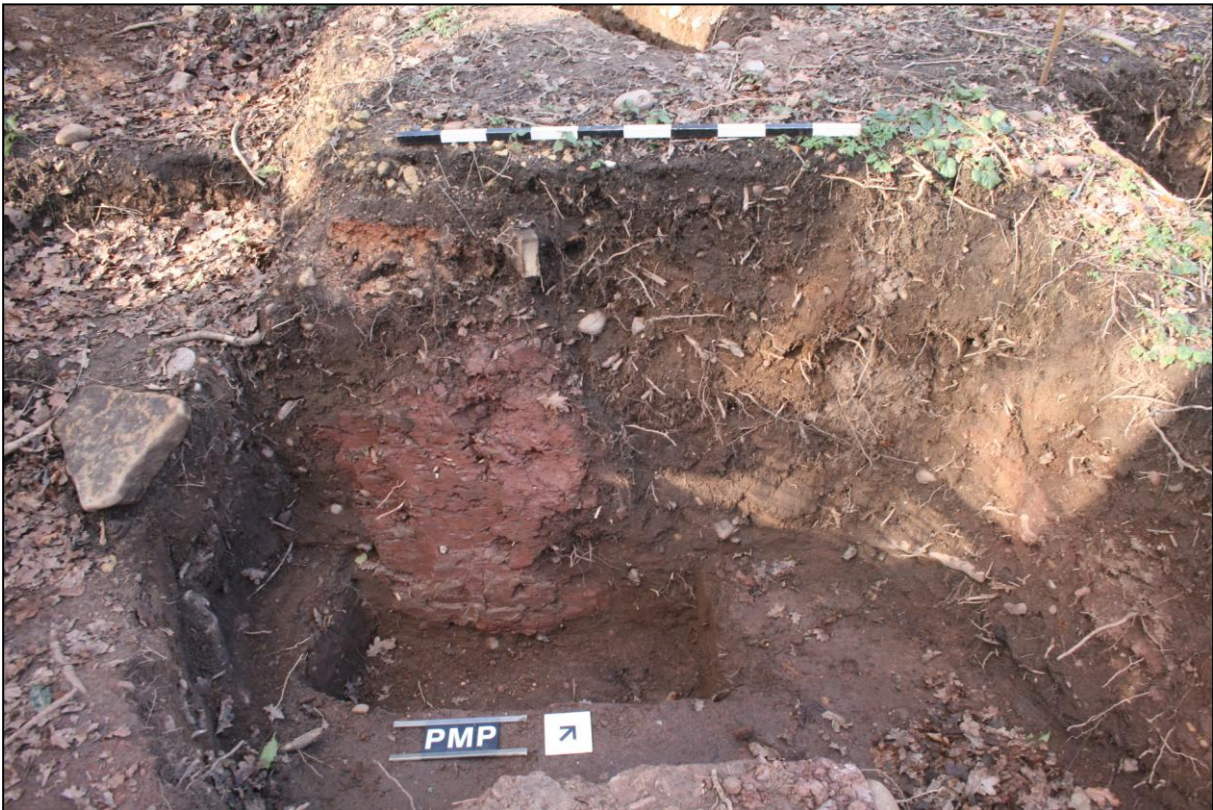
Plate 4: South east facing section of trench 2, showing clay deposit [1011] continuing into the embankment. Trench 4 is visible at the top of the image. Looking north west (L. Binns 2015)

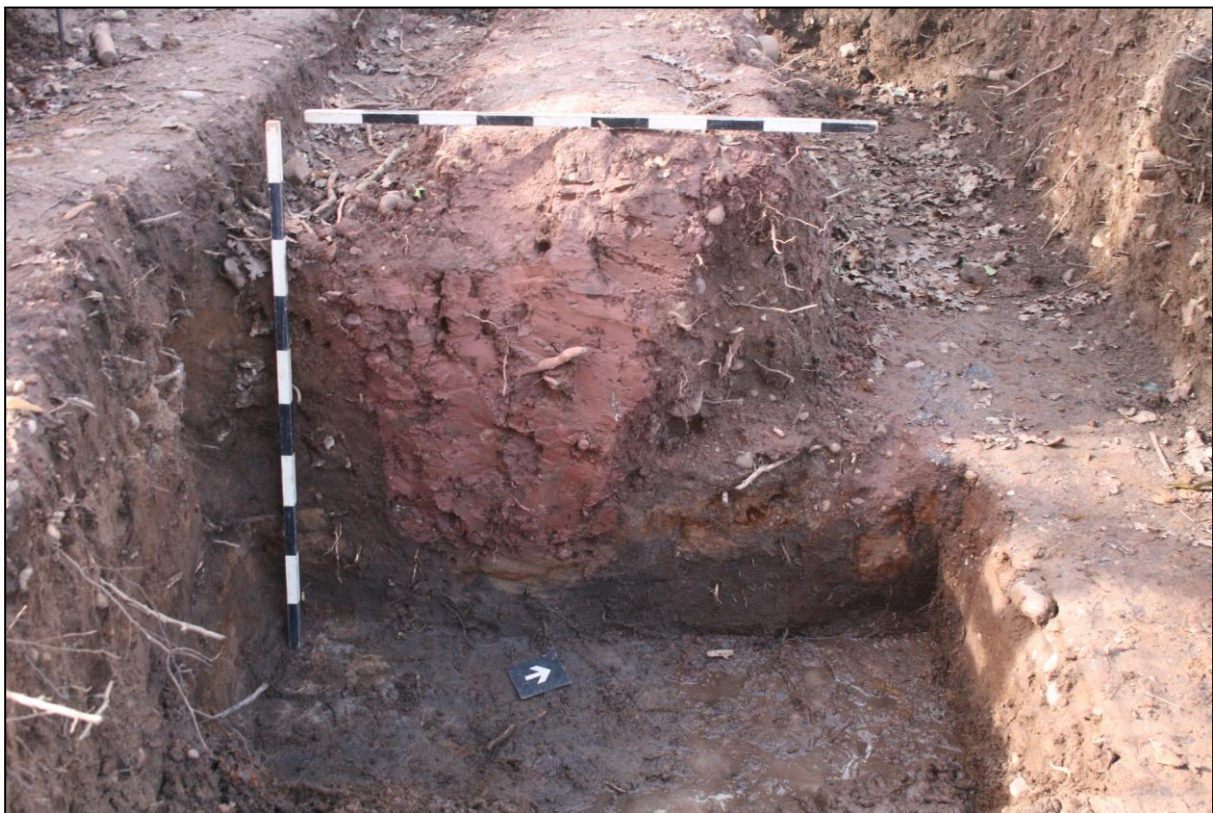
Plate 5: South east facing section in the middle of trench 2 showing clay deposit [1011] running east-west, and posthole [2015]. Looking north west (L. Binns 2015)

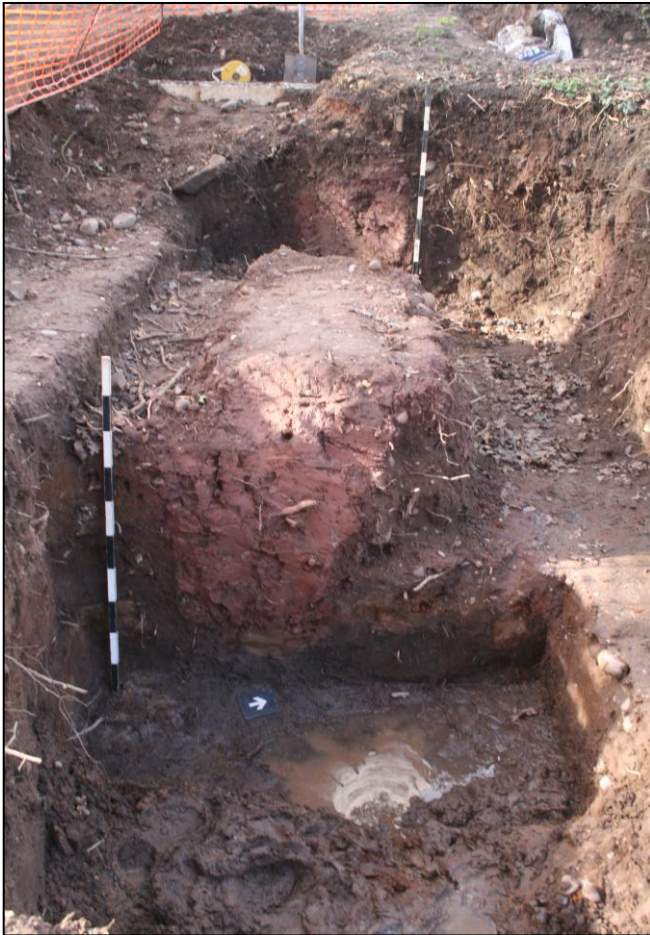
Plate 6: Continuation of clay deposit [1011] Looking north west (L. Binns 2015)

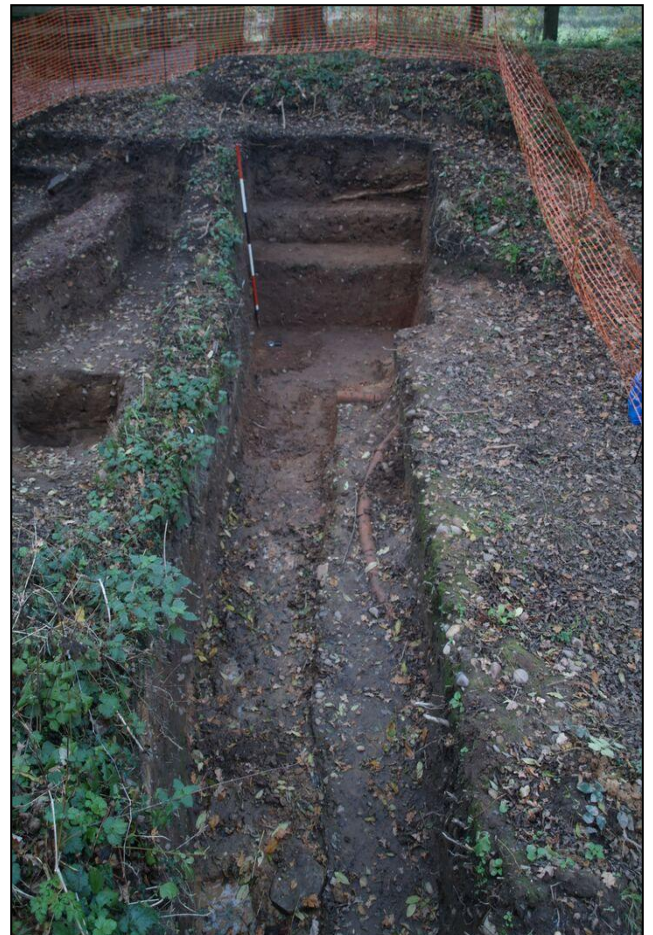
Plate 7: Trench 1. Looking north west (L. Binns 2015)

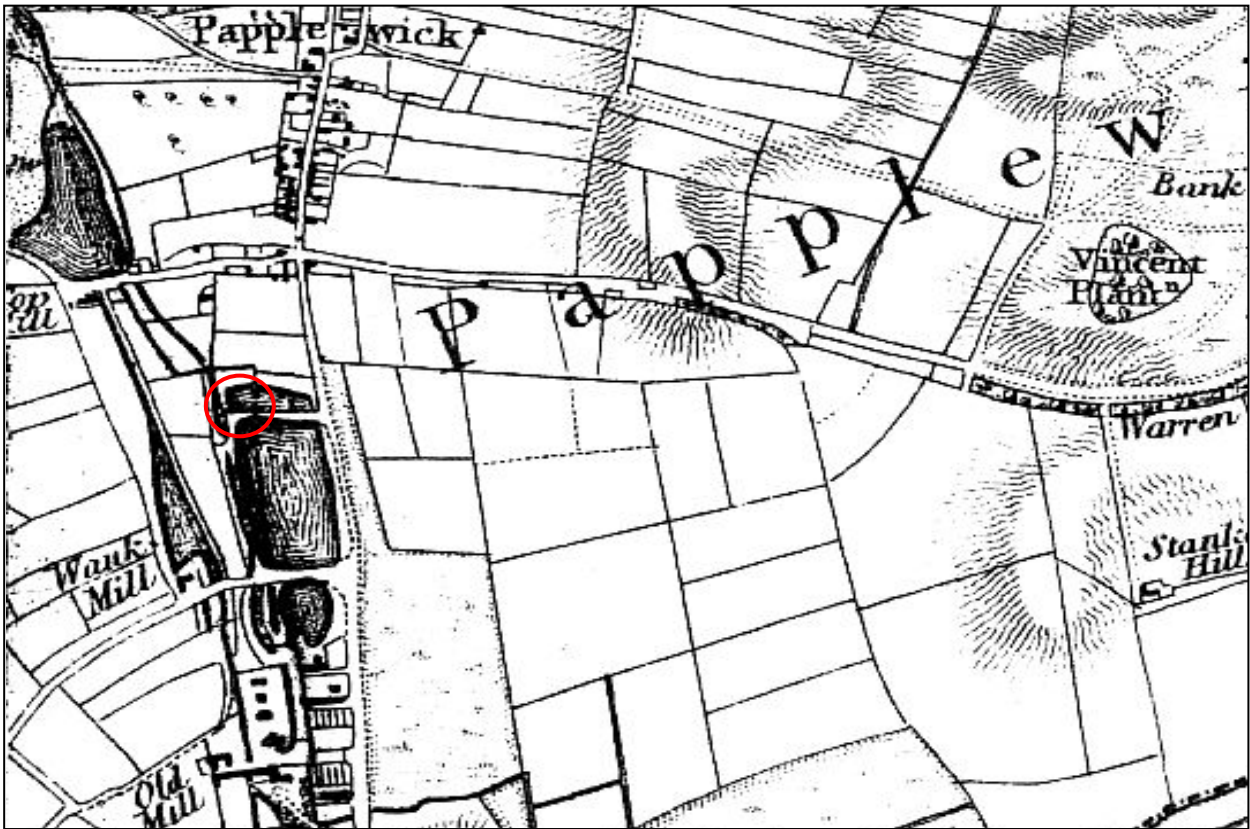
Figure 4: Sanderson's map of Nottingham 1835. The leat and subsidiary pond are clearly visible. Not to regular scale.

- 4.1.5 On Sanderson's map of 1835 (Figure 4) the subsidiary pond and holding pond still seem to hold water, although they look to be the same feature and the presence of a bank between the two is not very clear. However on the Ordnance Survey map of 1880 (Figure 5) the subsidiary pond seems to have dried up and the area has become a field, the holding pond is suggested to be an area of marshland

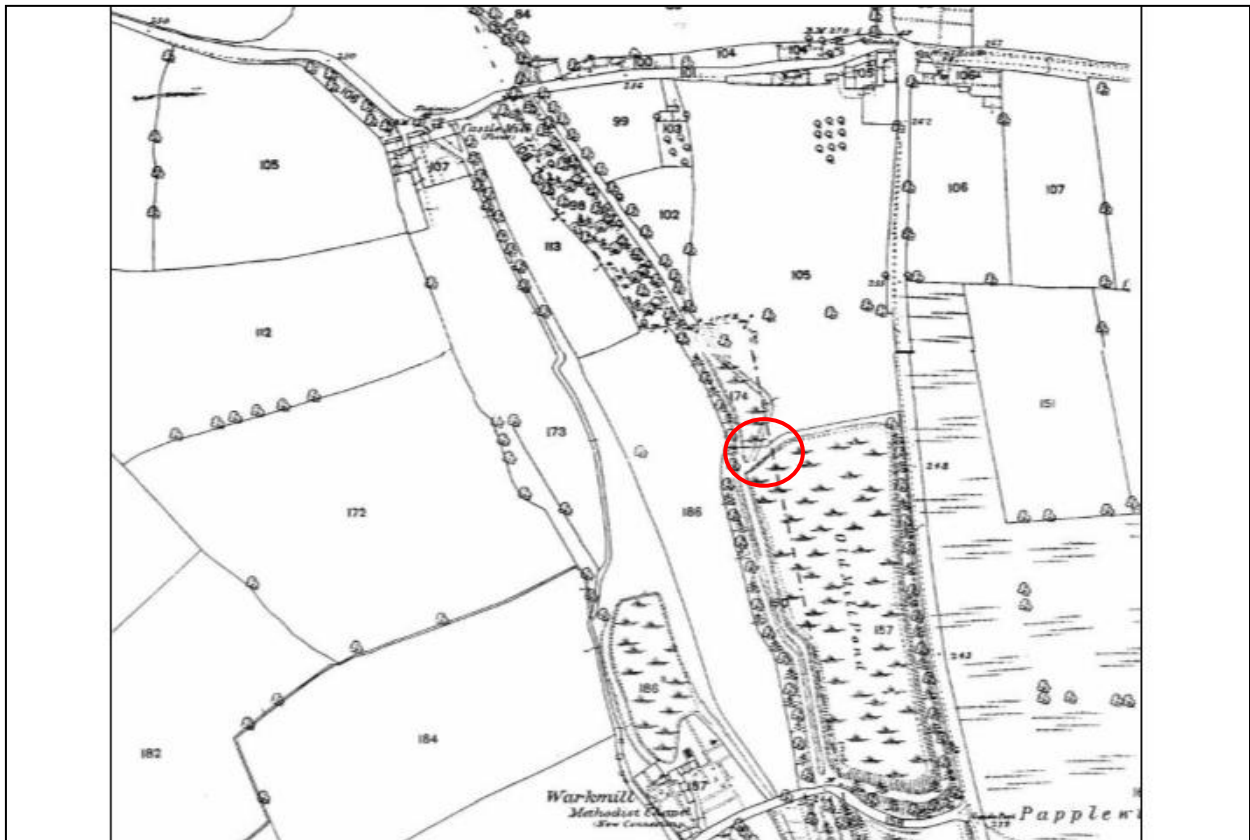
Figure 5: The holding pond and banks is still visible, although the area is suggested to be marshland. The subsidiary pond north of Moor Pond seems to have become a dry field area. Ordnance Survey 25 inch scale map of 1880-81. Scale 1:5000 (After Sheppard, 2001)

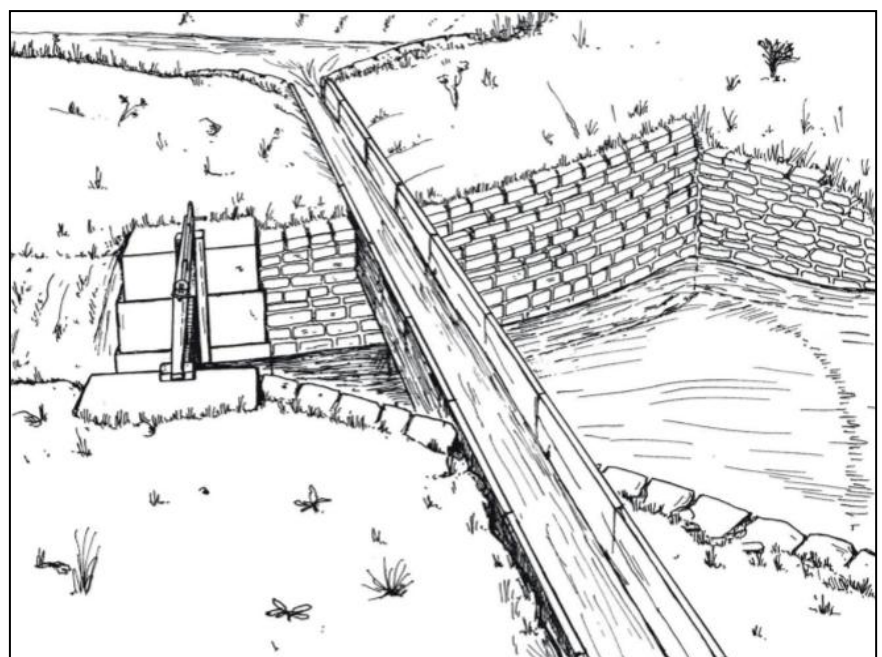
Figure 7: Reconstruction of the south sluice with trough or launder crossing over the stone wall approach to the gate (From Sheppard, 2007)
