**ARCHAEOLOGICAL RECORDING
OF A WALL STRUCTURE AT
PAPPLEWICK LANE, PAPPLEWICK,
NOTTINGHAMSHIRE, 2009-11**

**Archaeological Recording
of a Wall Structure at
Papplewick Lane, Papplewick,
Nottinghamshire, 2009-11**

A report for
Friends of Moor Pond Woods

OS Grid Ref. SK 5483 5049
TPA Project Code: PMP6
May 2015
TPA Report No. 056/2015

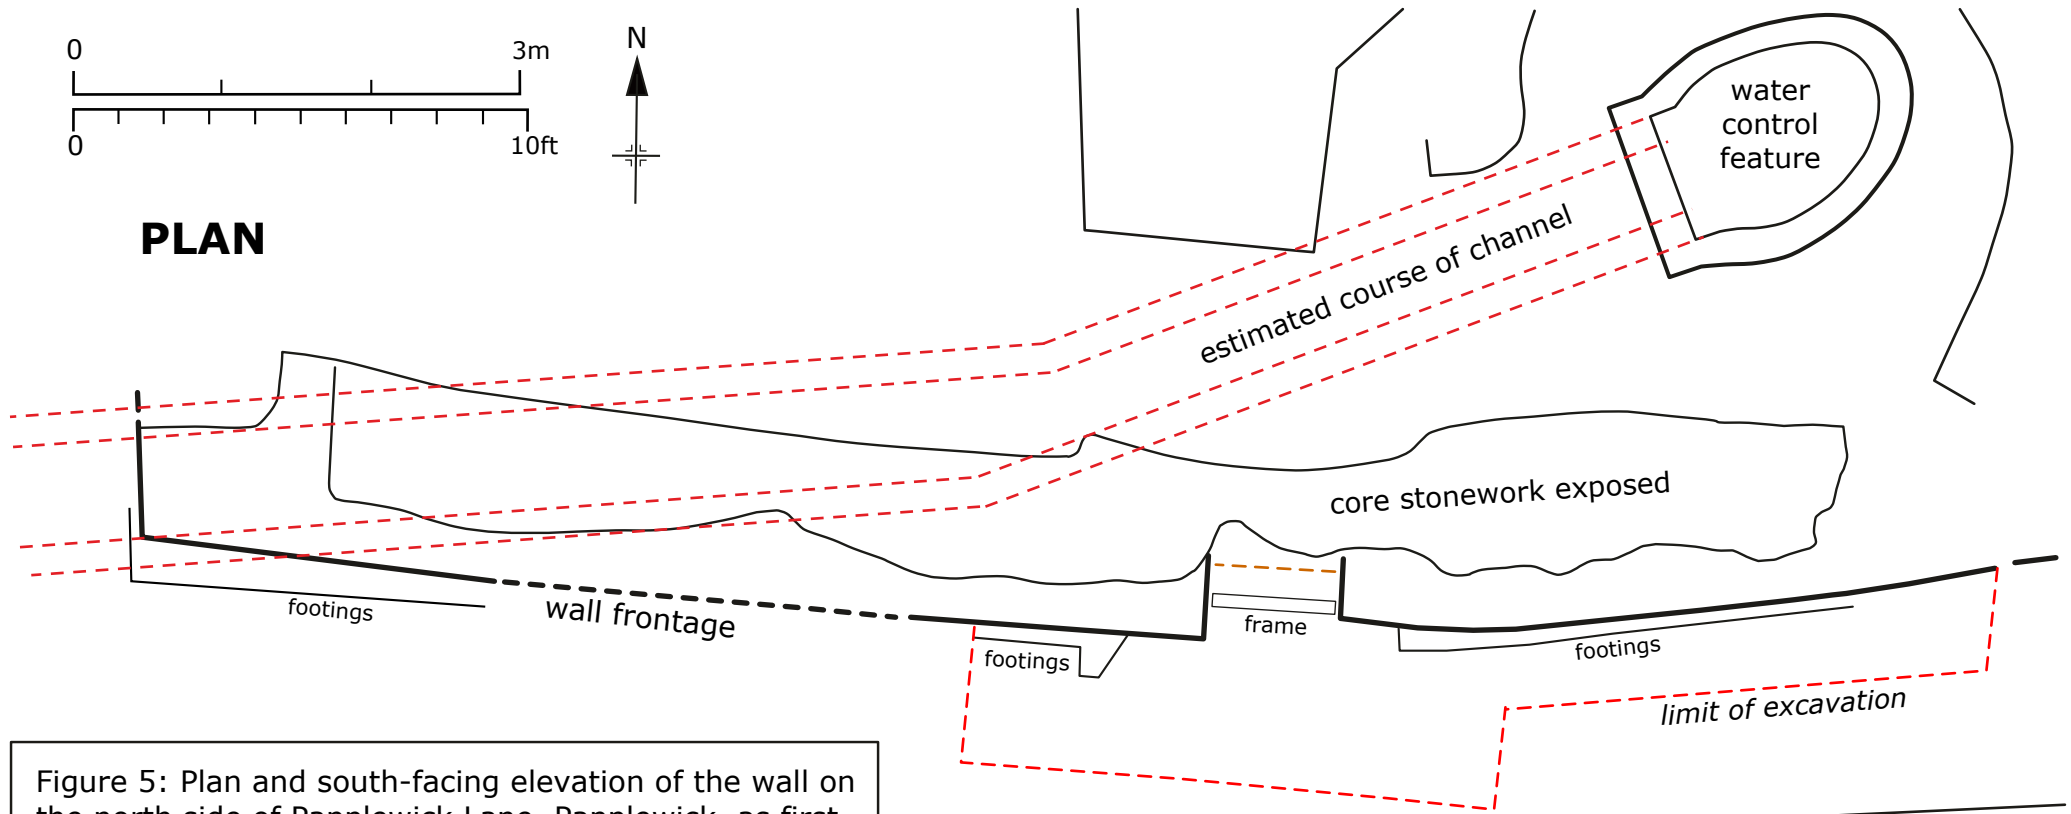
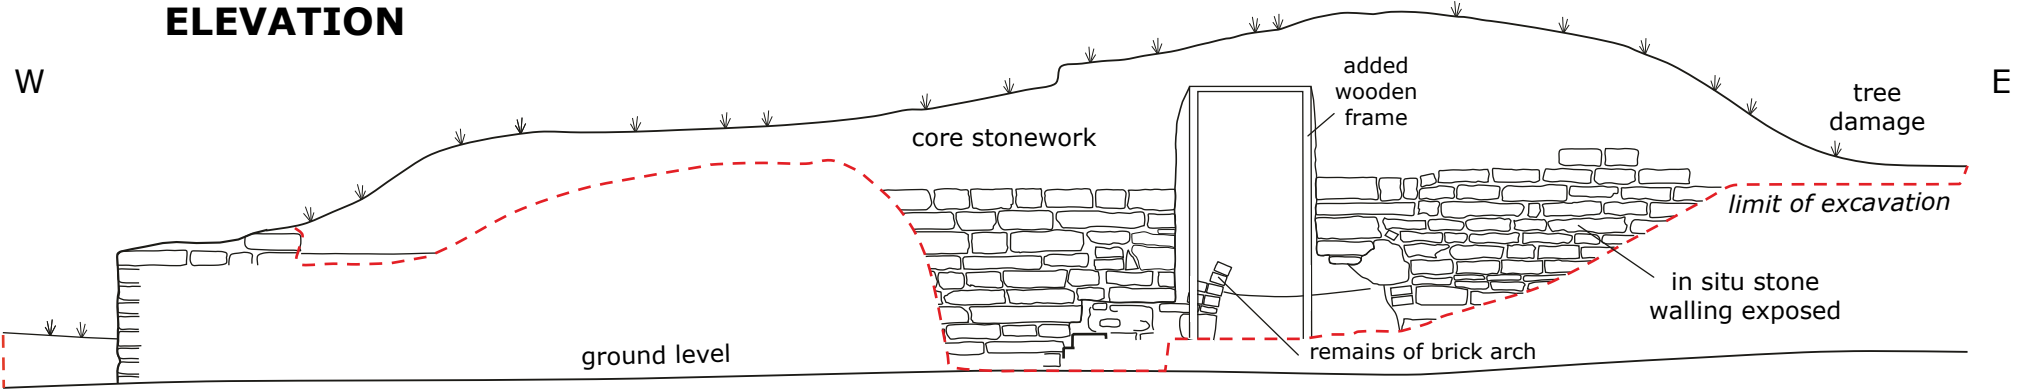
Figure 5: Plan and south-facing elevation of the wall on the north side of Papplewick Lane, Papplewick, as first exposed in 2009. Scale 1:50.

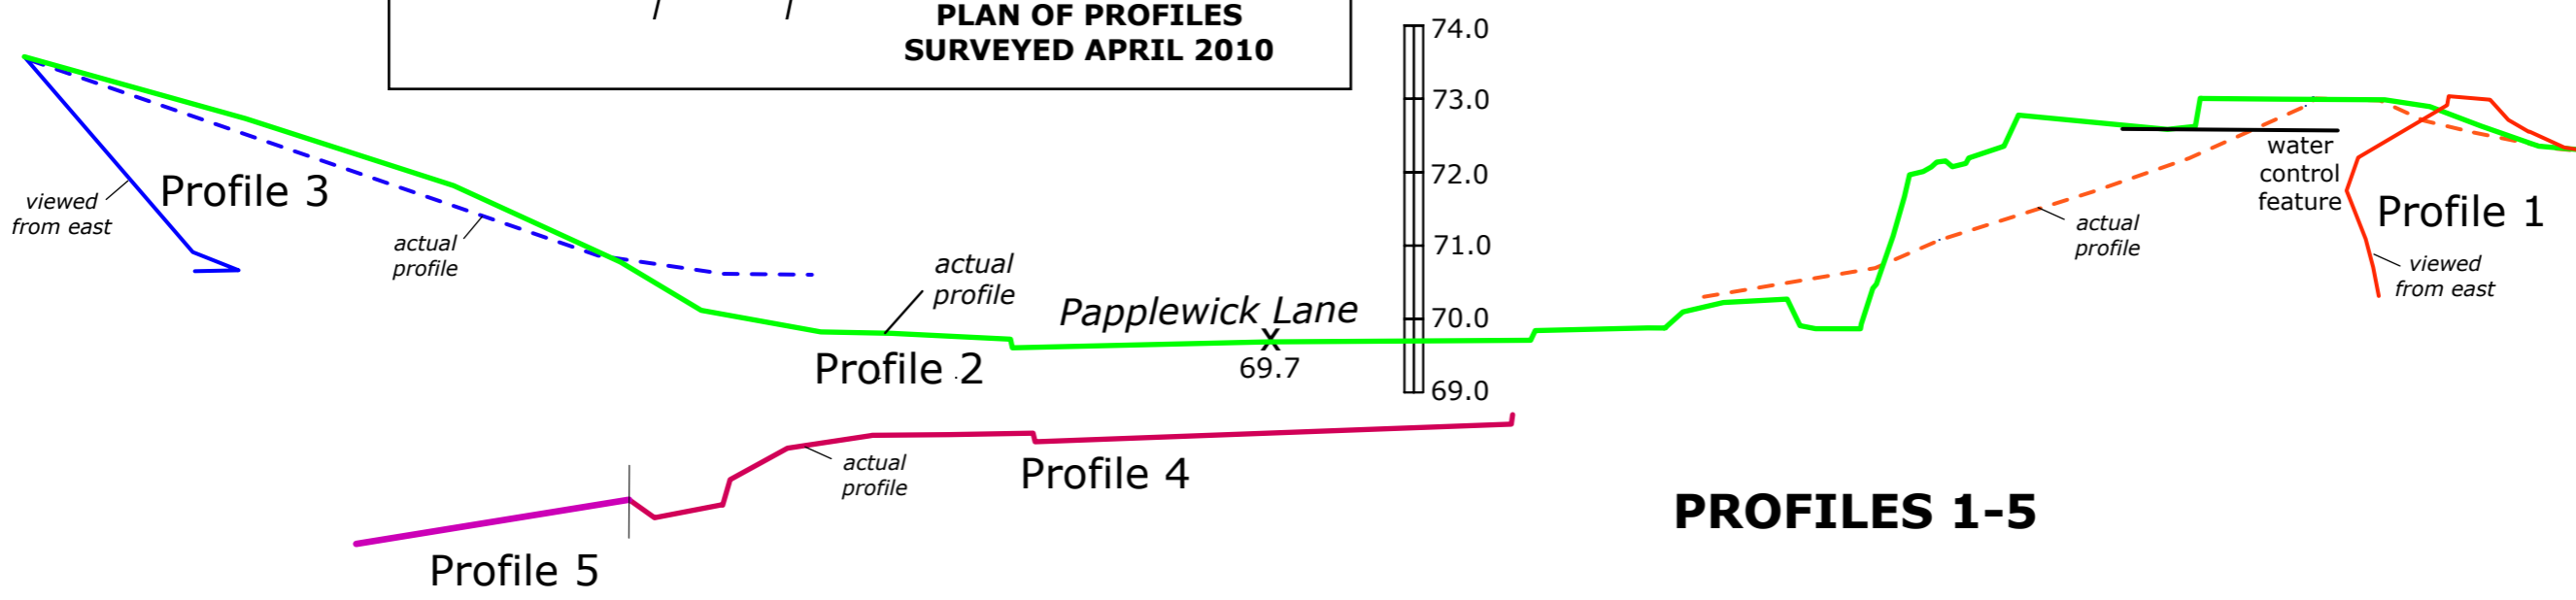
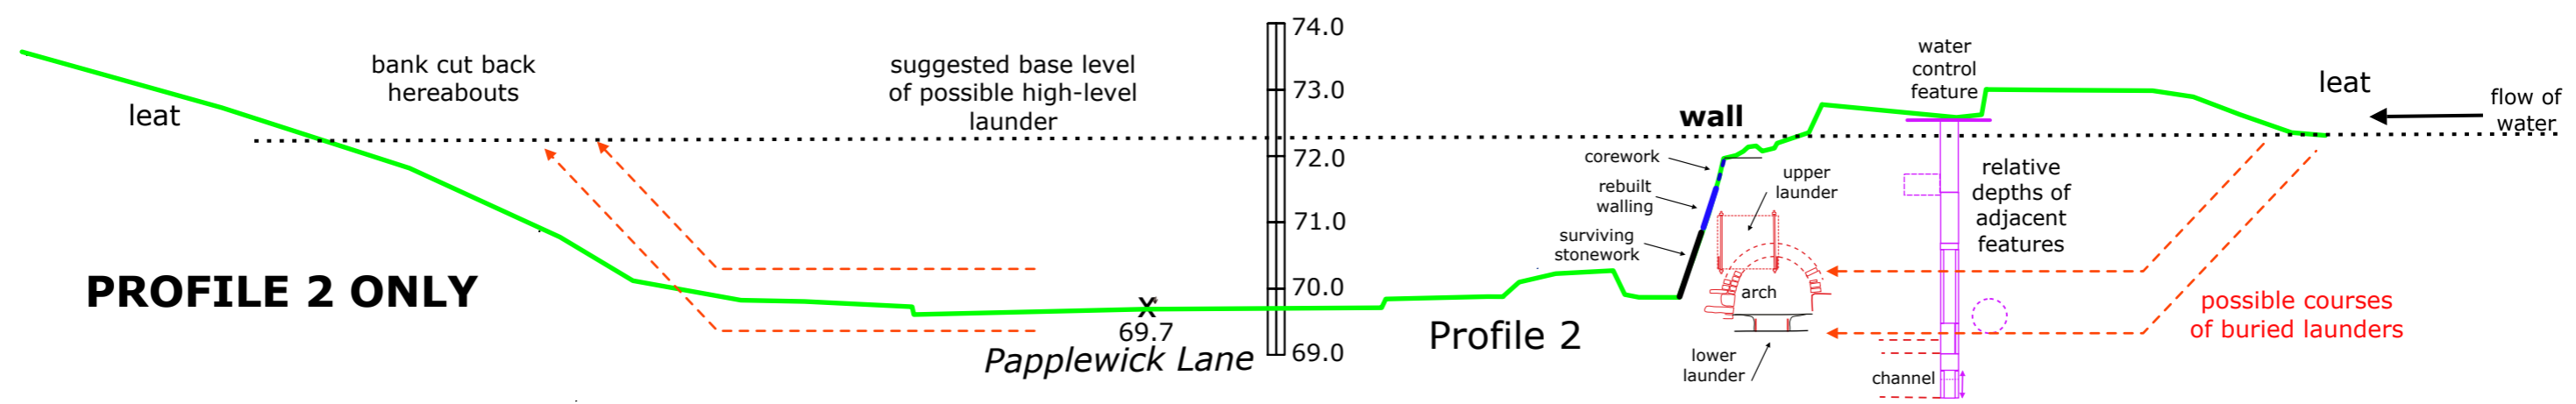
Figure 7: Profiles across the area around the walled feature on the north side of Papplewick Lane, Papplewick, and the relative depths of associated and adjacent features. Scale 1:100.

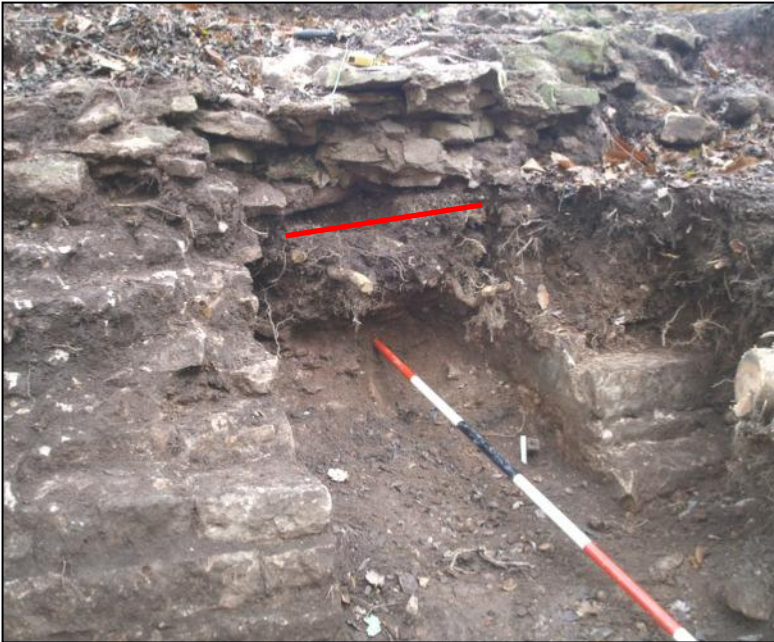
Plate 4: View showing both sides of the entry and the stratigraphy of the soil infill, together with the level at which the wall's core-work overlies the entry (indicated by red line).

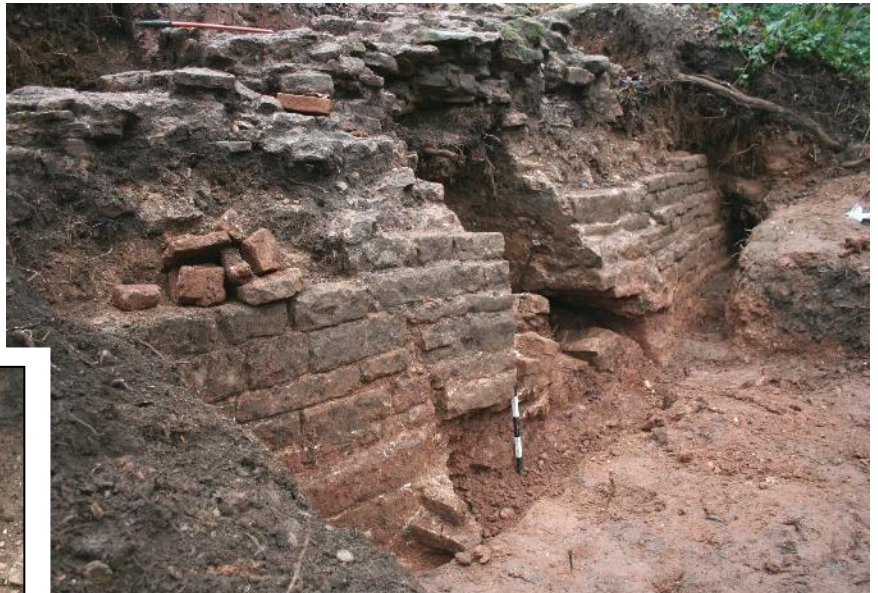
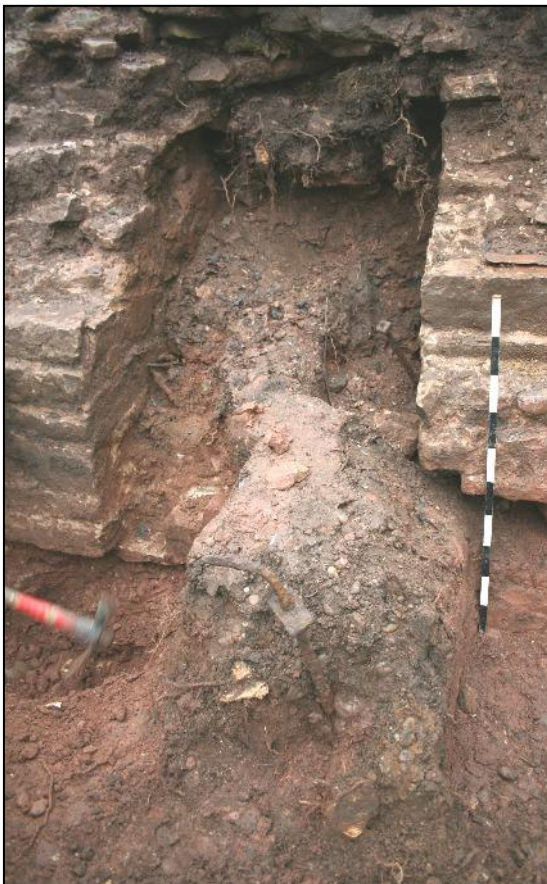
Plate 6: Iron nails and rods showing both within and extending outside the wall entry.

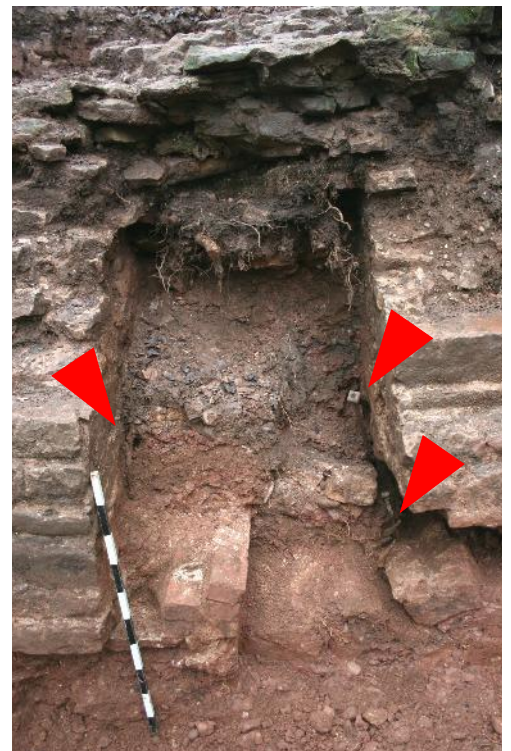
Plate 7: Another view of metalwork (indicated by arrows) and the cleared remains of the base of a brick arch close to and flush with the west corner of the wall entry.

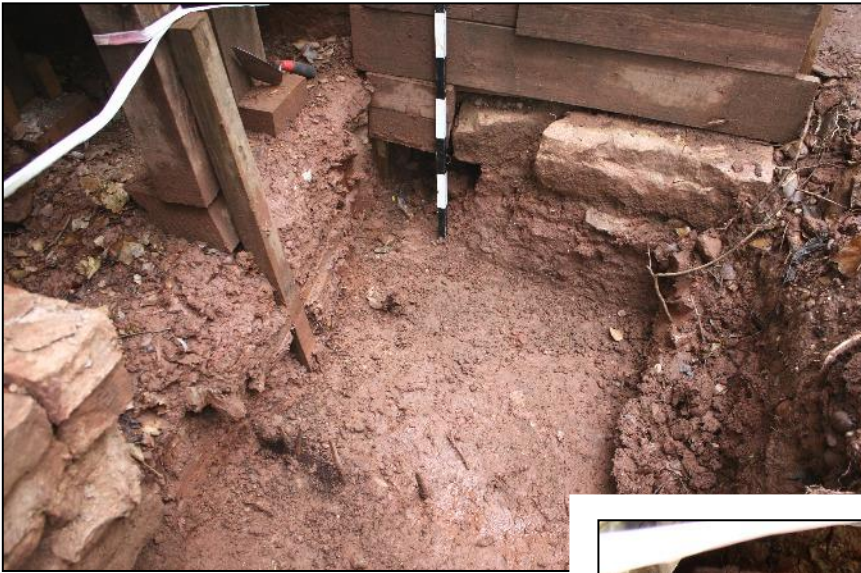
Plate 8: Iron nails of former wooden drain, shute or launder, here exposed at low level outside wall entry.

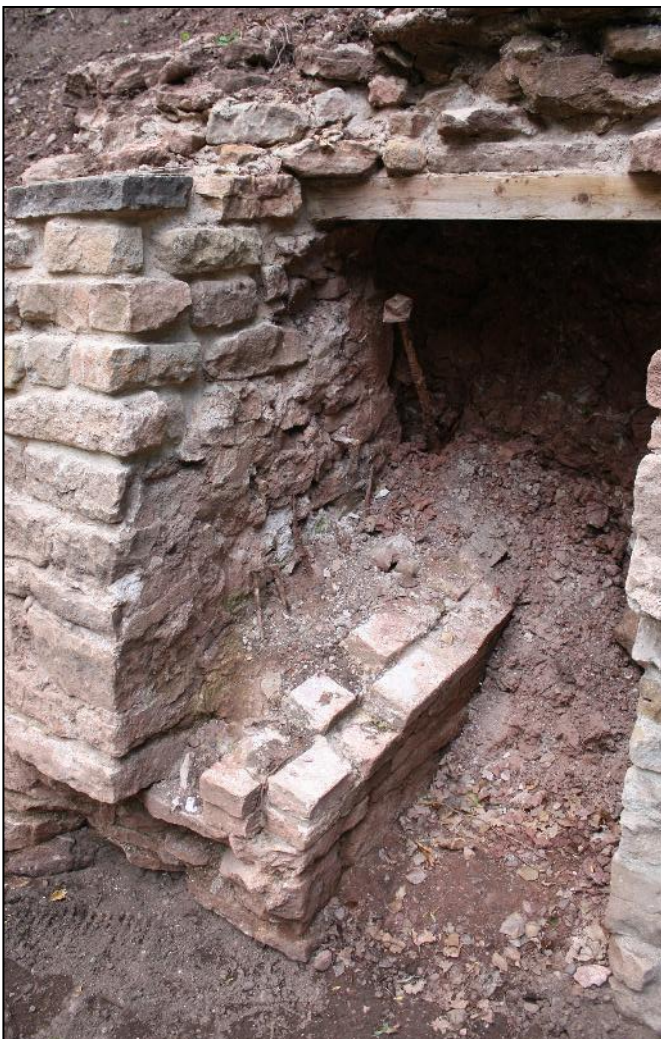
Plate 10: Surviving west side of former brick drain extending back into the wall entry.

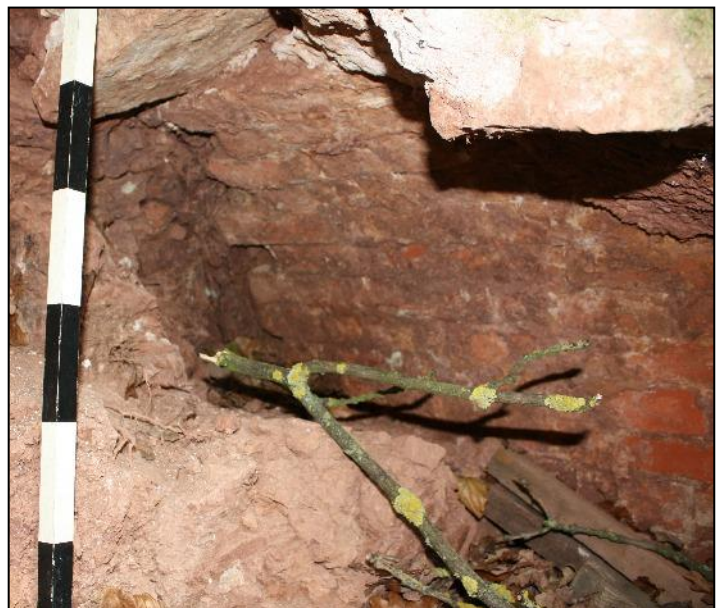
Plate 11: More intact east side of the brick drain, here overlain by extended stonework.

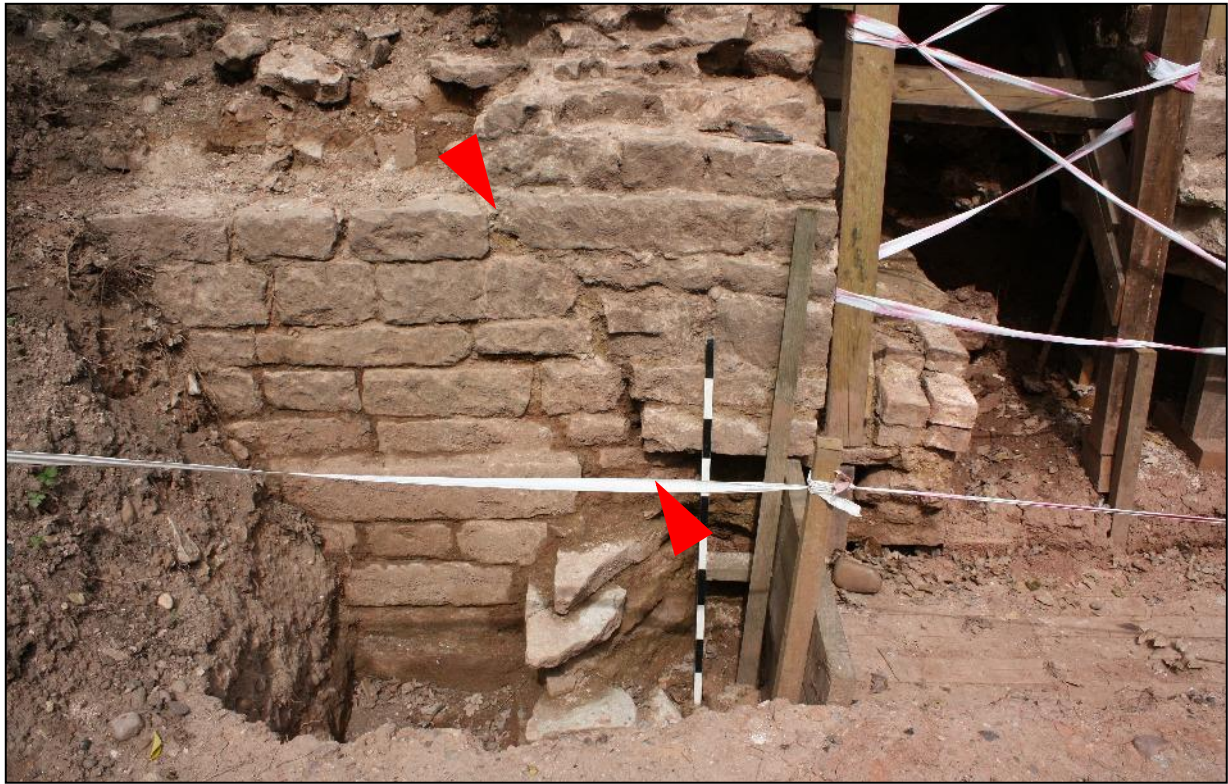
Plate 12: Intact stonework on left (west) side of the central entry, with part of brick arch showing to the right. The arrows indicate a break or change in the stonework.

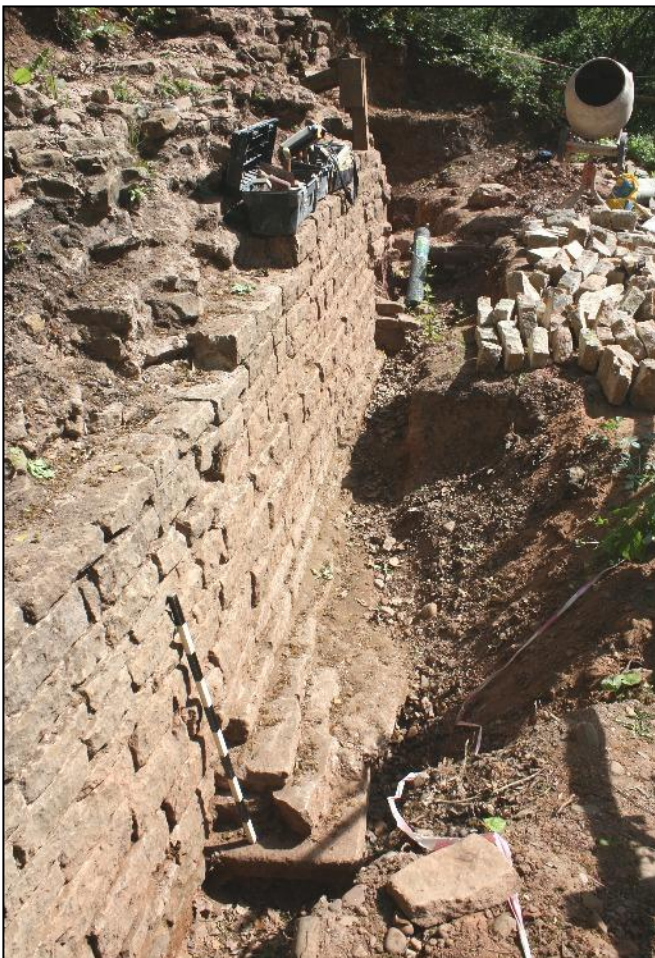
Plate 13: View looking eastwards along the west part of the walled feature, showing projecting foundation stones.

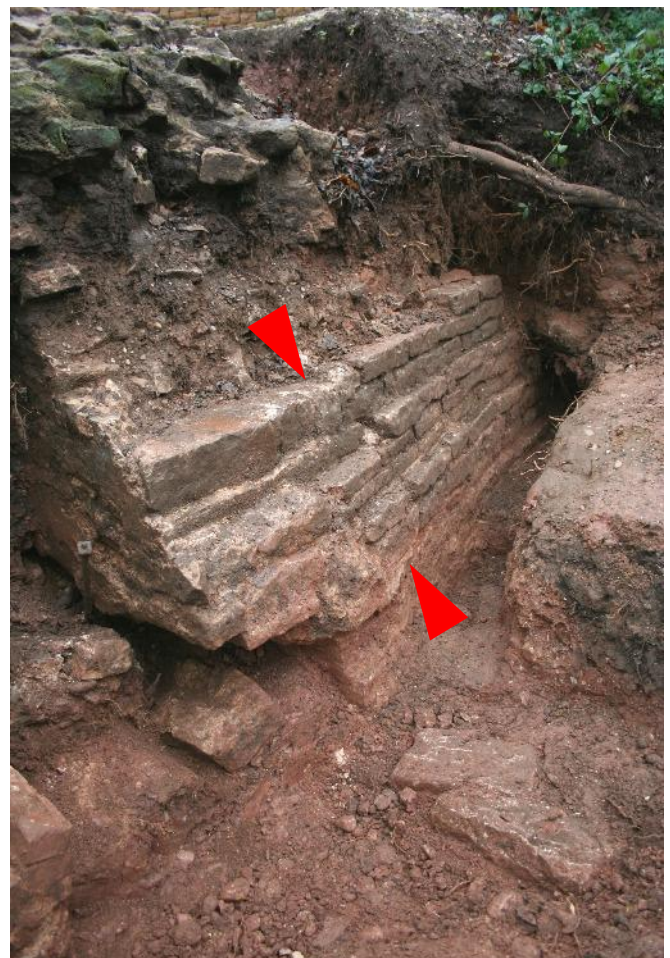
Plate 14: Partly excavated east part of the walled feature showing change in angle towards the central entry.

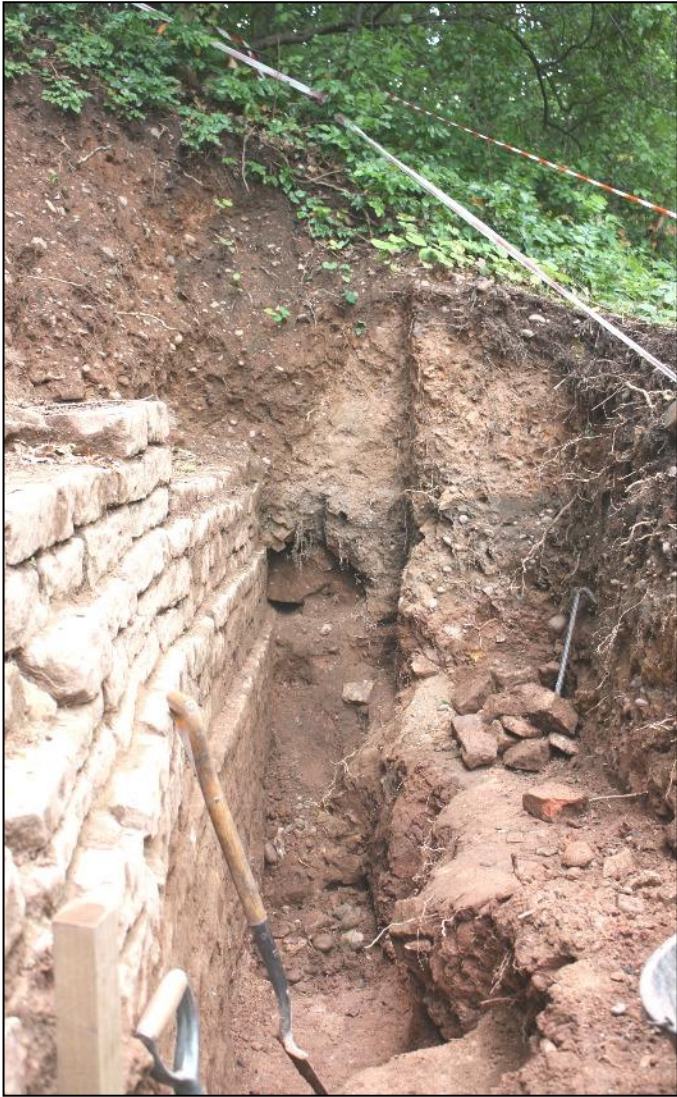
Plate 15: View of excavation work alongside the eastern extent of the wall, here showing differences in the accumulated soil layers.

See Plate 15 for an indication of the build-up of soil levels and how tree roots had affected this part of the site.

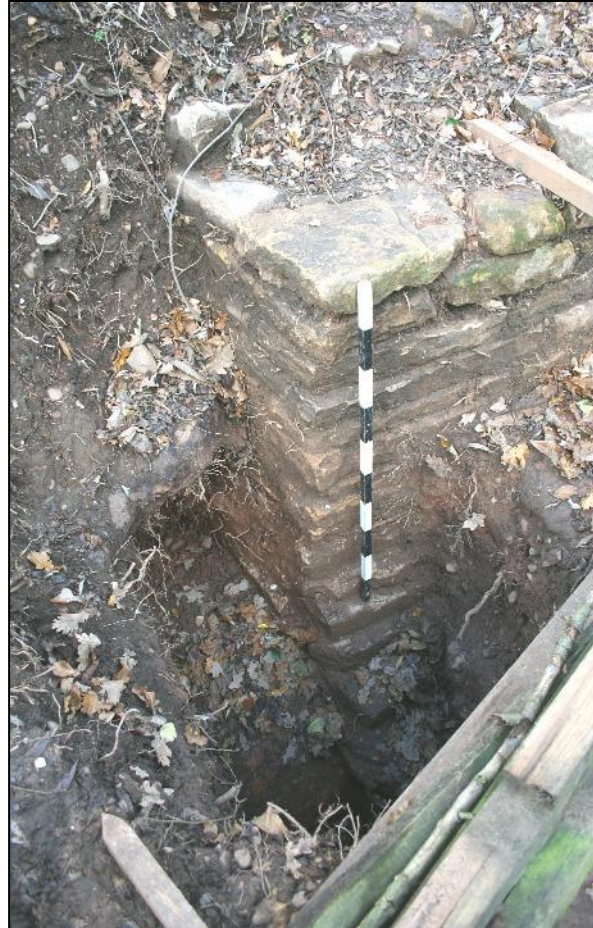
Plate 16: South-west corner of the wall with, to base, extending foundation courses and a brick drain, here covered by leaves.

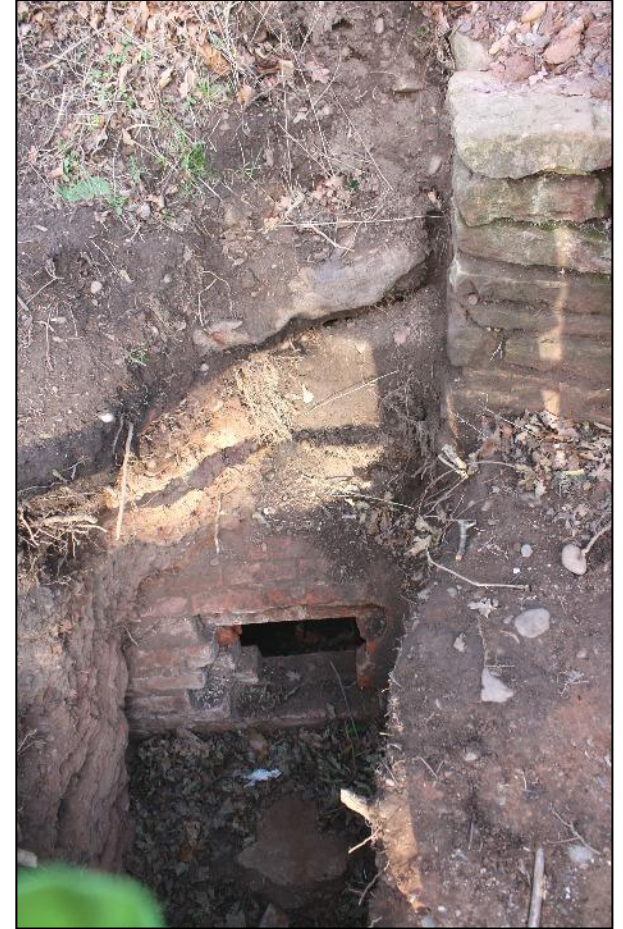
Plate 17: Entry subsequently made into side of brick drain (see Plates 20-22).

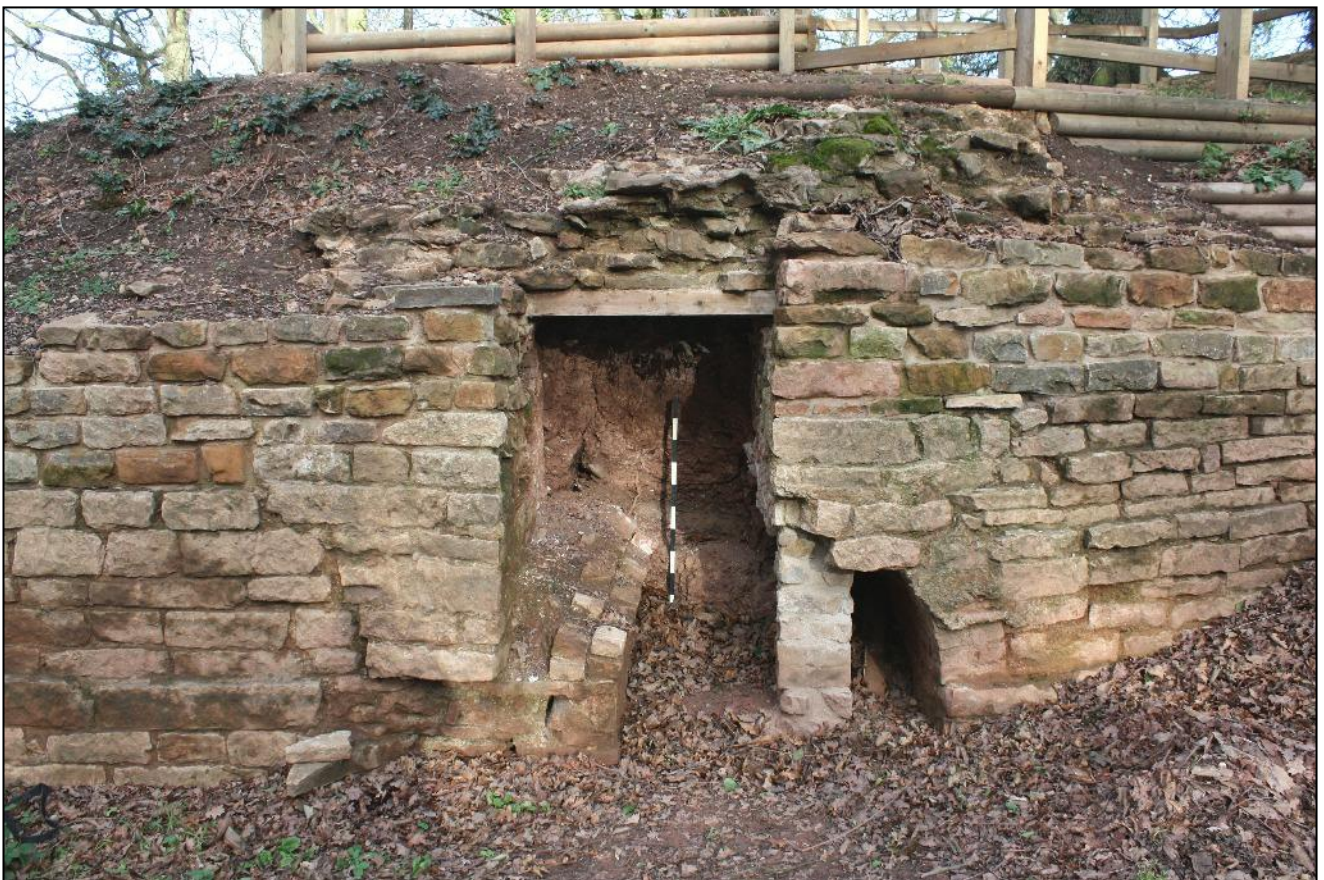
Plate 19: The central entry with more of the brick arch showing, along with an added support timber and a brick pillar.

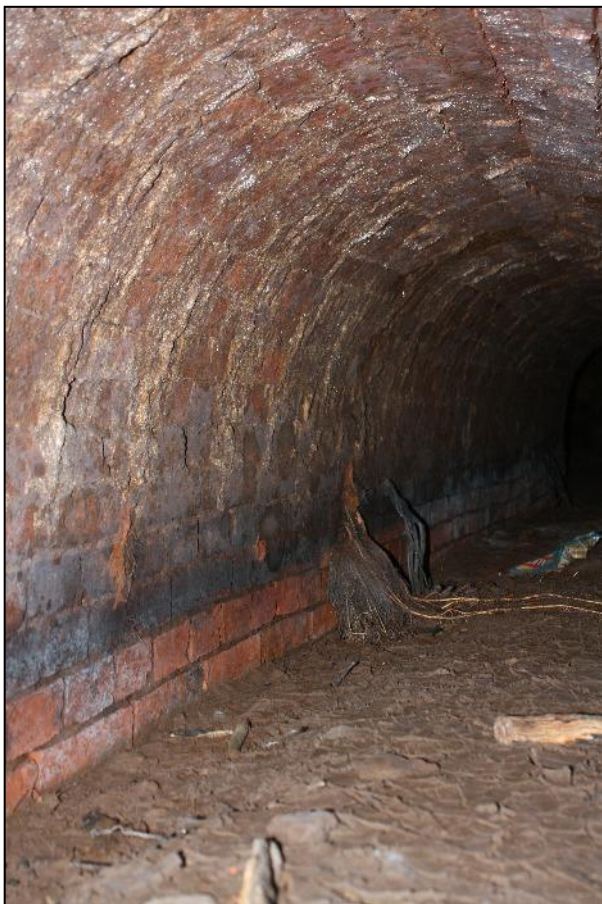
Plate 20: View of internal side walling of arched brick drain, looking east from a point near the south-west corner of the wall near Papplewick Lane.

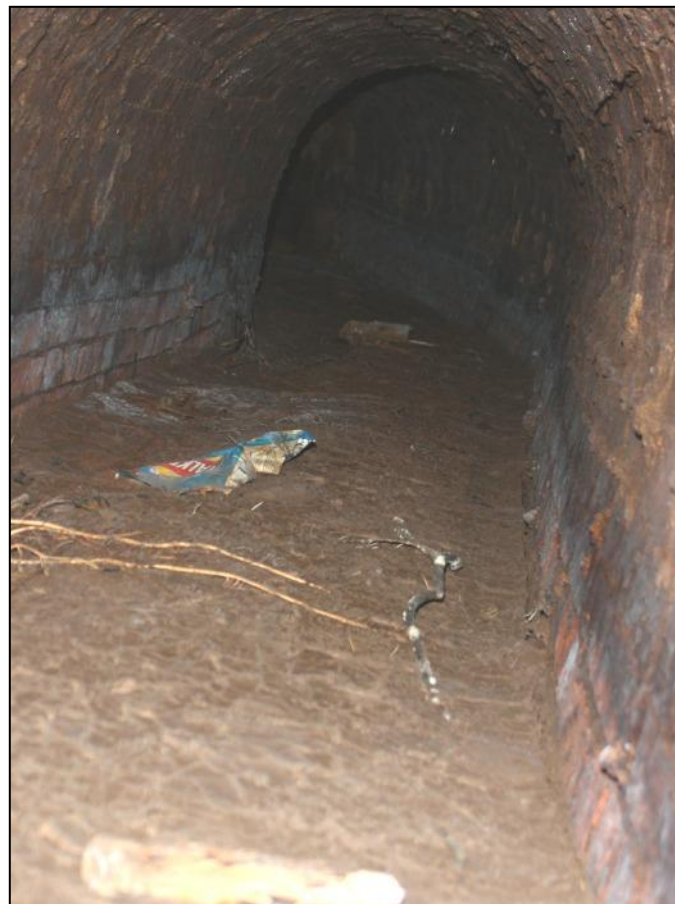
Plate 21: Another view showing change of direction of drain as it continues towards the water control feature.

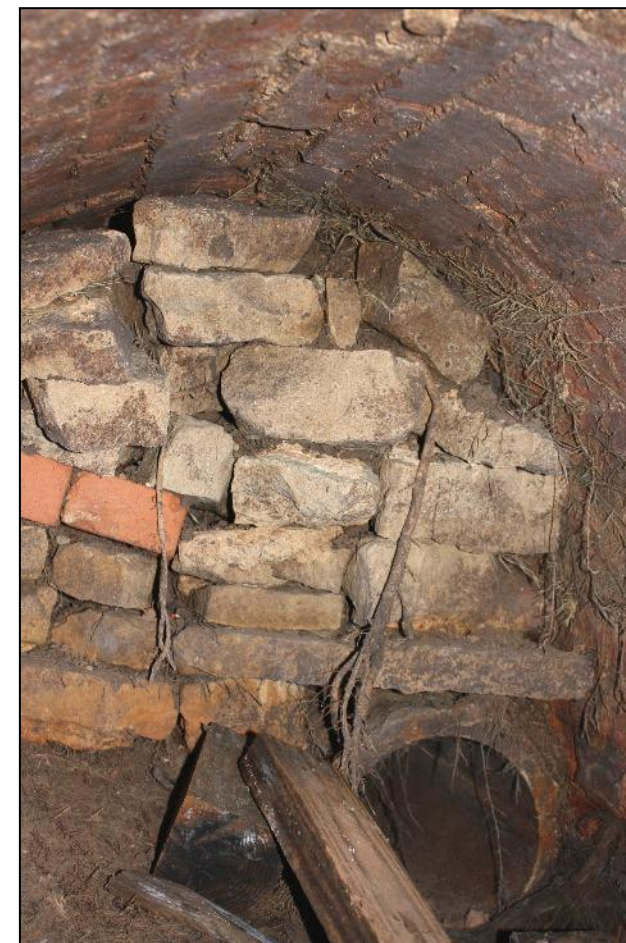
Plate 22: View looking west showing stone and brickwork blocking and ceramic drain.

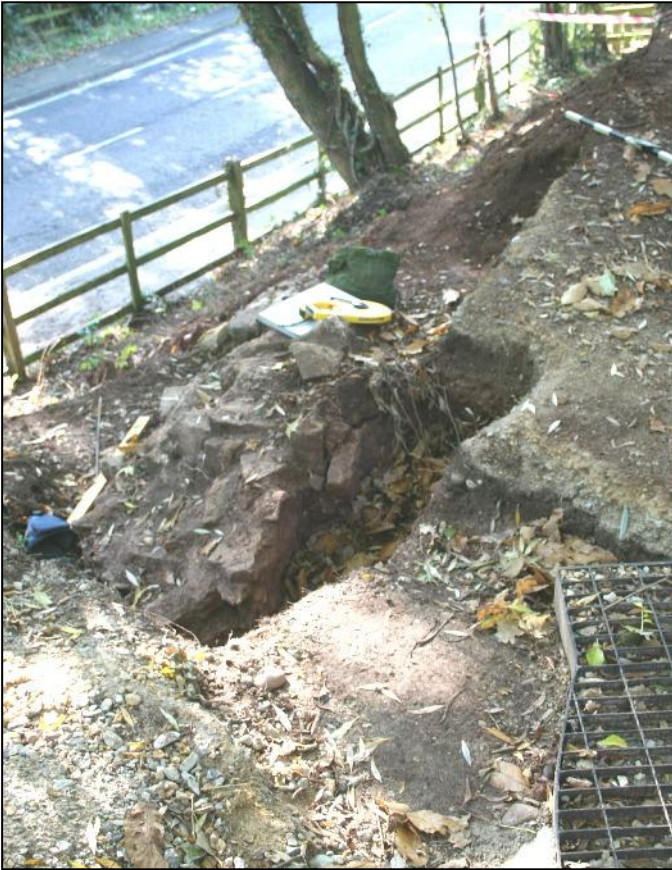
Plate 23: View of the north, rear side of the wall's core stonework.

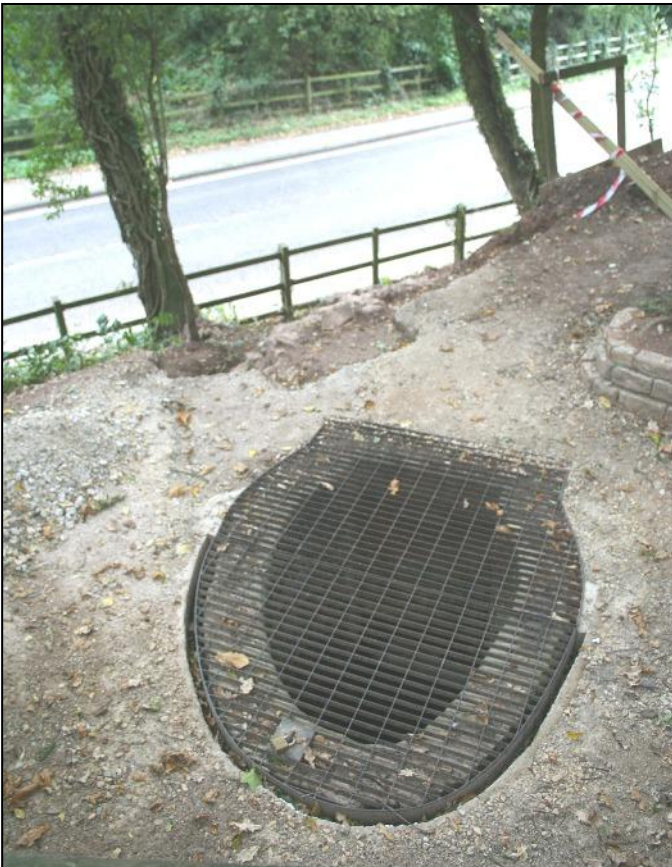
Plate 24: Rebuilt top (with safety grill) of the water control feature, situated behind the wall on Papplewick Lane.

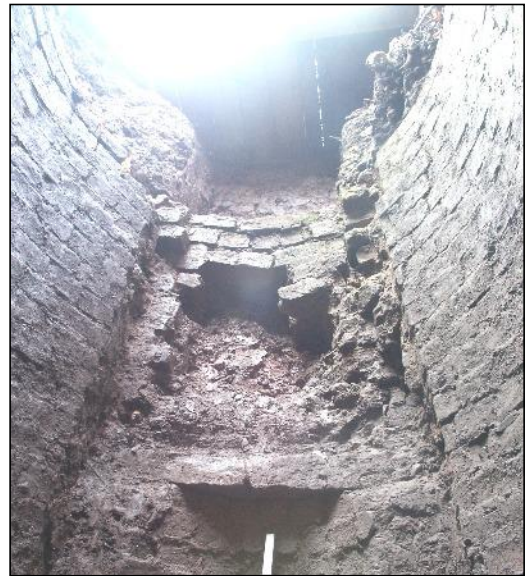
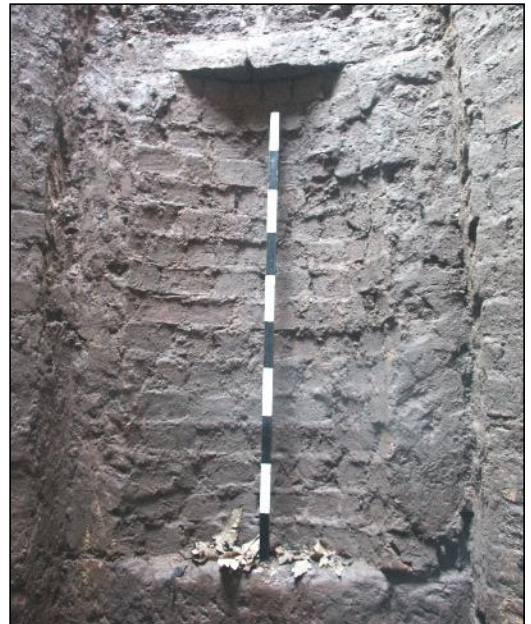
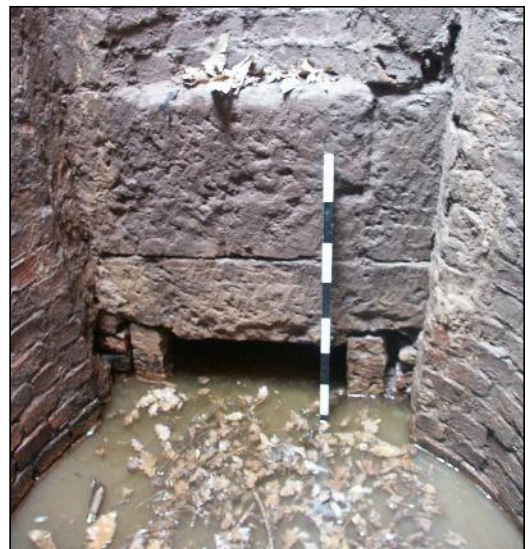
Plate 25: Montage of views of the south-west side of the interior of the water control feature.

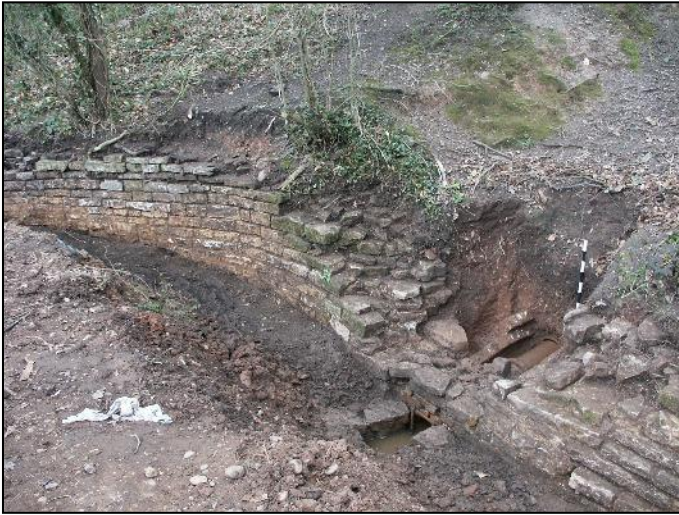
Plate 26: Length of walling showing on the south-west inner edge of Moor Pond.

Although the precise alignment of the drain could not be determined, it was possible to see a distinct kink between the point of access and where the drain met the water control point – see Plate 21. In Figure 6 an attempt has been made to show a likely course for the drain in this area. The evidence also suggests that beyond the kink the drain was slightly narrower. Just beyond the point of access the drain had been blocked with stone and a ceramic pipe installed (Plate 22). This parallels a similar alteration where water first entered at Moor Pond itself (Plate 26).

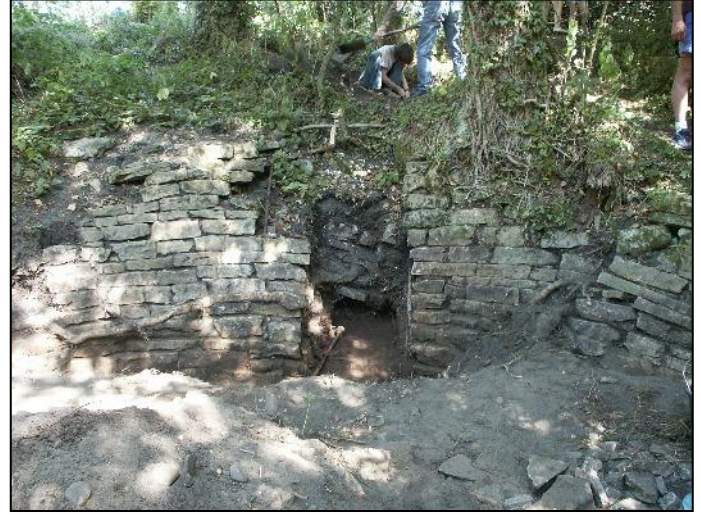
Plate 27: Length of walling with narrow central opening showing on the east inner side of Moor Pond.

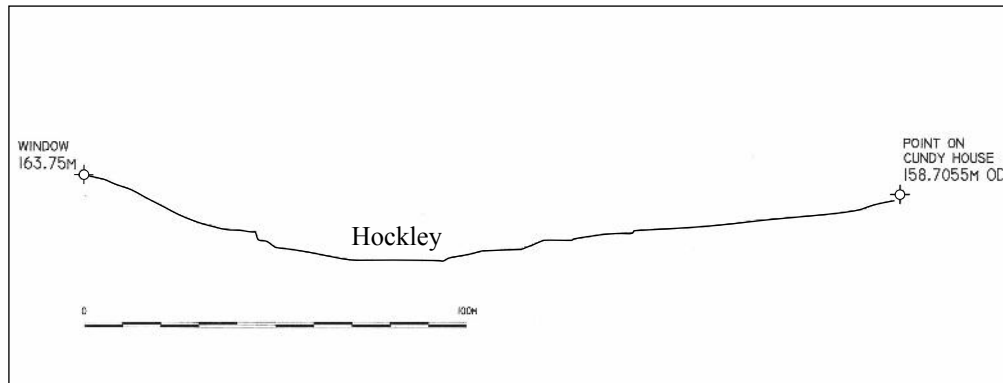
Plate 28: Surveyed profile across a valley known as Hockley, close to Bolsover Castle, Derbyshire, showing the course once followed by a water pipe running between a conduit house (the *Cundy House*) and the so-called *Cistern House* on the north-east side of the Seventeenth century castle.

The higher level launder poses a further problem as at this height it would have caused an obstruction on Papplewick Lane. It is known to have extended beyond the wall opening and it may then have been designed to then drop to a lower level, commensurate to that of the previous launder. The overall water system for the Robinson mills had to cross a number of tracks and roads and the evidence suggests that water probably ran across at just below road level and that overlying boards or narrow fording would have allowed continued road use. Any need to deal with a rise in level was possible through simple gravity feed – most notably between the two sides of Papplewick Lane. An example of this offered here is at Bolsover Castle where spring water from a 17th century conduit house once flowed into a valley and up the other side simply by force of gravity to supply a water tank within the Castle (used in turn to power a vertical gin and thereby supply water to a fountain) – see Plates 28-30.

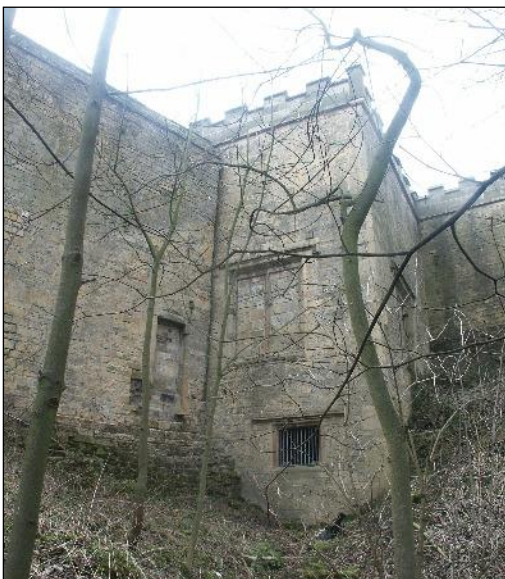
Plate 29: External view of the *Cistern House*. The top extends from a crenellated high-level wall surrounding the *Fountain Garden*.

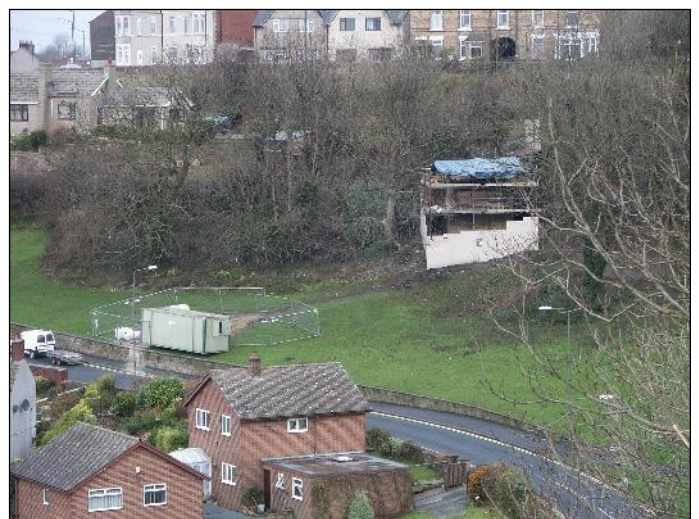
Plate 30: View taken from the *Fountain Garden* wall showing Hockley and the *Cundy House* surrounded by scaffolding during its restoration in 2002-03.
